PEACEFUL BAY HERITAGE PRECINCT

CONSERVATION PLAN

PREPARED BY DAVID HEAVER AND ASSOCIATES ARCHITECTS
FOR THE SHIRE OF DENMARK

DECEMBER 2003

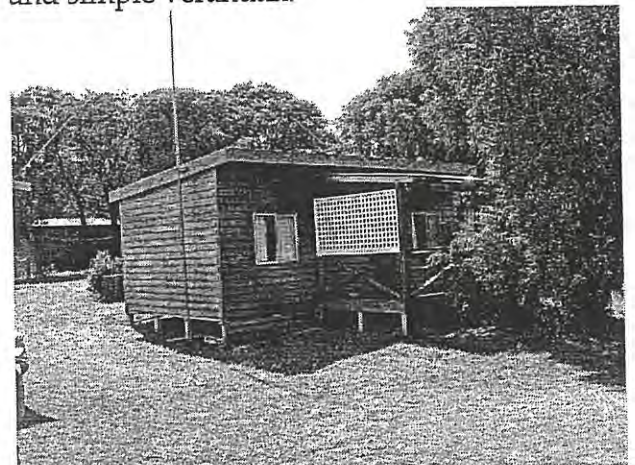
Photo 8 Timber clad skillion
The lattice work to the verandah addition is not an authentic detail.

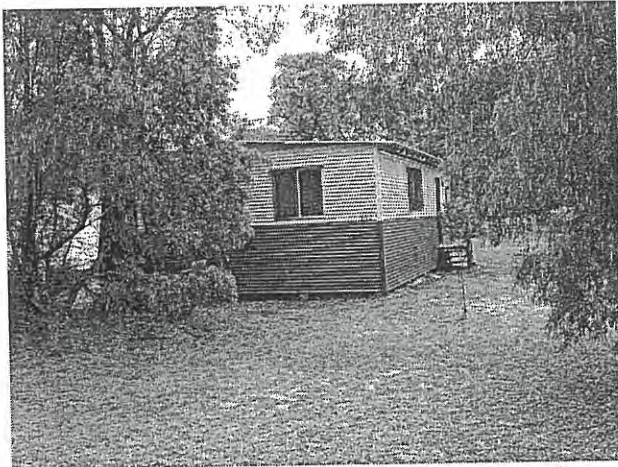
Photo 19 Authentic cladding has been replaced with colorbonded corrugated steel

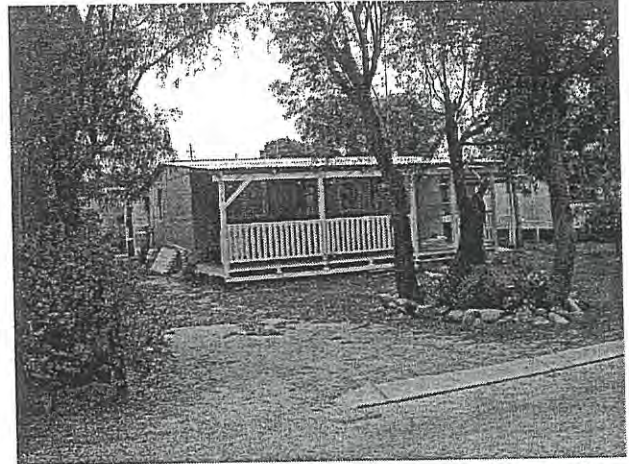
Photo 20 Balustrading is a decorative element that is not authentic to the precinct

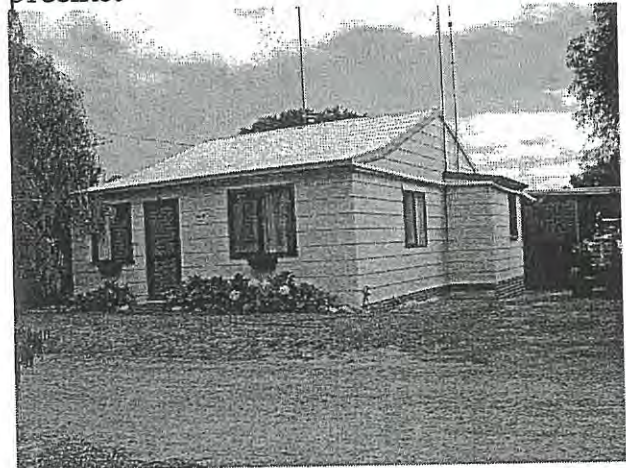
Photo 22 Wide profile cement sheet boarding is not authentic

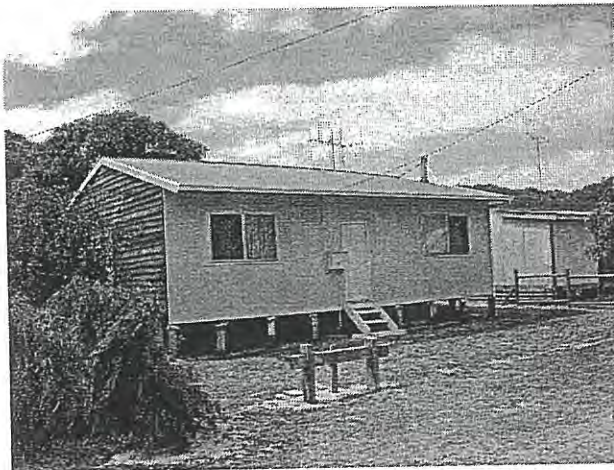
Photo 23 The timber boarding to the front of this cottage has been replaced with flat cement sheet

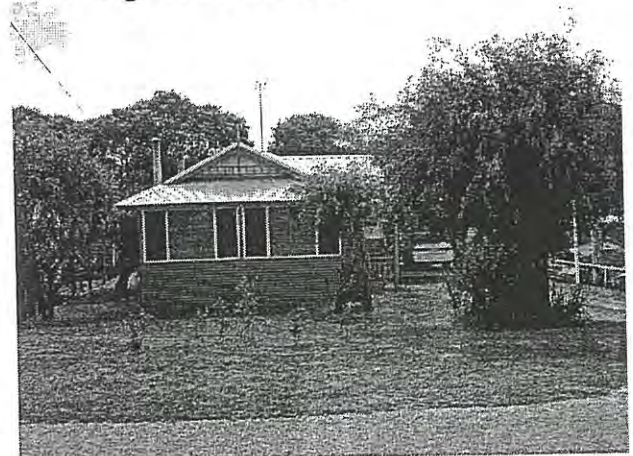
Photo 24 House has recently been extended and reclad with corrugated customorb
Decorative elements such as that on the gable are not authentic to the place, neither is the hipped carport.

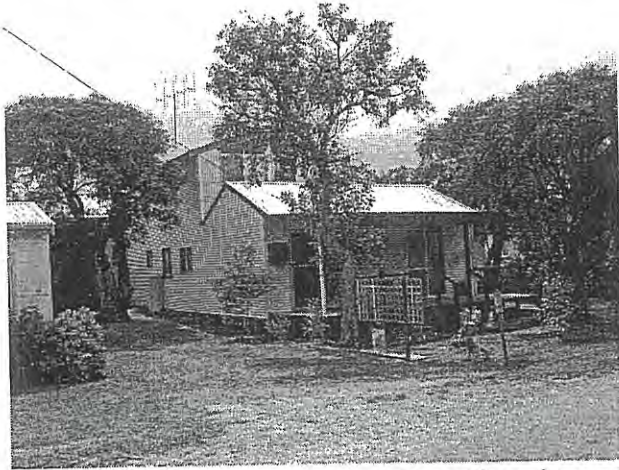
Photo 25 Two storey construction is not authentic to the precinct

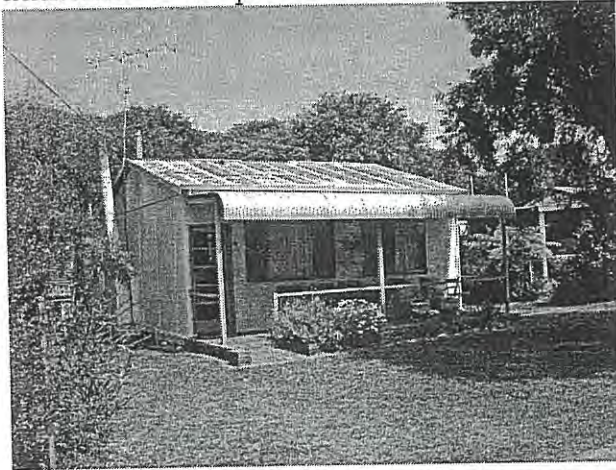
Photo 27 Bullnose verandah is not an authentic detail

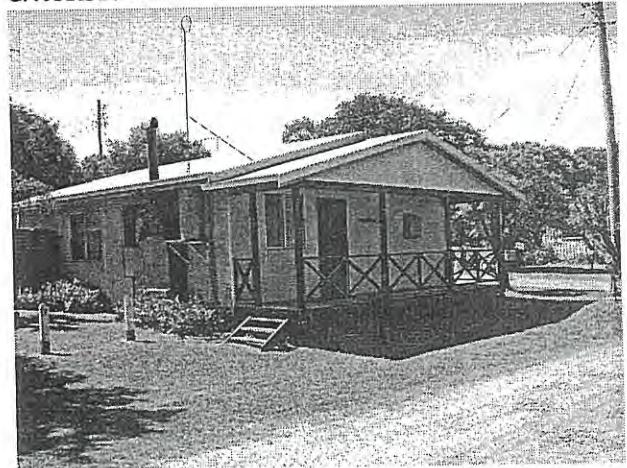
Photo 28 New verandah
New verandahs are starting to be added. Decorative elements such as crossed balustrading are not authentic to the precinct.

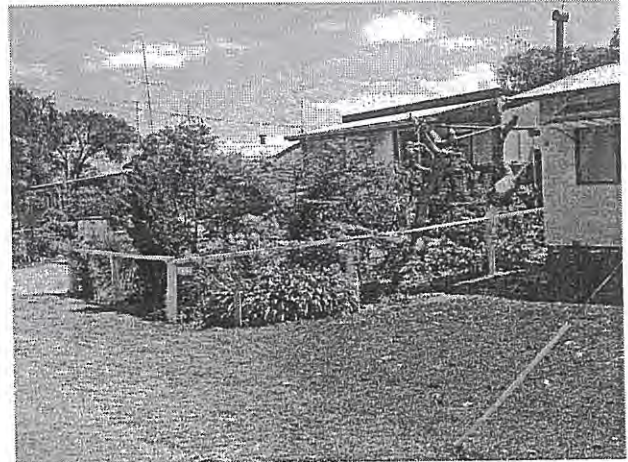
Photo 42 Exotic Planting
Planting of exotic species is not authentic, but because of the increase in permanent population is becoming more frequent.

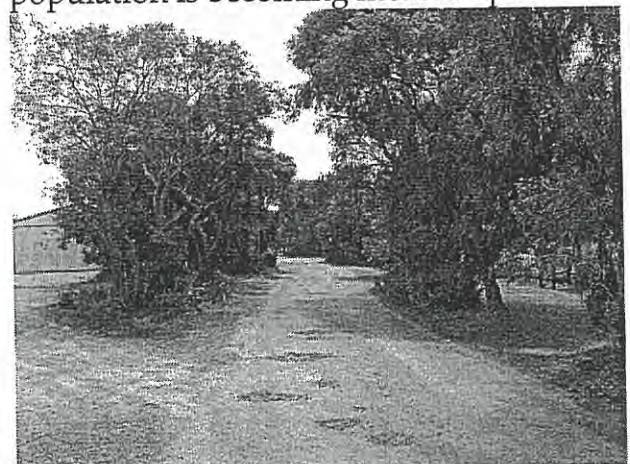
Photo 44 Large areas of gravelled surfaces around the Fire Brigade building

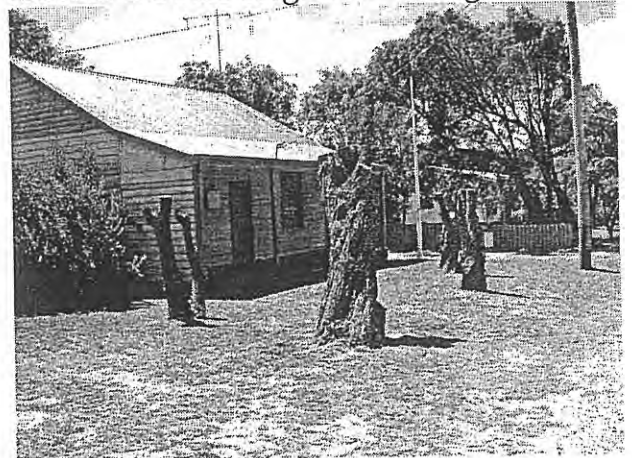
Photo 46 Peppermints have been lopped to stumps

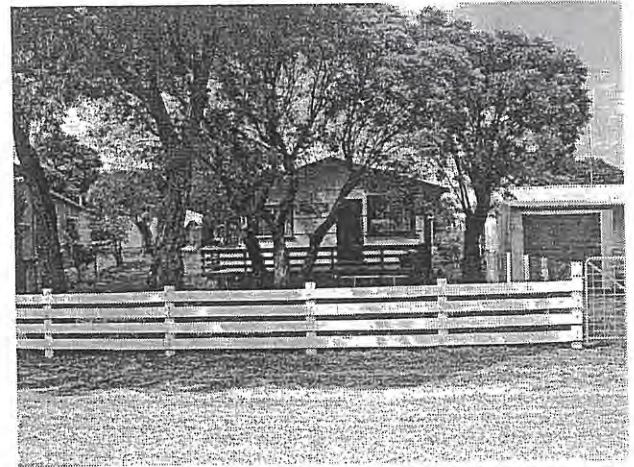
Photo 48 Wide post and rail fence is visually intrusive

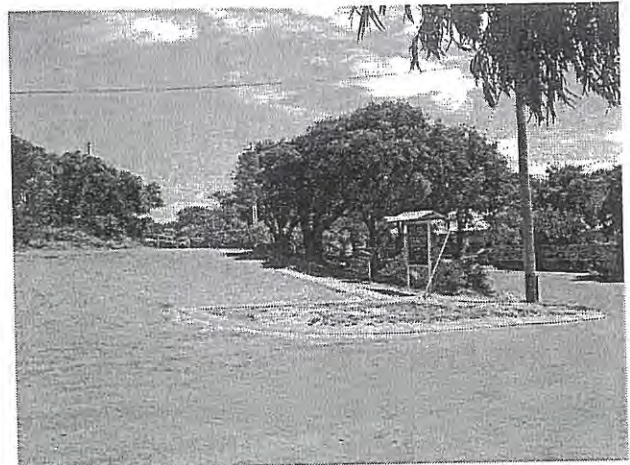
Photo 58 The road and car park at the entry to the precinct
This is the entry statement for the precinct and should be upgraded

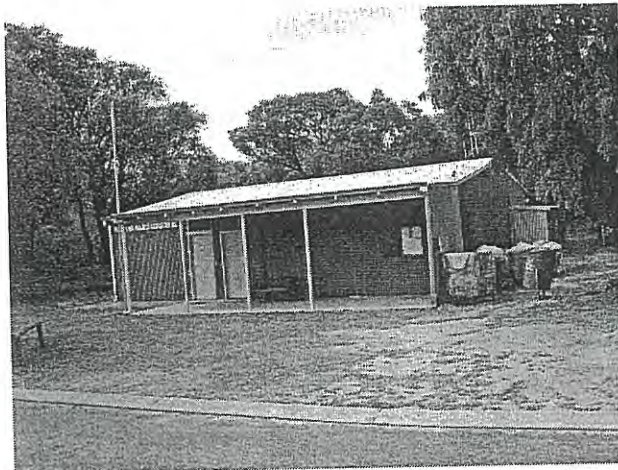
Photo 59 The Progress Association Hall on First Avenue.
This building could be upgraded to be more in keeping with the precinct.

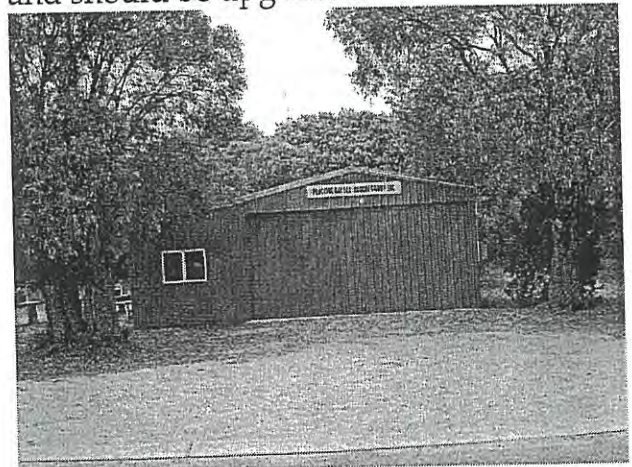
Photo 60 The Sea Rescue Building on First Avenue
This building could be upgraded to be more in keeping with the precinct.

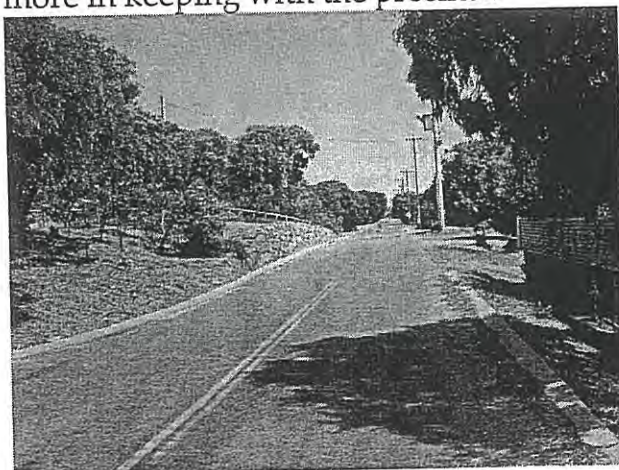
Photo 61 First Avenue at the entrance to the precinct
Bitumen, kerbing and linework are not in keeping with the precinct.

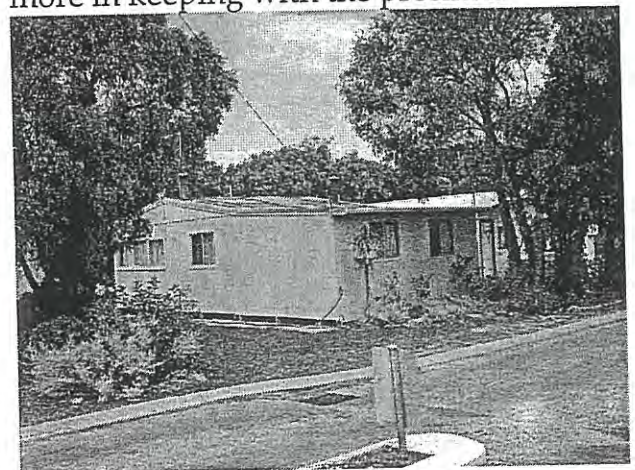
Photo 62 Traffic Island to First Avenue
This is not considered appropriate to the character of the precinct

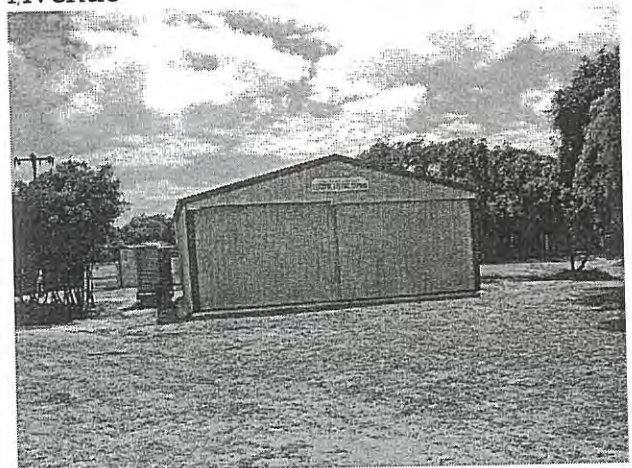
Photo 66 Fire Brigade building on West Avenue
This is a large steel building standing alone in a large area of gravel
