# **Wilson Inlet Foreshore Flora Survey**

**March 2011**

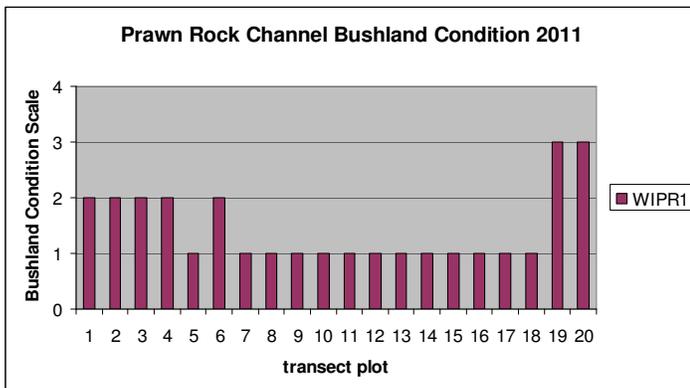
Figure 1.1 Prawn Rock Channel Bushland Condition

Bushland Condition: Overall the Bushland Condition was generally “Poor” or “Degraded”, with incursion of introduced *Paspalum spp.* (Couch) and *Pennisetum clandestinum* (Kikuyu) grasses throughout the area. Only the last 2 inland meters of the transect line (plot 19 and 20) showed improvement to “Good” condition (see figure 1.1). This coincided with proximity to/reduction in water level.

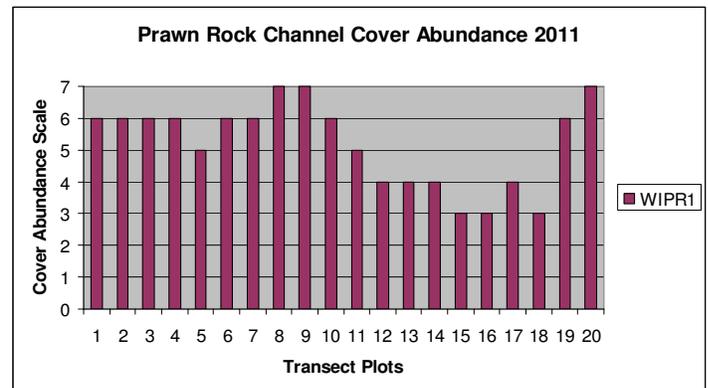
Figure 1.2 Prawn Rock Channel Cover Abundance

Cover Abundance: Ranged from 3 to 7 cover along the transect line (see figure 1.2). There appeared to be no correlation between the Cover Abundance values and water levels as any one Cover Abundance value varied considerably over differing inundation levels.

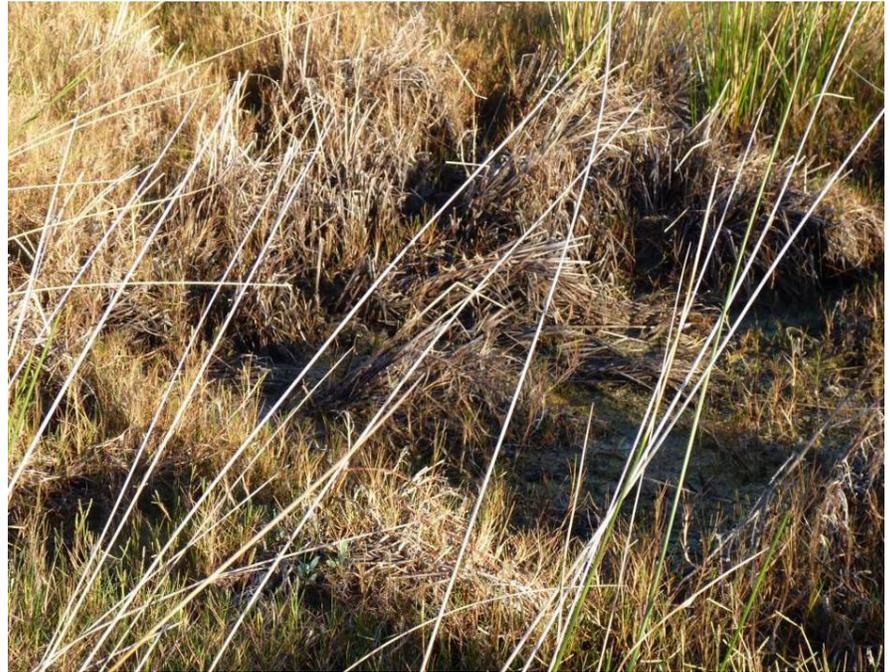
It was noted that along and around the transect, particularly in deeper water sections, there were a number of dead clumps of a native sedge species (see Photo 1.2), which the couch was growing over. This may be why the couch could survive in the deeper water sections of the transect. A number of dead *Melaleuca* species were also seen in the vicinity; however these deaths occurred over a number of years ago due to drainage/road works nearby (pers. comm. Shire of Denmark).

**Photo 1.2** Prawn Rock Channel; example of dead sedge clumps and couch invasion

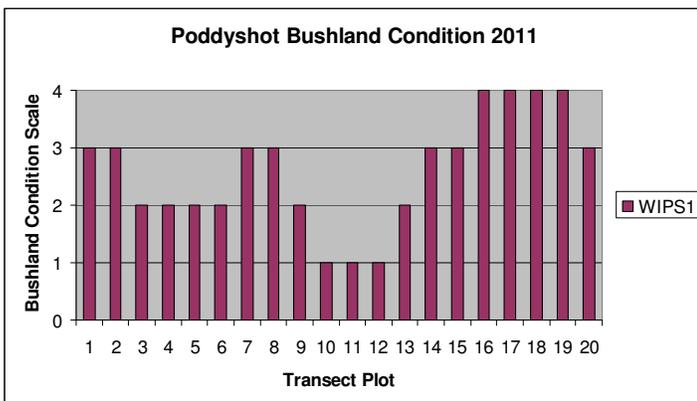
**Figure 2.1** Poddysshot Bushland Condition

**Bushland Condition:** The Poddysshot transect varied greatly, ranging from “Degraded” to “Very Good” (see figure 2.1). “Very Good” condition was only recorded along the latter, inland section of the transect; plots 16 – 19. “Good” condition was recorded throughout the transect with no general trend i.e. plots 1, 2, 7, 8, 14 and 20. “Poor” and “Degraded” conditions were similarly distributed. The lower condition grades were mainly due to incursion from the invasive grass species, *Paspalum spp.* (Couch) and *Pennisetum clandestinum* (Kikuyu). There was also a smaller population of other invasive weeds including *Chenopodium spp.* (Goosefoot).

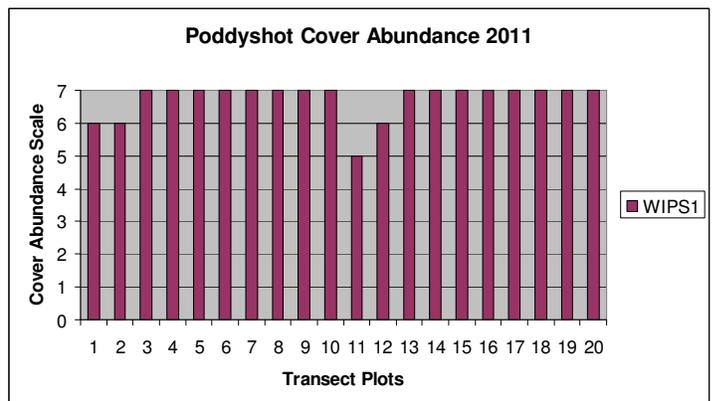
**Figure 2.2** Poddysshot Cover Abundance

Cover Abundance: Fairly uniform along the transect line from 5 to 7, with the majority of plots recording 7 (75-100% cover) (see figure 2.2). The plots that recorded 5 and 6 Cover Abundance coincided with the only recordings of water inundation (0.5cm to 9cm). Upperstorey cover began at plot 13 with stands of *Melaleuca cuticularis* and still supported understorey cover of 45% - 100%.

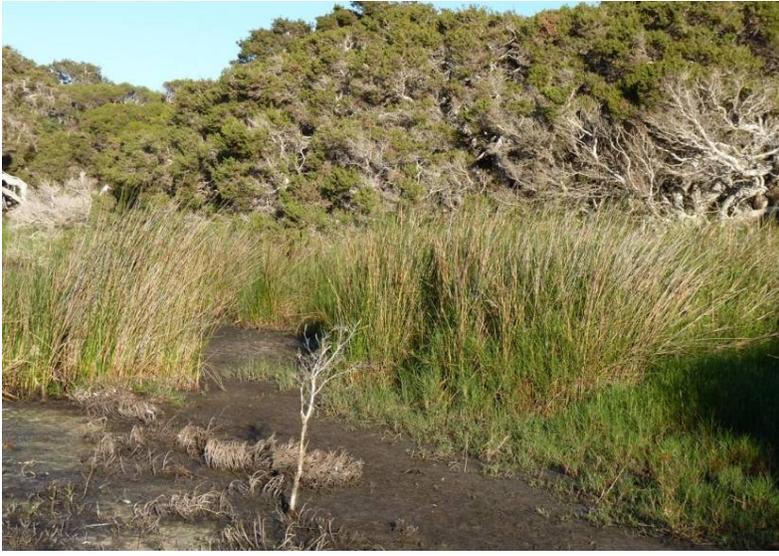
Flora species: *Juncus kraussii* and *Ficinia nodosa* were the dominant under storey native species, while the upperstorey consisted of *Melaleuca cuticularis* from plot 13 to 20. There was evidence of young *Melaleuca spp.* death in area within the inundation zone (see photo 2.2).

**Photo 2.2** Poddyshot, dead *Melaleuca spp.* (note; was taken mid March 2011. At time of survey Melaleuca was partially under water).

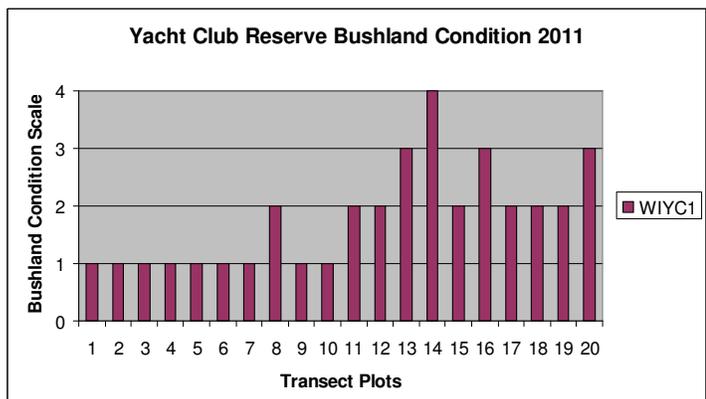
**Figure 3.1** Yacht Club reserve Bushland Condition

Bushland Condition: Generally “Poor” to “Degraded” along the length of the transect (see figure 3.1). Exceptions were plots 20, 16, 14 and 13 which were graded “Good”, “Good”, “Very Good” and “Good”, respectively. As mentioned previously, where there had been recent and current inundation there was little understorey and a number of weeds evidence leading to Bushland Condition generally graded as “Degraded” (plot 1 – 10), with the exception of plot 8 with a grade of “Poor”.

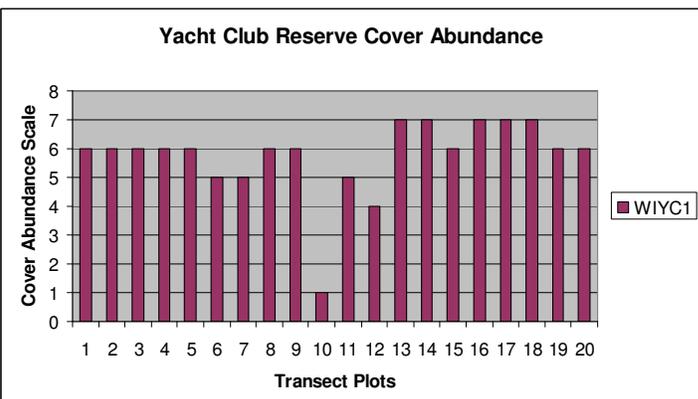
**Figure 3.2** Yacht Club Reserve Cover Abundance

Cover Abundance: Plots 1 to 9 recorded a value of “6” (see figure 3.2), primarily from upperstorey cover by *Melaleuca cuticularis* and *Melaleuca raphiophylla*. The understorey for these plots was generally negligible (less than 5% cover) except for plot 7 and 8 where weed incursion including *Chenopodium spp.* (Goosefoot) and *Sonchus spp.* (Sowthistle) had occurred. Further inland (plots 11 to 20) along the transect, the understorey cover increased to 20% - 100%. Plots 13 – 20 all recorded abundance cover of 7 with the exception of plot 15 which recorded a cover of 6. Plots 10, 11 and 12 recorded covers of 1, 5 and 4 respectively. In these plots there were gaps in the upperstorey and <5% to 50% understorey cover.

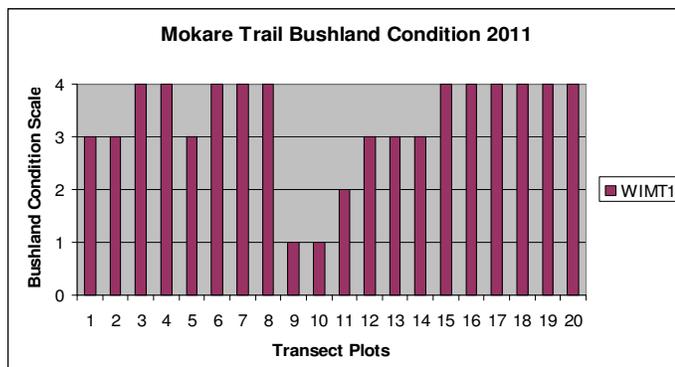
Figure 4.1 Mokare Trail Bushland Condition

Bushland Condition: Fairly consistent over the transect line with “Good” - “Very Good” condition in all except three plots (9, 10 and 11) (see figure 4.1). Mokare Trail intersected the transect on plots 9 and 10 and half of plot 11, hence the “Degraded” Bushland Condition score for plots 9 and 10 and “Poor” for plot 11. Minimal weed incursion by *Paspalum spp.*(Couch) occurred primarily at the foreshore bank edge and a small number of *Eragrostis curvula* (African Lovegrass) and *Chenopodium spp.* (Goosefoot), occurred near the Mokare trail edge (plot 11).

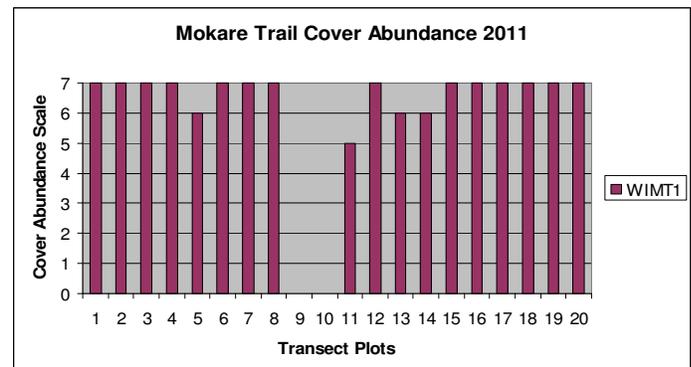
Figure 4.2 Mokare Trail Cover Abundance

**Cover Abundance:** Was also fairly uniform with grades of 6 and 7 along the transect, excluding where the Mokare trail intercepted the transect (see figure 4.2). Plot 11 recorded a value of 5 and plots 9 and 10 were “not applicable”. The cover was made up thick understorey and open upper canopy.

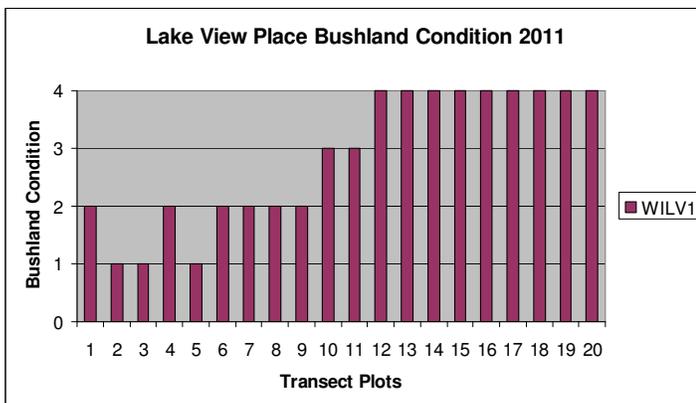
**Figure 5.1** Lake View Place Bushland Condition

**Bushland Condition:** Ranged from “Degraded” to “Very Good” (see figure 5.1). From the shoreline end, (plots 1 – 9), the condition was “Degraded” - “Poor” with invasion by *Paspalum spp.* (Couch), *Chenopodium spp.* (Goosefoot) and *Conyza spp.* (Fleabane). From plot 10 Bushland Condition improved with plots 10 and 11 recording “Good” and 12 – 20 “Very Good”.

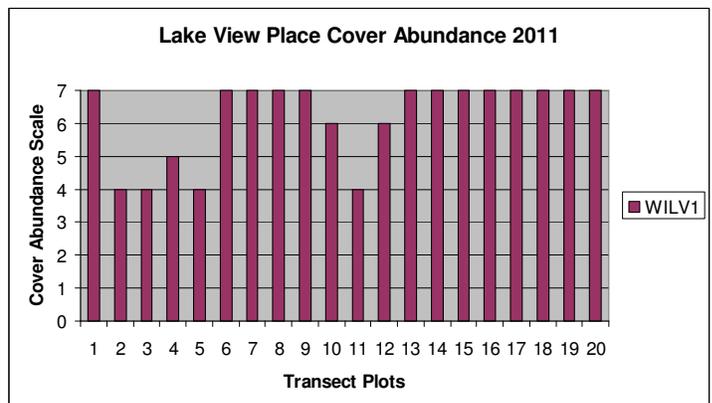
**Figure 5.2** Lake View Place Cover Abundance

**Cover Abundance:** Was generally high with 15 out of the 20 plots recording cover of 6 and 7 (see figure 5.2). Plots 2, 3, 5 and 11 recorded cover of 4 and plot 4 recorded cover of 5. A high percentage of the cover for shoreline end plots was from invasive flora species as described above in Bushland Condition section.

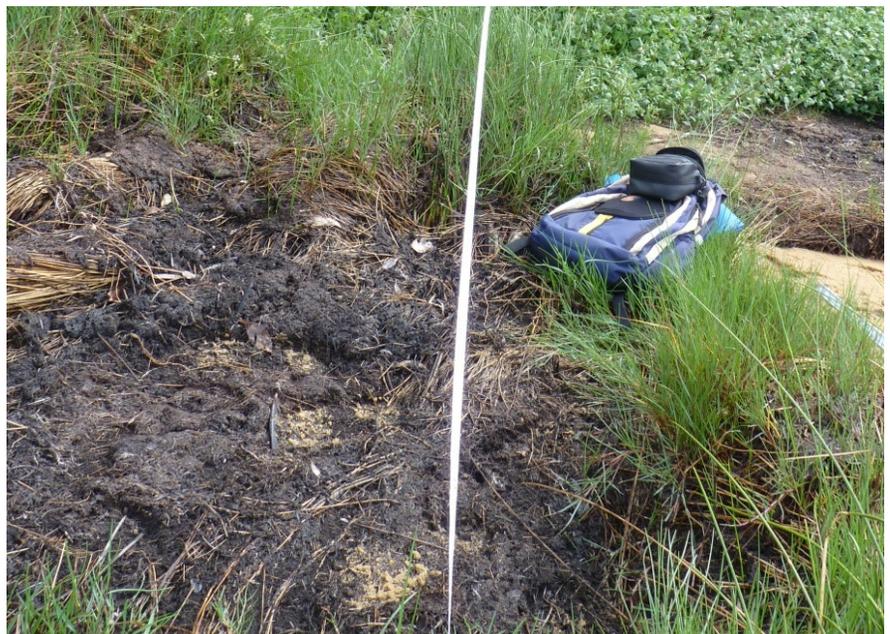
It was also noted that there were a number of dead sedges in and around some of the shoreline end plots (see Photo 5.2).

**Photo 5.2** Example of dead sedges and other vegetative matter

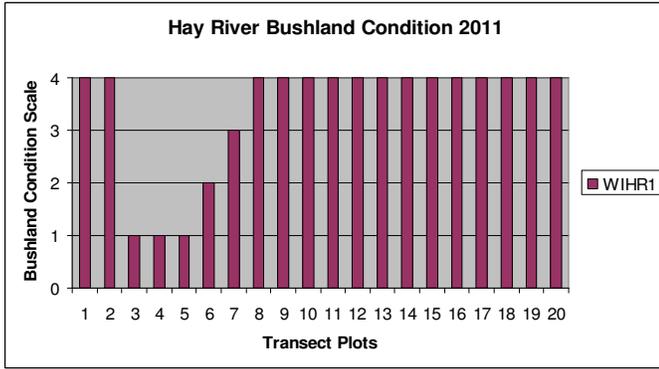
Figure 7.1 Hay River Bushland Condition

Bushland Condition: Generally “Very Good” with only plots 3, 4, 5, 6 and 7 graded “Degraded”, “Degraded”, “Degraded”, “Poor” and “Good” respectively (see figure 7.1). There was minimal weed incursion in the “Degraded” and “Poor” conditioned plots, however a vehicle track ran through plots 3, 4 and 5 which caused a high level of disturbance and changes to vegetation structure.

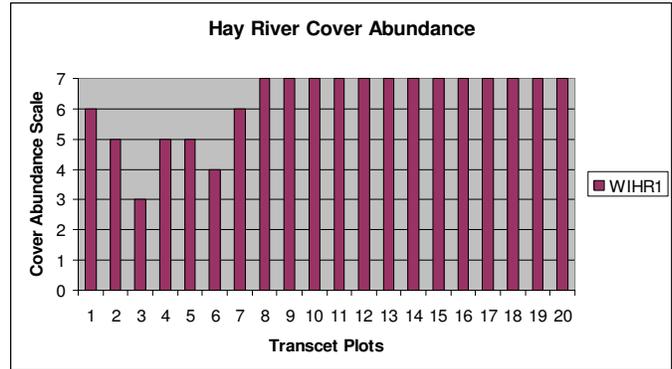
Figure 7.2 Hay River Cover Abundance

Cover Abundance: Was fairly uniform along the transect with plots 8 – 20 recording 7 (see figure 7.2). The dense cover was primarily made up of *Melaleuca cuticularis* and *M. densa* with very little under storey.

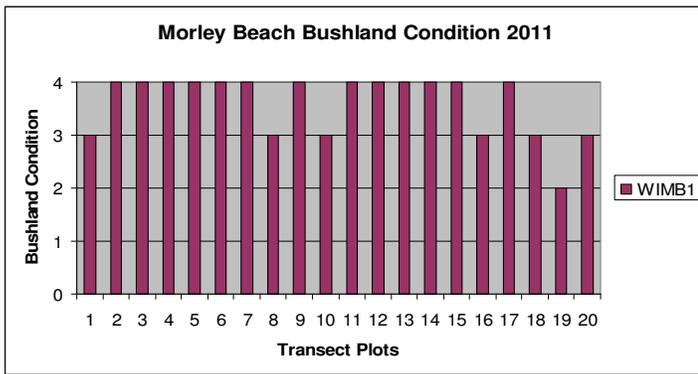
**Figure 8.1** Morley Beach Bushland Condition

Bushland Condition: Both ends (shoreline and inland ends) were “Poor” (plots 1, 19 and 20) with all remaining plots in either “Good” or “Very Good” condition (see figure 8.1). There was a small amount of *Chenopodium spp.* (Goosefoot) incursion in the area as well as evidence of disturbance to the shoreline fringing vegetation from vehicles accessing and driving along the beach.

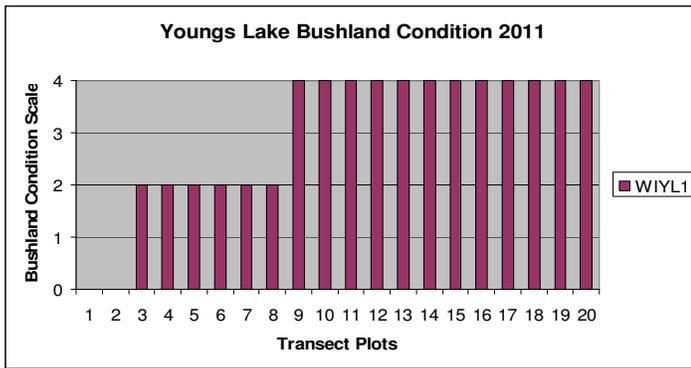
Figure 9.1 Youngs Lake Bushland Condition

Bushland Condition: Was “Very Good” (plots 9 -20) in the latter inland section of the transect (see figure 9.1). Plots 1 and 2 recorded no vegetation and were underwater, hence, “not applicable” was recorded. Further along the transect plots 3 – 8 recorded “Poor” condition with little vegetative matter.

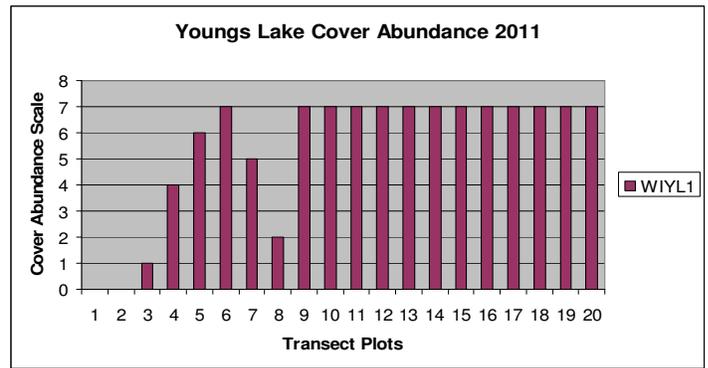
Figure 9.2 Youngs Lake Cover Abundance

Cover Abundance: Showed a general trend of increasing Cover Abundance values from shoreline to inland (see figure 9.2). Plots 1 and 2 recorded no vegetation but a number of granite rocks, so “not applicable” was recorded. Plots 3 – 8 ranged from 1 to 7 and plots 9 – 20 all recorded 7.

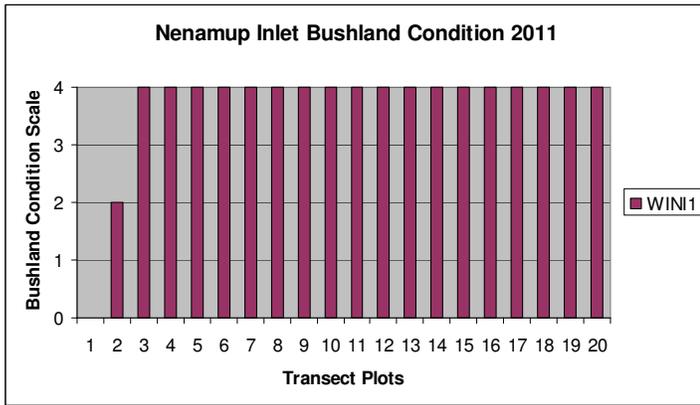
**Figure 10.1** Nenamup Inlet Bushland Condition

**Bushland Condition:** Was “Very Good” except for the two plots (plots 1 and 2) closest to the shoreline transect end (see figure 10.1). Plot 1 recorded “not applicable” due to no vegetation and complete water inundation. Plot 2 recorded a “Poor” bushland condition with 3 *Juncus kraussii* plants in the plot.

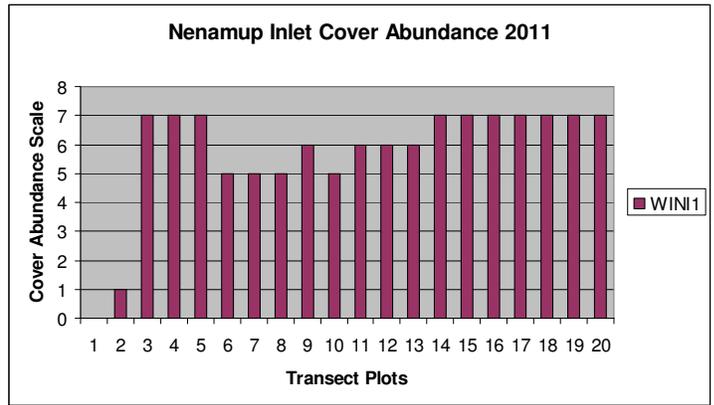
**Figure 10.2** Nenamup Inlet Cover Abundance

**Cover Abundance:** Was reasonably uniform, particularly at the inland end where plots 14 – 20 all recorded 7 (see figure 10.2). The lowest Cover Abundance values were recorded at plot 2 with a grading of 1. Plot 1, due to no vegetation and underwater, was “not applicable”. Between plots 3 – 13 the abundance cover ranged from 5 to 7 with no correlation to water depth, i.e., plots 3 – 5 recorded 7, plots 6 – 8 recorded 5 and plots 9 – 13 recorded 6.

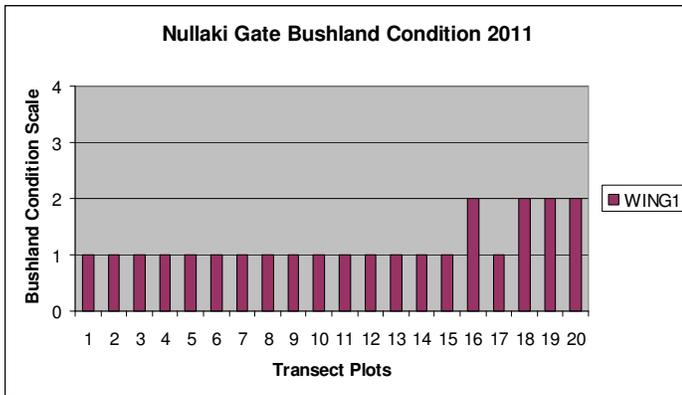
Figure 11.1 Nullaki Gate Bushland Condition

Bushland Condition: The transect was fairly degraded, with plots 1 – 17 recording “Degraded” condition (except for plot 16) and plots 18 – 20 recording “Poor” (see figure 11.1). The site showed a large infestation of *Paspalum spp.* (Couch) and little to no native vegetation. It was noted that the site showed evidence of past informal camping which may be contributing to the high level of disturbance to the area along with other factors.

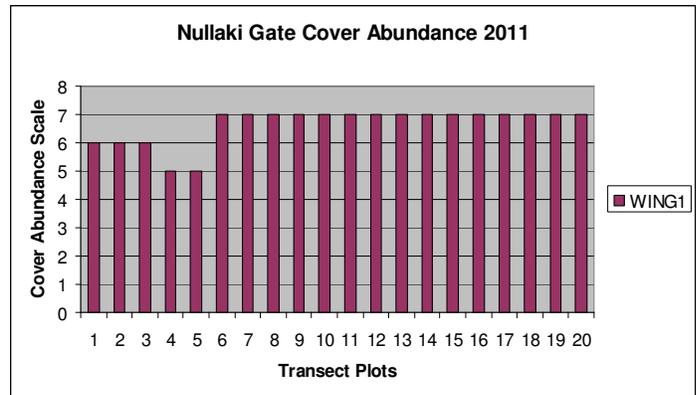
Figure 11.2 Nullaki Gate Cover Abundance

Cover Abundance: Was uniformly high, with only plot 4 (cover value of 5) recording a value less than 6 (see figure 11.2). As mentioned before, cover for plots 1 – 12, except for 5 plants, was only made up of the introduced Couch grass species. There was little upperstorey cover with a large number of dead trees.

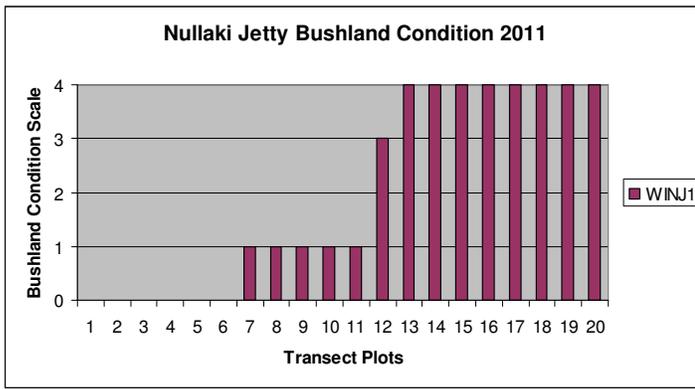
**Figure 12.1** Nullaki Jetty Bushland Condition

Bushland Condition: Improved traveling away from the shoreline transect end (see figure 12.1). Plots 1 -6 were “not applicable” due to being underwater and having no vegetation. Plots 7 – 11 were “Degraded”, plot 12 “Good” and plots 13 – 20 “Very Good”. The main invasive species along the “Poor” section of the transect were *Paspalum spp.* (Couch) and *Chenopodium spp.* (Goosefoot).

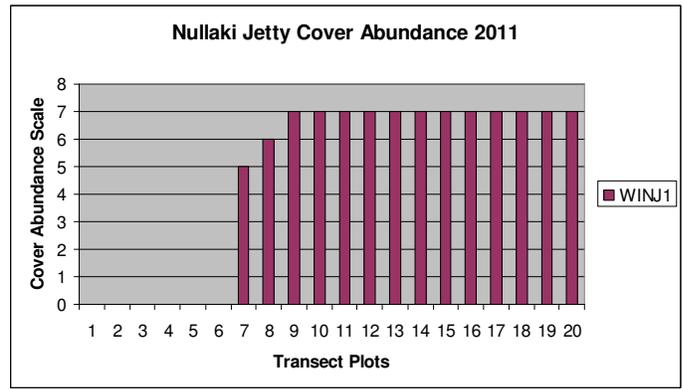
**Figure 12.2** Nullaki Jetty Cover Abundance

Cover Abundance: The majority of plots that Cover Abundance was applicable to recorded 7 (see figure 12.2), with the exception of plots 7 and 8 which were graded 5 and 6 respectively and recorded water depths of 40cm and 20cm. Cover In plots 7, 8 and 9 was wholly made up of *Paspalum spp.* (Couch).
