***ENVIRONMENTAL
MANAGEMENT PLAN –
CONDITION 4-1, MS.521
REVISED NOVEMBER 2016***

SHIRE OF DENMARK

OCEAN BEACH LIMESAND QUARRY, DENMARK

Report on Geotechnical Investigation and Mine Closure

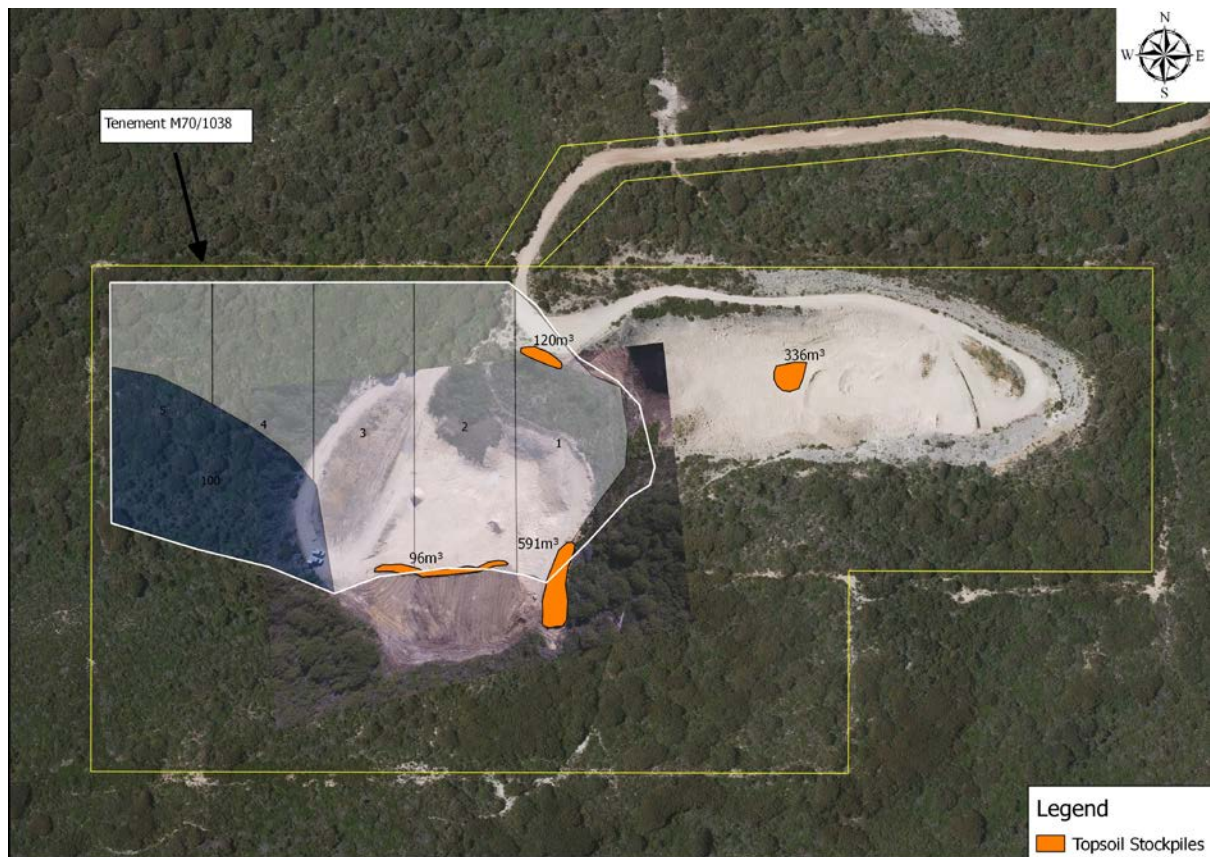
Figure 4: Location of Topsoil Stockpiles and Volumes

Figure 4 shows the location and approximate volume of the topsoil stockpiles currently retained at Ocean Beach Limesand Quarry.

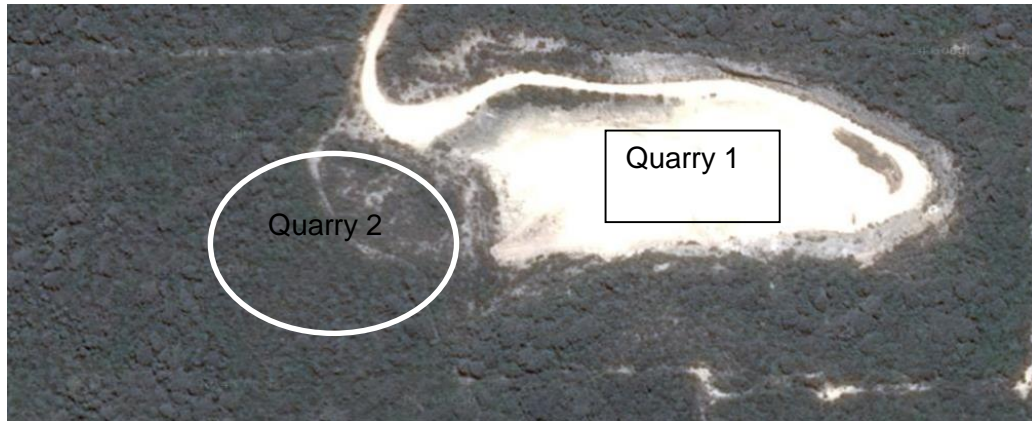
Figure 2: Plan View of Site - Quarry 1 and 2

The operation involves the excavation, sieving and crushing of lime sand. Stage 1 and stage 2 mining can be seen in Figure 2. Mining takes place using front-end loader for all mining and loading whilst a bulldozer with a ripper attachment is used to break down cemented material.

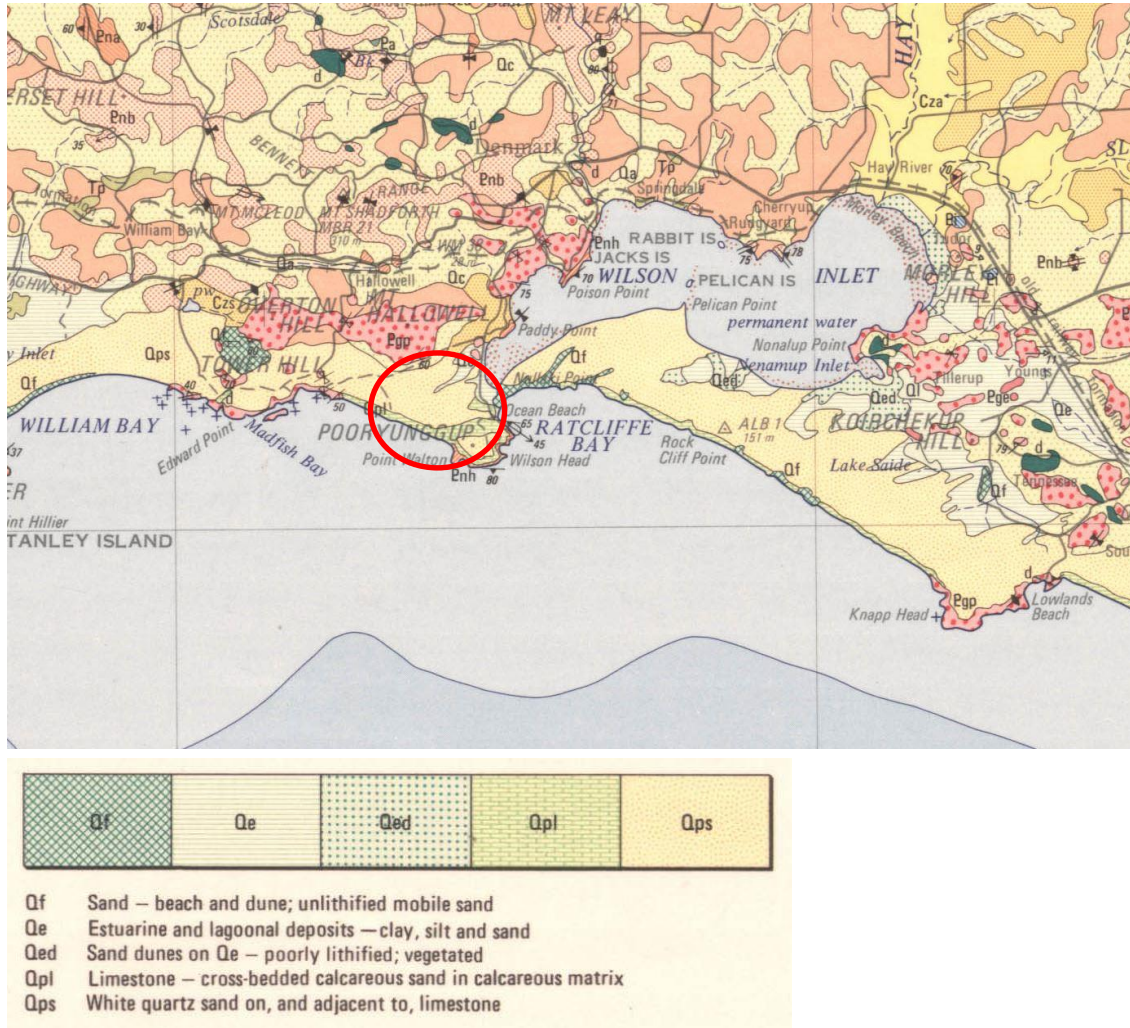
Figure 3: Site Geology – Ocean Beach Lime Quarry (<http://www.geoscience.gov.au>)

The regional geology comprises of white quartz sand and limestone. (Refer to Figure 3).

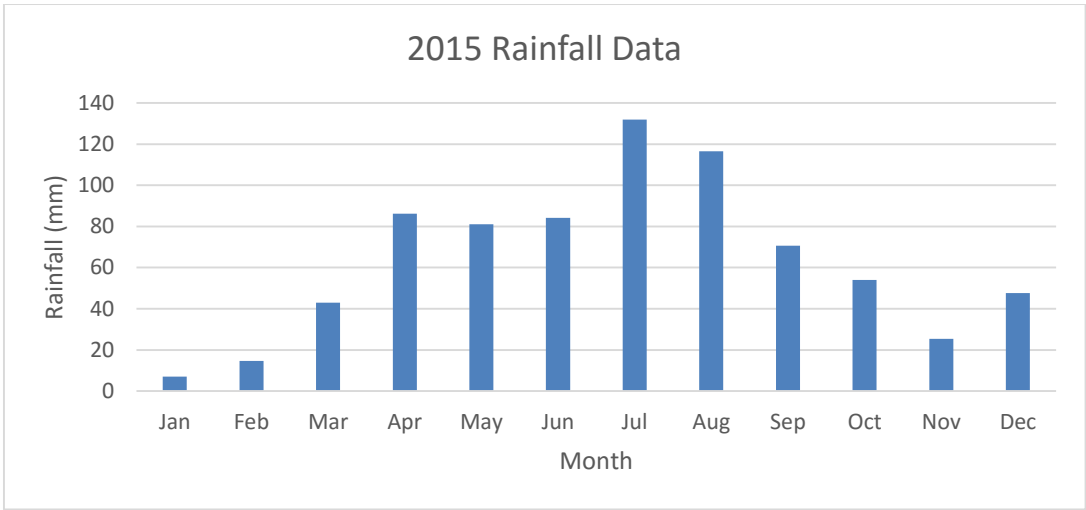
Figure 4: Monthly rainfall data 2015 – Denmark station 009531, 117.36°E, 34.96°S

Annual rainfall is typically between 800-1200mm with wettest season between April and September (Refer to Figure 4 and 5).

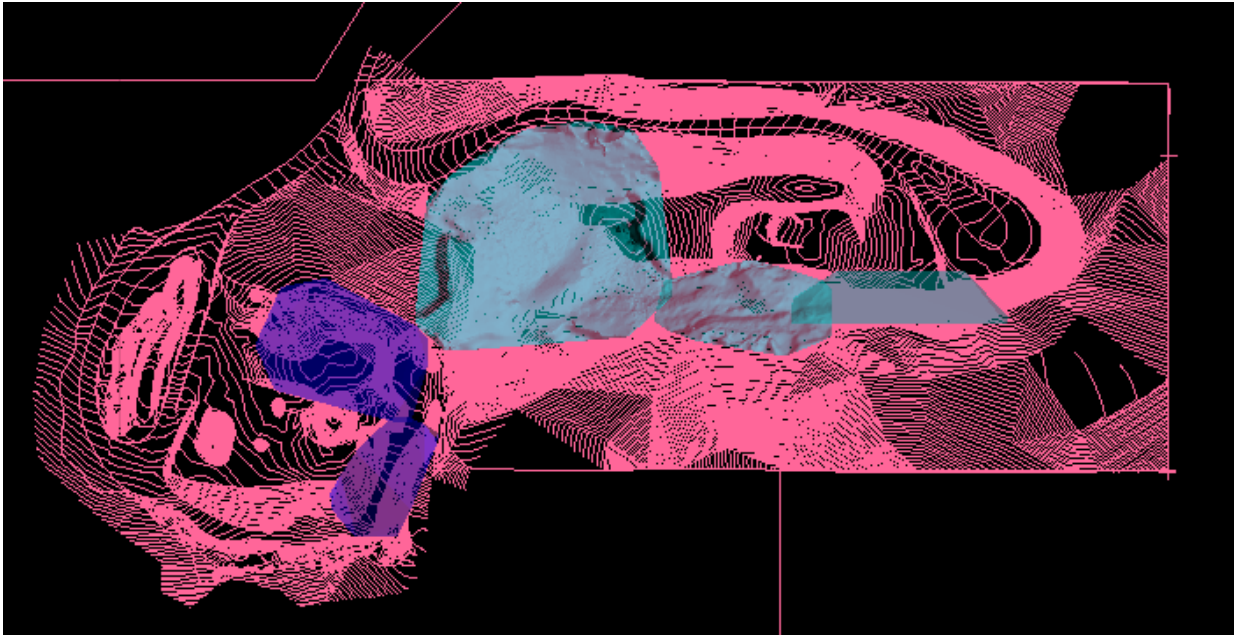
Figure 6: Location of photogrammetry survey – Quarry 1 (turquoise) + Quarry 2 (purple)

The fieldwork was carried out between 25th and 26th May. The survey was undertaken on the South and West walls of Quarry 1 and the North, East and Southern walls of Quarry 2 (Refer to Figure 6).

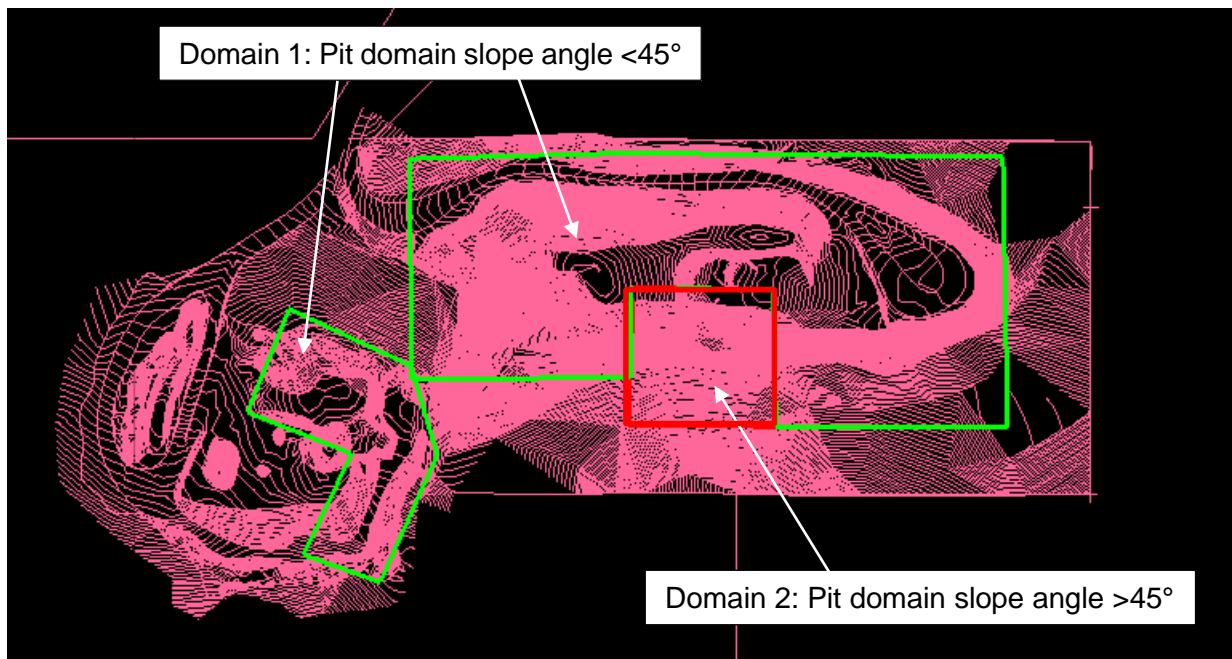
Figure 7: Quarry domains based on slope angles $<45^\circ$ ad $>45^\circ$

The quarry has been divided into two (2) domains based on slope angles greater than forty five degrees ($>45^\circ$) and slope angles less than 45 degrees ($<45^\circ$) which can be seen in Figure 7. The critical section in domain 2 (worst case slope angle) can be seen in drawing 1.

3D models were generated using the orthophotos to analyse the slope geometry in further detail and select critical sections of the slope to model. Typically, 3D models indicate overall slope angles of between 40-53 degrees in Quarry. In quarry 2, overall slope angles between 25-40 degrees.

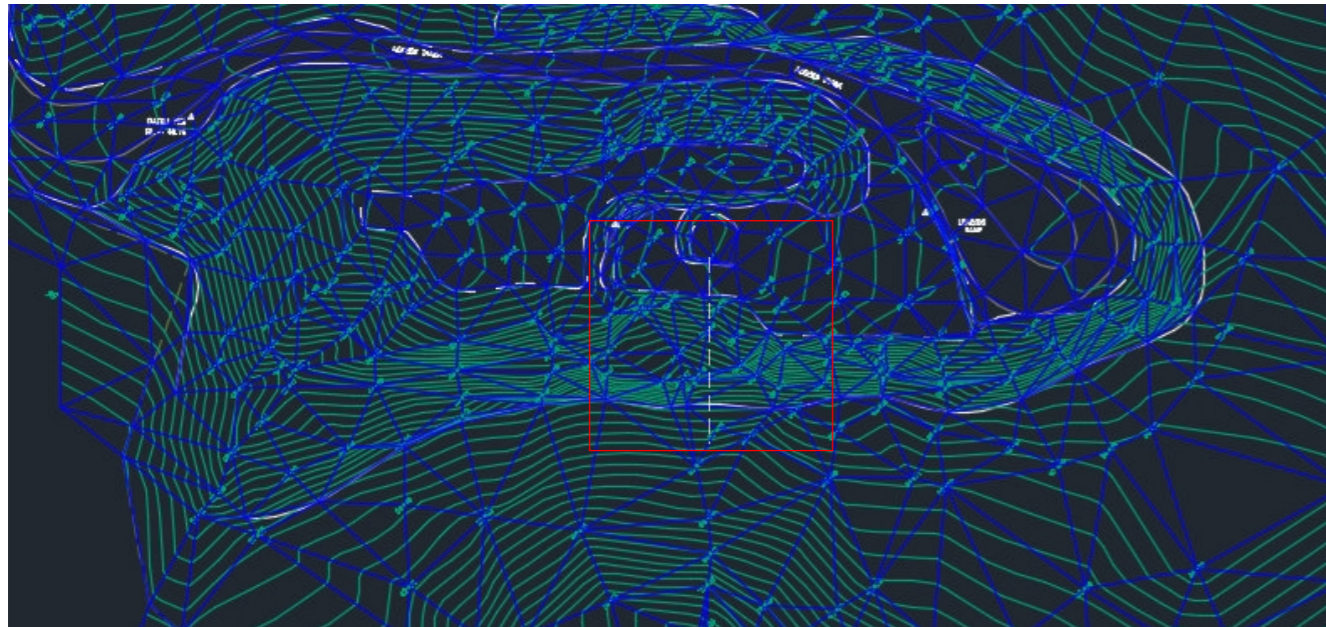
Critical section planview (domain 2)

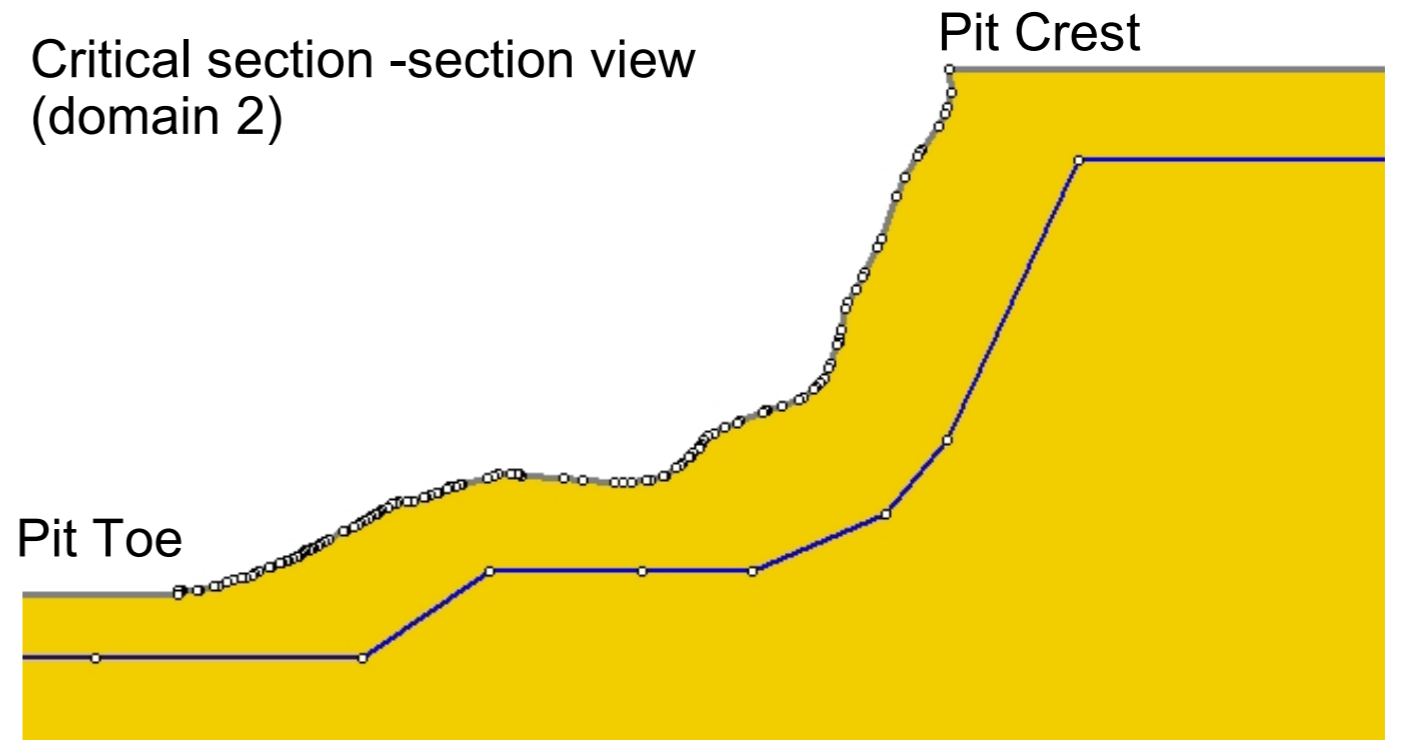
Critical section -section view (domain 2)

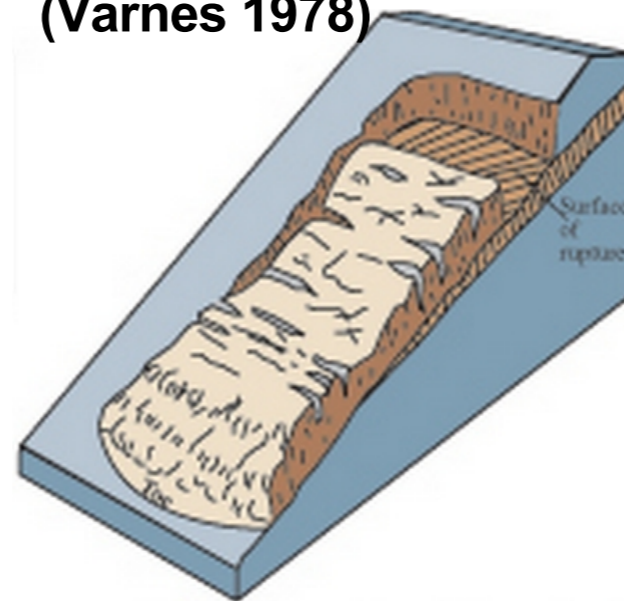
Progressive translational slump failure mechanism (Varnes 1978)

Based on the assessment of pit wall geometry, a non-circular failure plane has been selected as most the appropriate mechanism to represent translational slumping (Varnes 1978). The cuckoo search algorithm was used as it reduces constraints for the non-circular failure plane. Morgenstern and Price and Spencer method was used accounting for inter-slice forces.

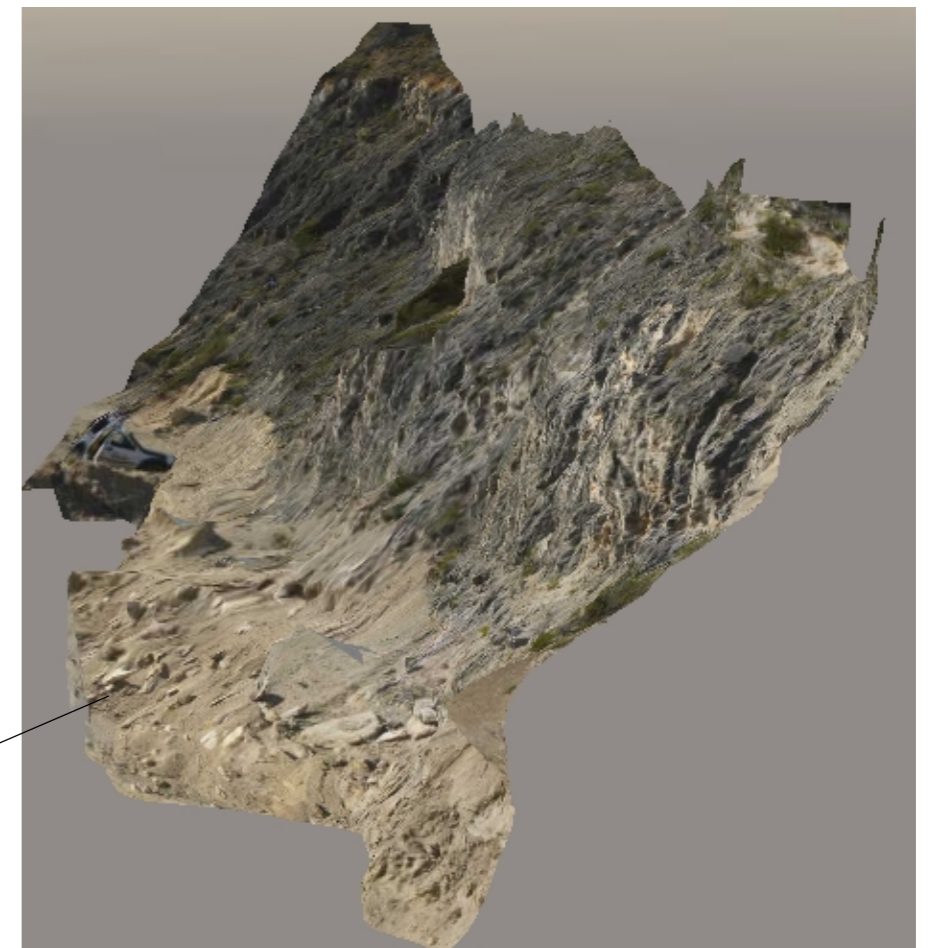
3D model developed from photogrammetry survey (domain 2)

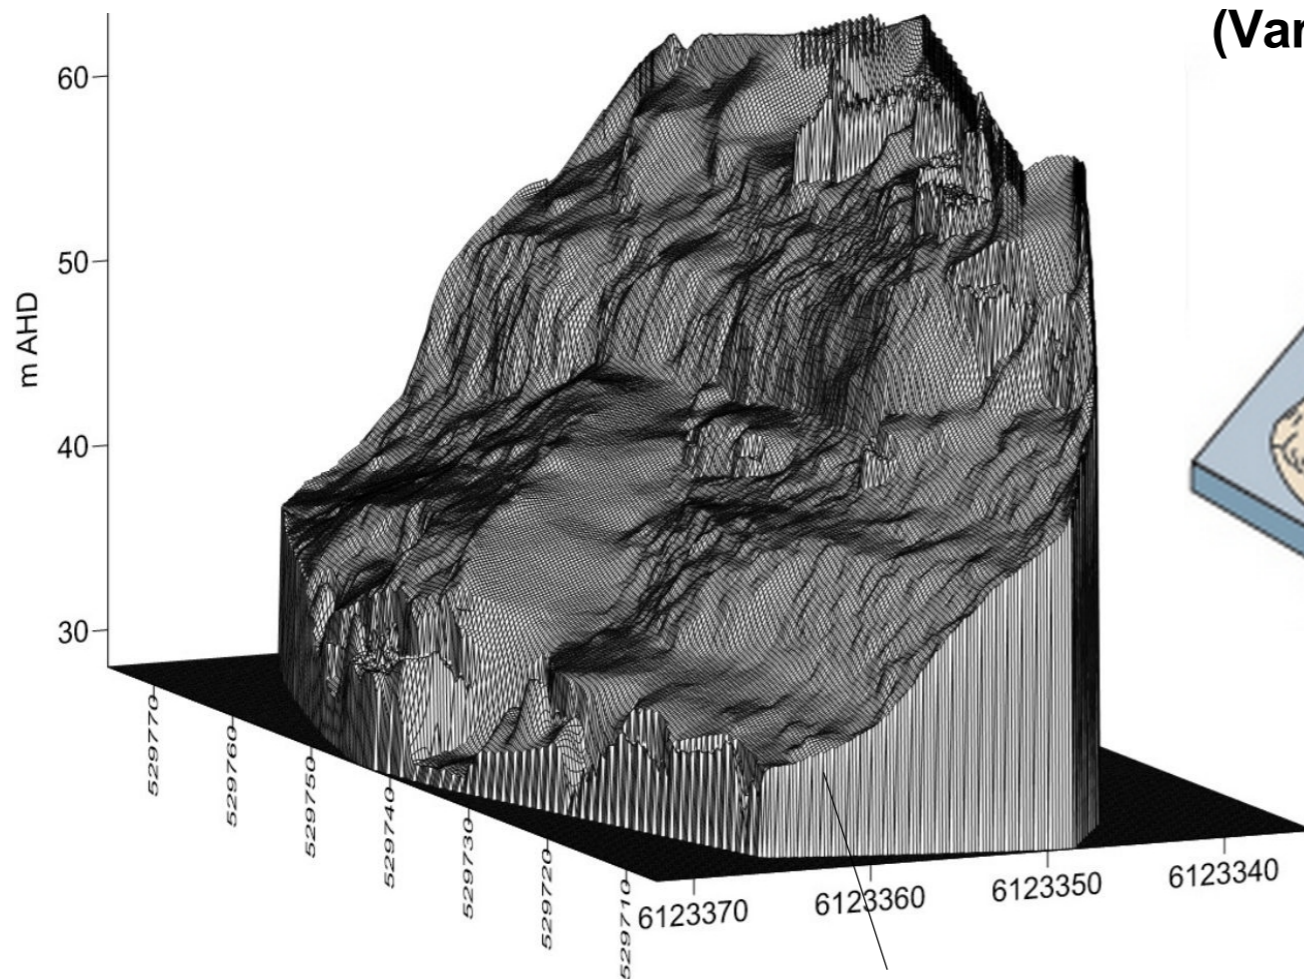
3D model in wireframe format Domain 2

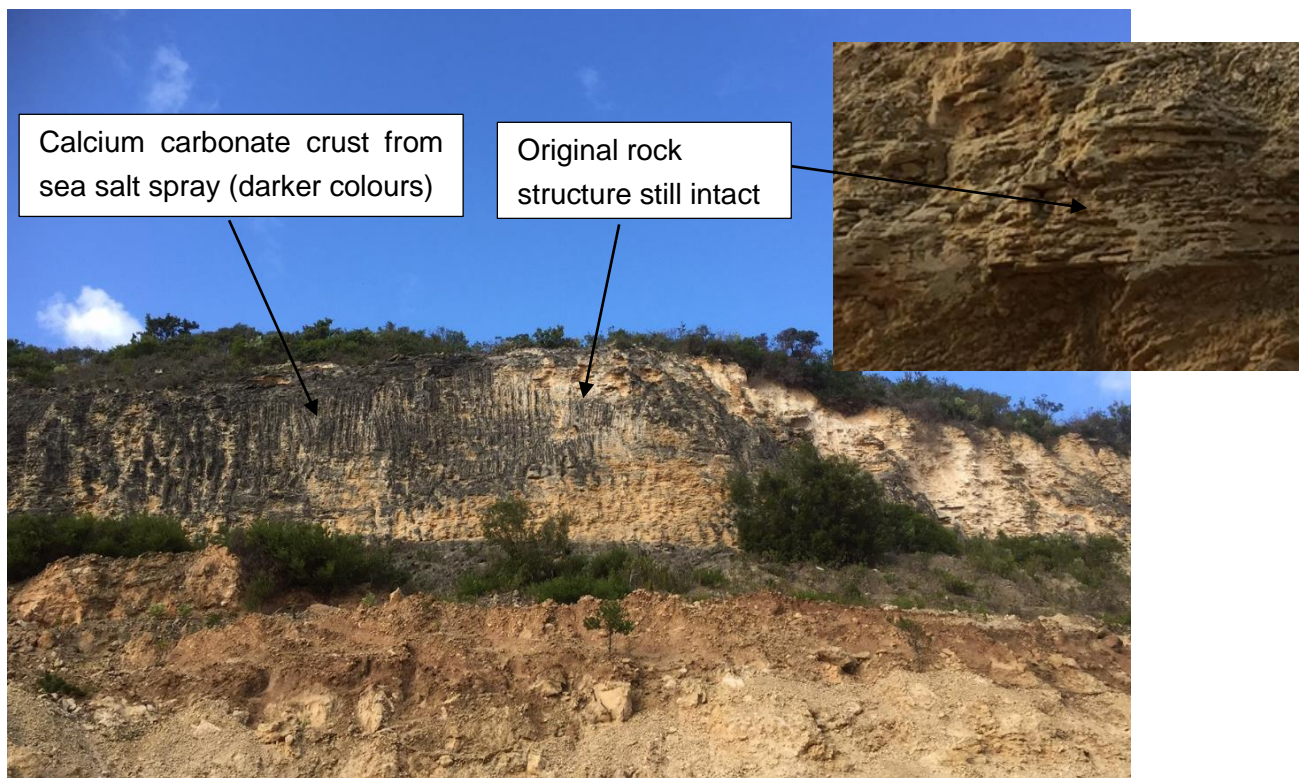
Figure 8: Weathering at Ocean Beach lime quarry – Critical section – quarry 1

Highly weathered to completely weathered quartz sand / limestone can be seen in the critical section (domain 2) in Figure 8.

Weathering will take place through predominantly chemical (dissolution) processes due to carbonates in the material. This will leave the soil surface in an unstable state and susceptible to erosion by wind and water. Current slope geometry is indicative of multiple translational slumping (Varnes 1978). This has led to a near vertical back scarp. Evidence of this process can be seen in Figure 8. The time it takes for weathering to occur and subsequent loss of rock mass cohesion is dependent on a number of variables. Weathering timeframes are difficult to predict on an engineering timescale and often occur over long periods or geological time (Miscevic 2001). Also of note is that this process is being slowed down in specific areas by a calcium carbonate crust likely developed from sea salt spray (Refer to Figure 8).

General weathering observations on site indicate that the respective quarry walls will comprise only weathered material. It appears the quarry walls are formed of material which is predominantly highly weathered to completely weathered. Progressive failure is occurring due to material to progress to this stage is critical for stability of the quarry walls. Materials have been classified on weathering based on definitions from International Standards Rock Mechanics (refer to Table 1).

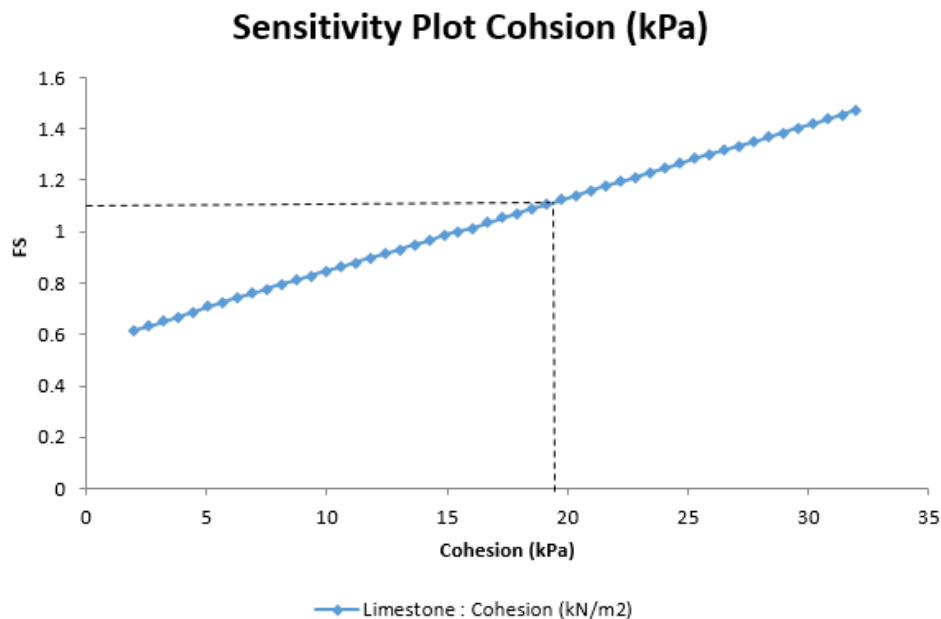
Figure 9: Sensitivity analysis on cohesion

Back analysis was carried out on critical section to determine appropriate material parameters. This section was considered the most critical section due to highest vertical slope and slope geometry. Friction angle was set at 35 degrees based on empirical evidence for sub angular fine to coarse SAND (Craig 2007). The process of weathering will not affect the friction angle. Sensitivity analysis was therefore carried out on cohesion to achieve a factor of safety of 1.1 which represents conditions close to or near to an unstable condition. Results indicate value of 19.0 kPa (Refer to Figure 9).

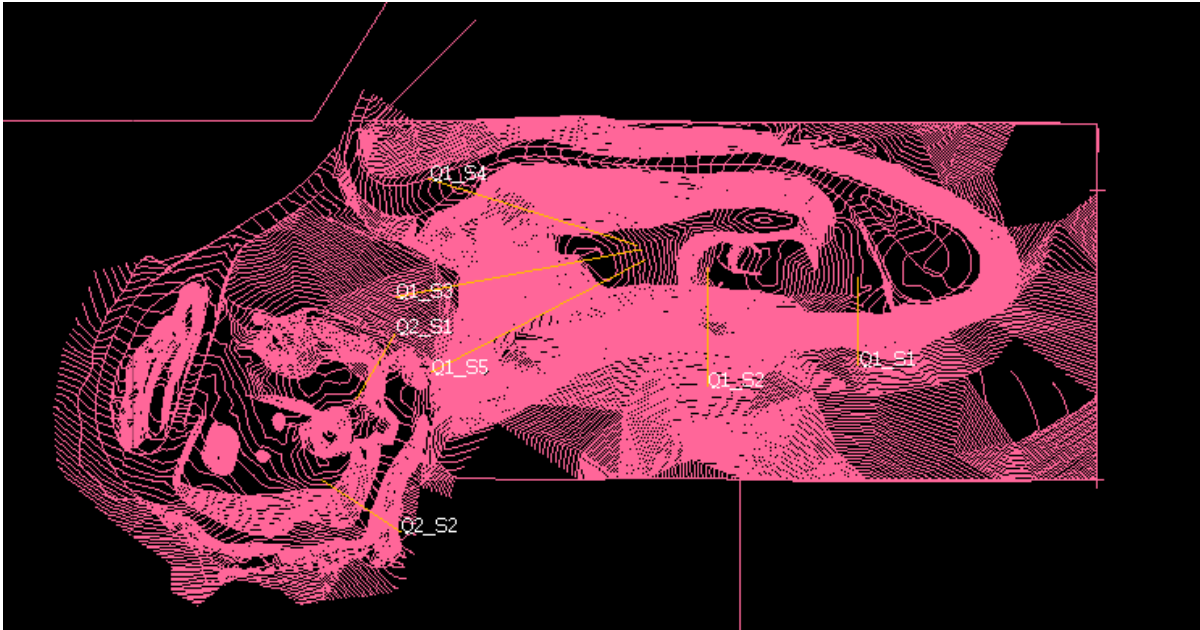
Figure 10: Critical sections at Ocean Beach Lime Quarry

Critical sections can be seen in Figure 10 and were selected to gain a representative view of stability across the quarry.

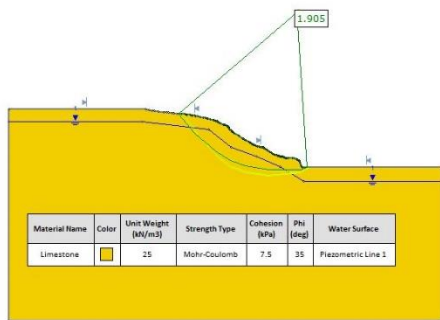
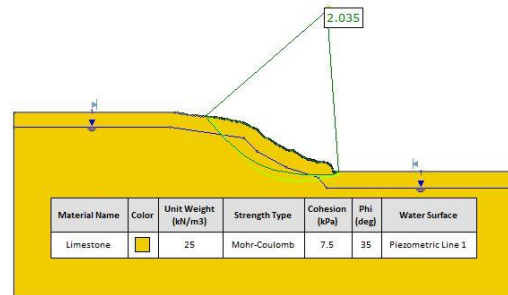
Figure 12: Modelling results overall slope stability

Results for quarry 2 can be seen in Figure 12.

Q2 Section 1 – FS = 1.91

Q2 Section 2 – FS = 2.04

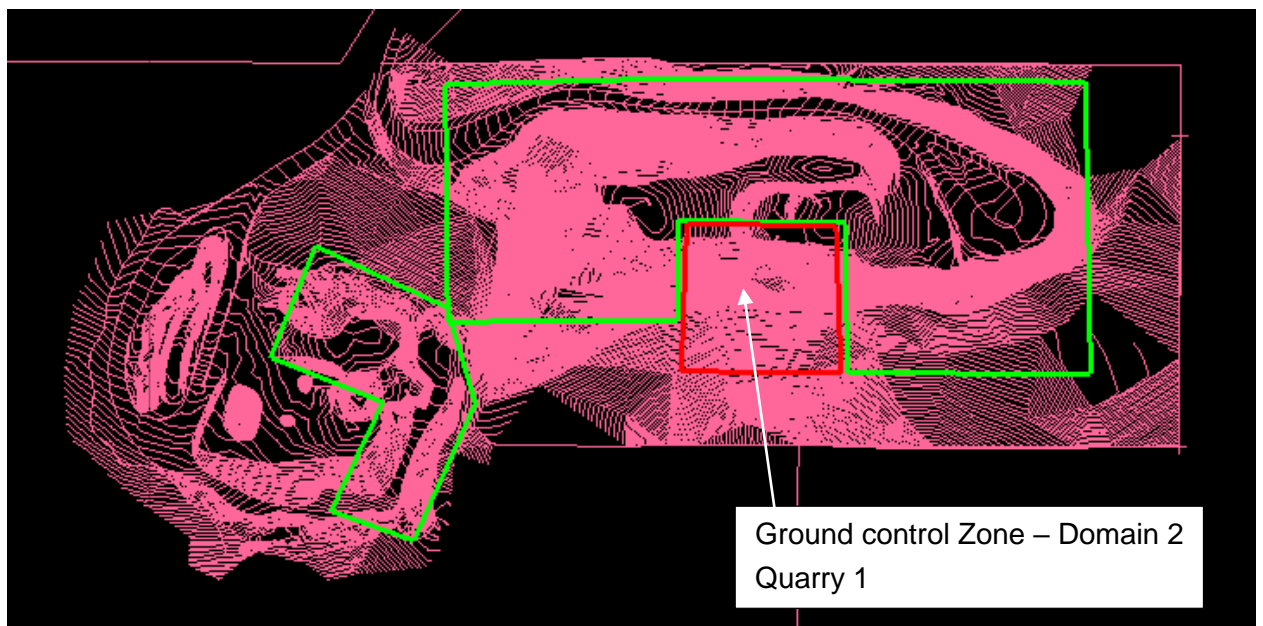
Figure 13: Ocean Beach Quarry –area where ground control management plan is recommended

Typically, 3D models generated from photogrammetry indicate overall slope angles of between 45-53° in quarry 1 and between 25-40° in quarry 2. A section of the South wall in quarry 1 has been subject to progressive translational failure resulting in a back scarp of 53° (overall slope angle). Chemical weathering (dissolution) and subsequent erosion by water has been identified as the likely cause of this progressive type failure. Limit equilibrium modelling has been carried out using back analysis of the failed section to derive material parameters. Modelling indicates that all zones have factors of safety within the DMP's acceptance criteria as the critical section has a low consequence of failure. Ground control in this area of the quarry is recommended to arrest the progressive failure mechanism. The area where ground control is recommended can be seen in Figure 13.

Ground control management in the form of monitoring slope displacement using prisms, a deflection barrier or drain to divert water away from the crest of the slope and a weighted toe are recommended to arrest progressive type translational failures targeted in domain 2 – quarry 1.

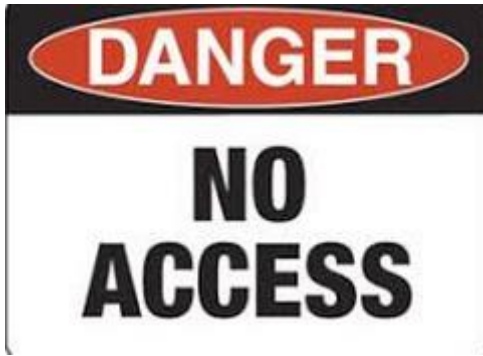
Fence or abandonment berms

A fence or abandonment bund to prevent public access to quarry 1 (also include appropriate signage).

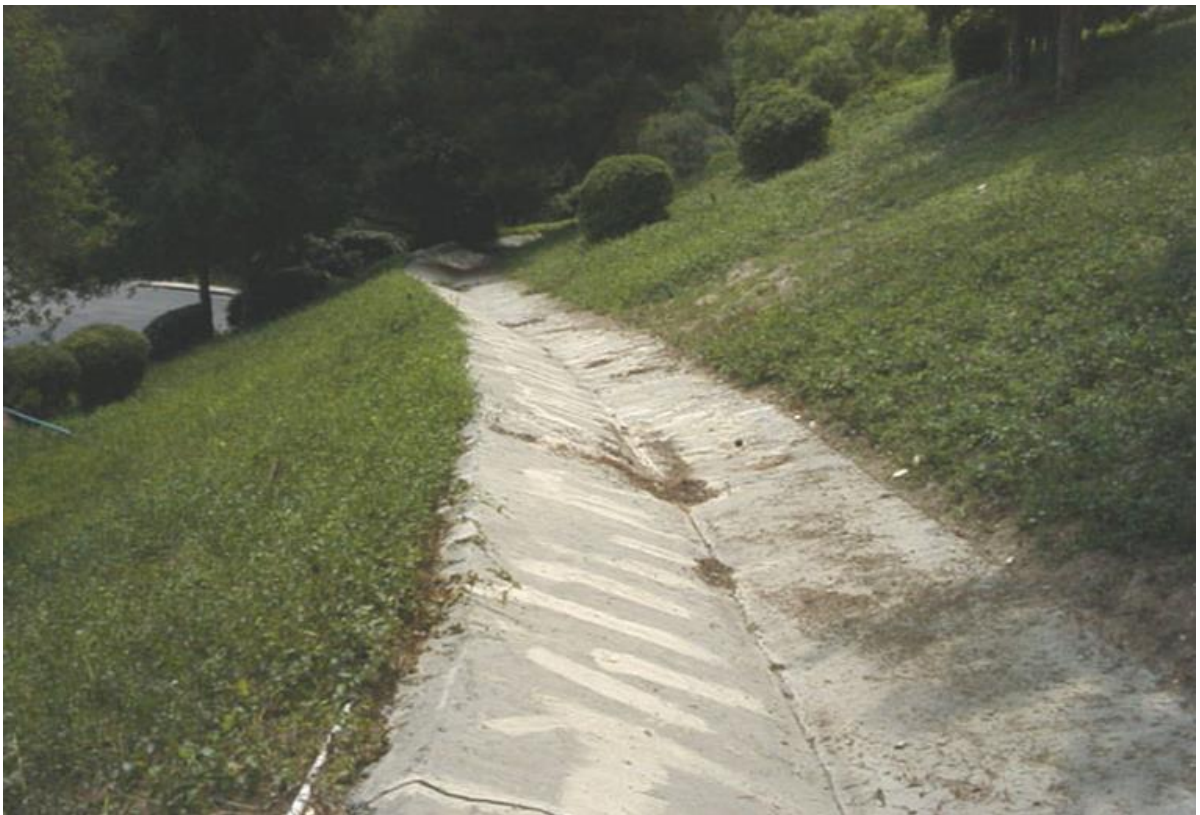
Deflection barrier OR Swale drain

Positioned at crest of slope to redirect excess water and reduce erosion

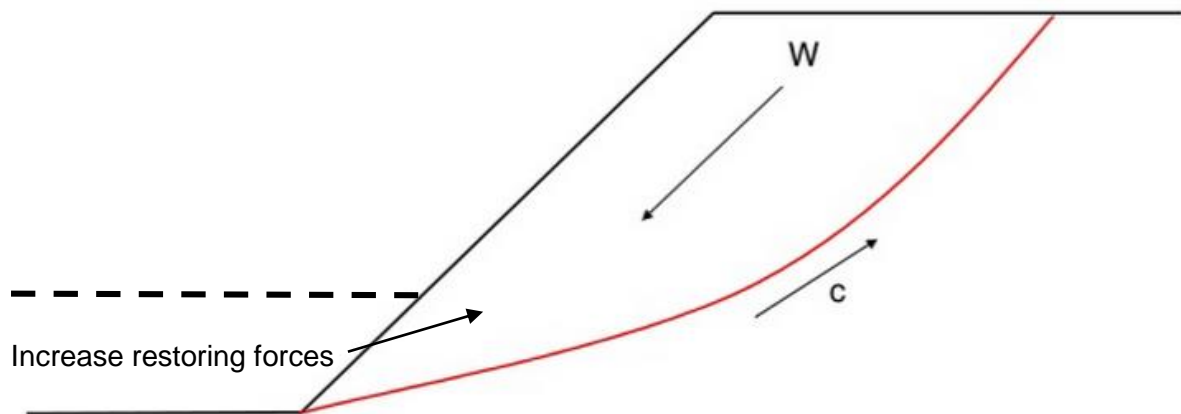
Weighted Toe

Increase design level to weight toe and increase restoring forces and arrest progressive slope failure

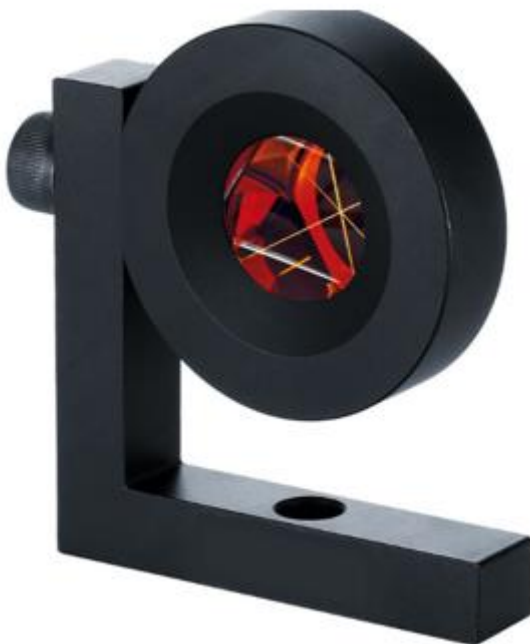
Monitoring inspections to assess progressive failure and / or monitoring using prisms.
