# **Wilson Inlet Foreshore Flora Survey**

**March 2011**

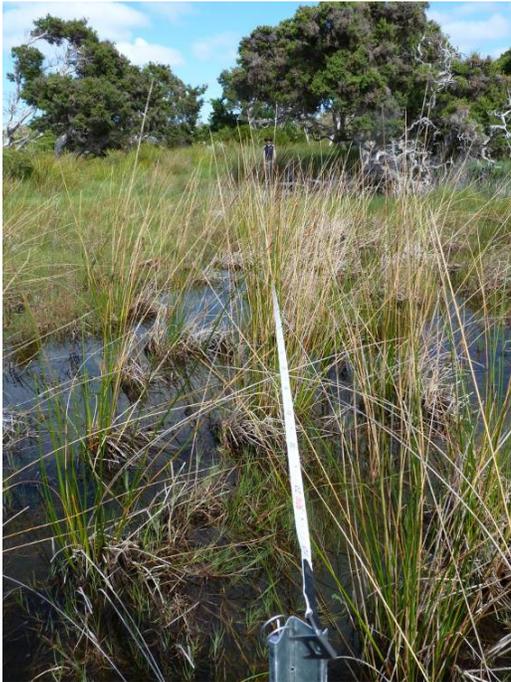
**Photo 1.1** Prawn Rock Channel transect line

The transect line was brought inland of the actual shoreline due to the uniform nature of the fringing vegetation and water depth inside of the actual shoreline (see Photo 1.1).

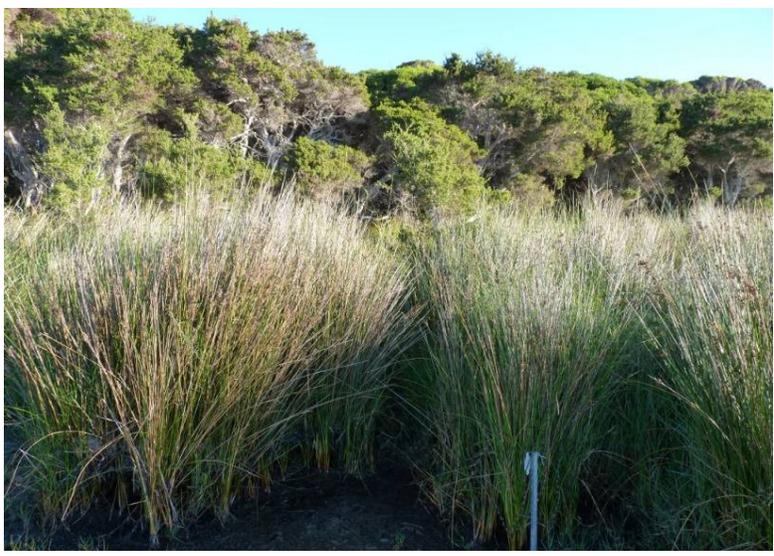
**Photo 2.1** Poddyshot transect (note original photo was lost, displayed photo taken mid March 2011. At time of survey water level was 9cm at shoreline marker.

**Water inundation:** Along the Poddysshot transect water inundation was recorded at plots 1, 2 and 11 (water level 9cm, 3cm and 2cm respectively). Plots 3 – 10 were only just above the water line with soil moist.

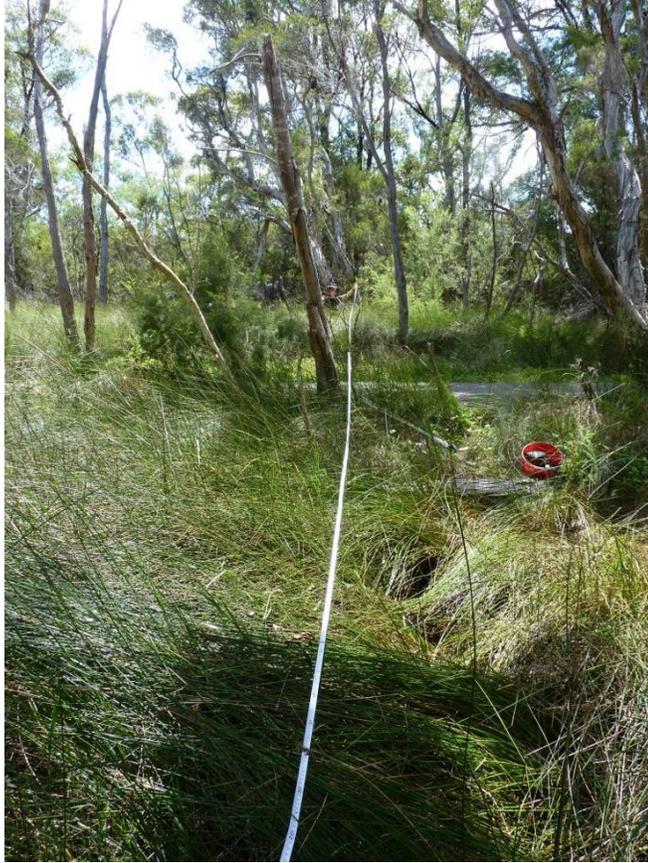
**Photo 4.1** Mokare Trail transect line

**Cover Abundance:** Was also fairly uniform with grades of 6 and 7 along the transect, excluding where the Mokare trail intercepted the transect (see figure 4.2). Plot 11 recorded a value of 5 and plots 9 and 10 were “not applicable”. The cover was made up thick understorey and open upper canopy.

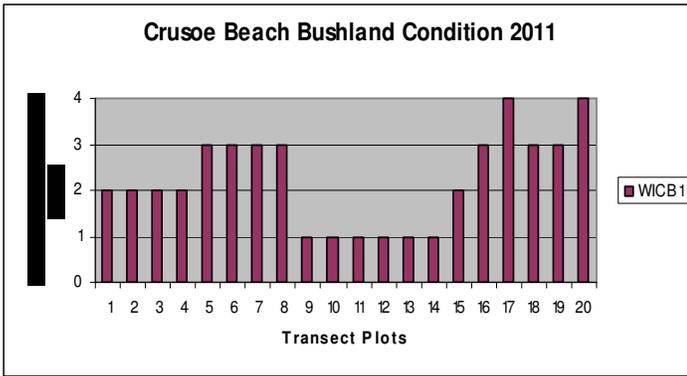
**Figure 6.1** Crusoe Beach Bushland Condition

Bushland Condition: Varied greatly over the transect, ranging from “Degraded” to “Very Good” (see figure 6.2). Plots 2,9,10,11,12,13 and 14 recorded “Degraded” condition. Plots 11 – 13 were bare sand except for 2 plants on plot 12. Plots 1, 3, 4 and 15 recorded “Poor” condition with *Paspalum spp.* (Couch) and a small number of other invasive flora species present. Plots 5, 6, 7, 8, 16, 18 and 19 recorded “Good” condition and plots 17 and 20 recorded “Very Good” condition.

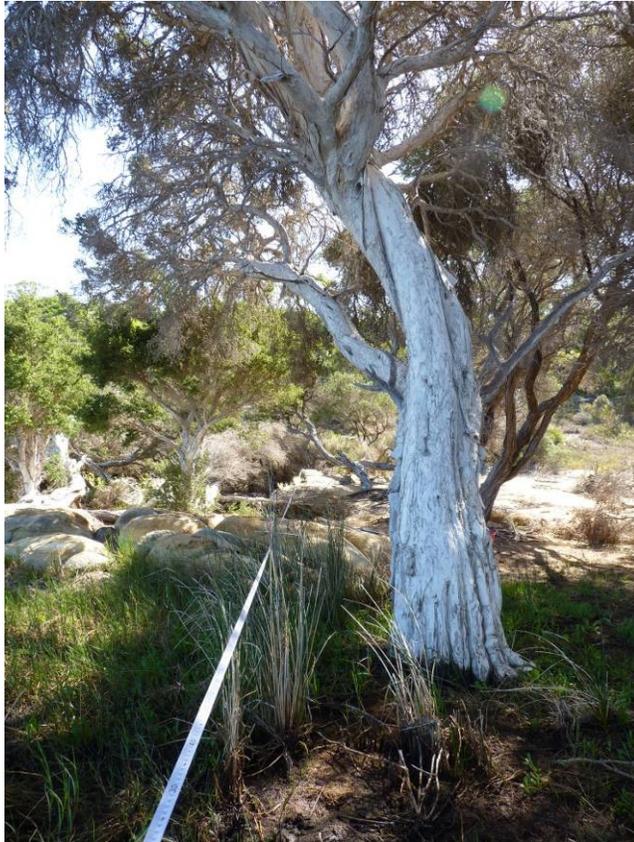
**Photo 6.1** Crusoe Beach transect line

It should be noted that the area is frequented by the public with signs of an informal track intersecting the transect line. Depth of soil along the transect also varied greatly depending on the underlying granite rock shelf which would have some impact on the vegetation.

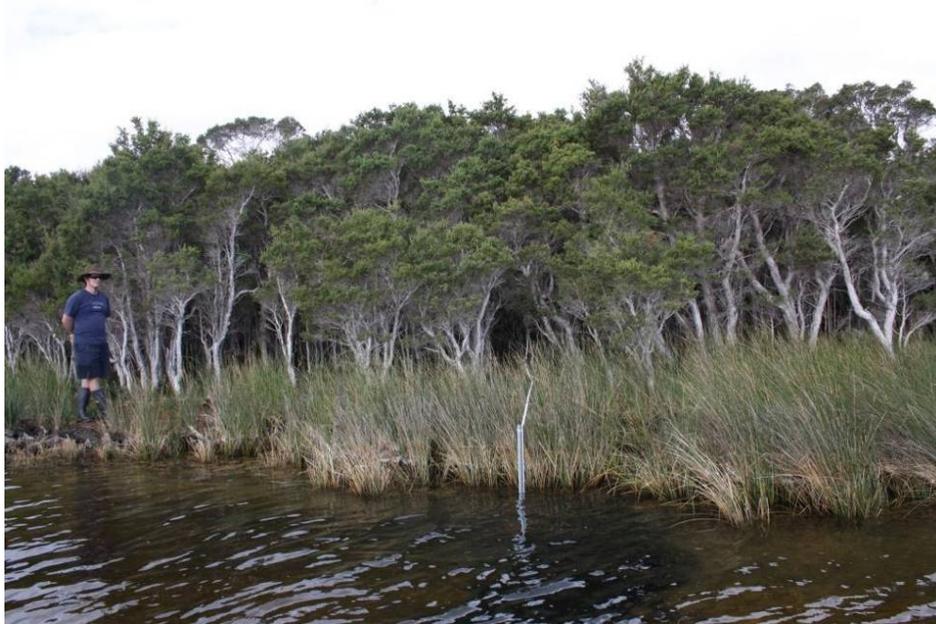
Photo 7.1 Hay River transect line

Flora species: As mentioned before, dense upperstorey of *M. cuticularis* and *M. densa* dominated the latter section of the transect line with little understorey, while along the shoreline section of the transect understorey species, *Sarcocornia blackiana* (samphire) and *Juncus krausii*, dominated with only a few of the upperstorey species present. It was noted that there were a number of dead younger *Melaleuca densa* at the transition zone.

Flora species: The dominant native species at the shoreline end was *Sarcocornia blackiana* (Samphire) and further inland, stands of *Melaleuca cuticularis* and *M. densa* dominated with little understorey. There were some signs that *M. densa* closer to the shoreline were stressed (see photo 7.1) but overall the vegetation looked healthy and unlike a number of other transect sites, the introduced *Paspalum spp.* (Couch) and *Chenopodium spp.* (Goosefoot) species were almost absent.

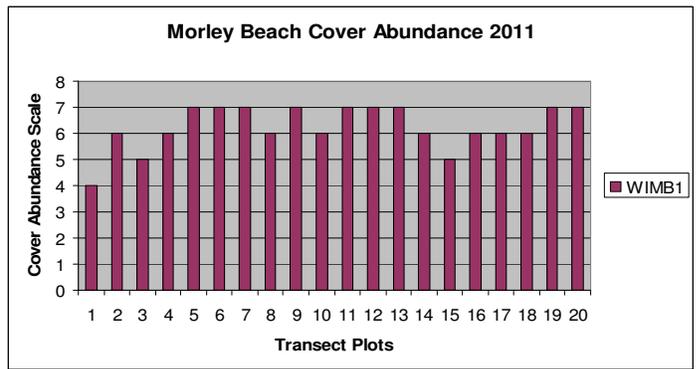
**Figure 8.2** Morley Beach Cover Abundance

Cover Abundance: Was generally high, with 6 - 7 cover for all plots except for plot 1, 3 and 15 which recorded 4, 5 and 5 respectively (see figure 8.2).

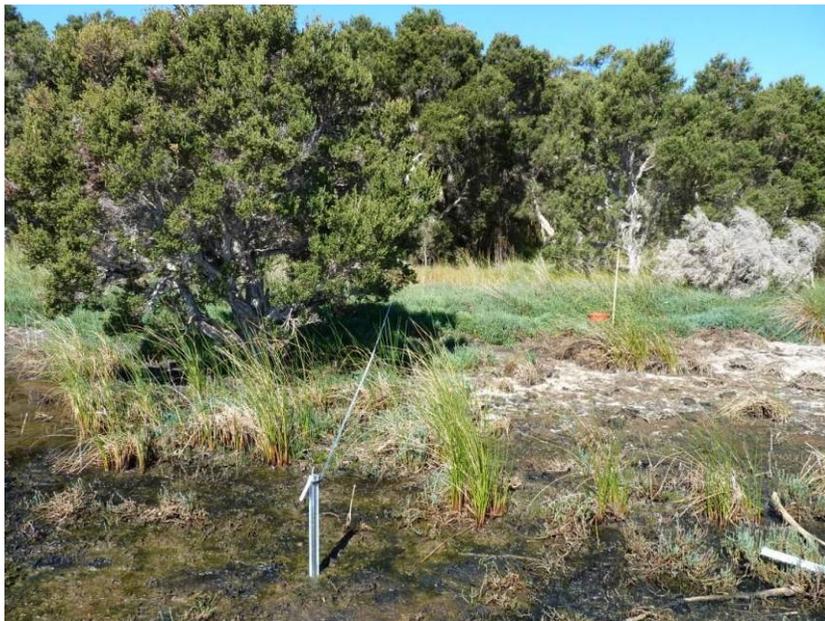
**Photo 8.1** Morley Beach transect line

Bushland Condition: Both ends (shoreline and inland ends) were “Poor” (plots 1, 19 and 20) with all remaining plots in either “Good” or “Very Good” condition (see figure 8.1). There was a small amount of *Chenopodium spp.* (Goosefoot) incursion in the area as well as evidence of disturbance to the shoreline fringing vegetation from vehicles accessing and driving along the beach.

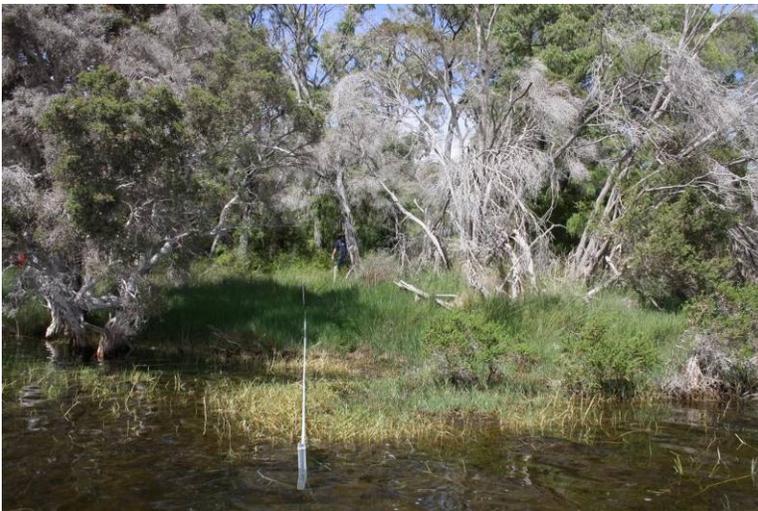
Photo 11.1 Nullaki Gate transect line

Bushland Condition: The transect was fairly degraded, with plots 1 – 17 recording “Degraded” condition (except for plot 16) and plots 18 – 20 recording “Poor” (see figure 11.1). The site showed a large infestation of *Paspalum spp.* (Couch) and little to no native vegetation. It was noted that the site showed evidence of past informal camping which may be contributing to the high level of disturbance to the area along with other factors.

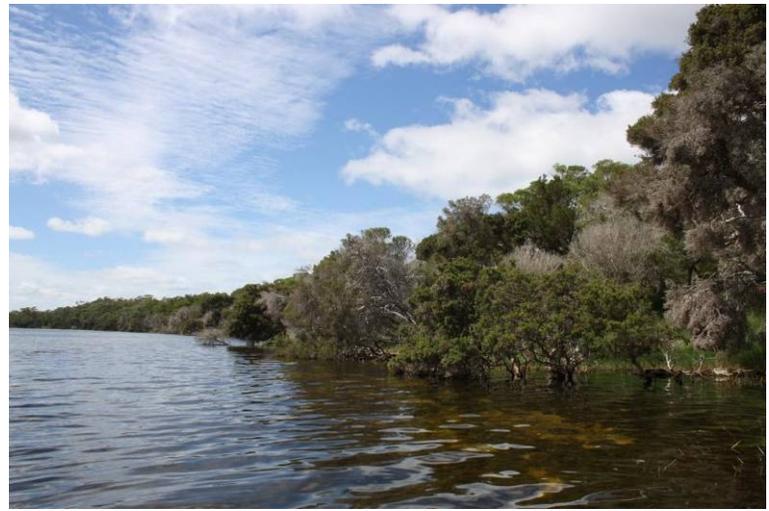
Photo 11.2 Nullaki foreshore looking east from transect

Flora species: Understorey species *Juncus kraussii* and *Rhagodia baccata* became more prevalent in the latter inland section of the transect (plots 13 – 20). Of the upperstorey there were none recorded along the actual transect; however there were a large number of tree deaths within the inundation area, (approximately 50% as a guideline). Dead species included *Melaleuca densa* and one *Agonis flexuosa*. All *M. densa* within 8 meters from the shoreline were dead. The dead trees appear to have died over 12 months ago as all the leaves are missing from them. Other *A. flexuosa* are also showing signs of stress (area between shoreline and Eden Road).

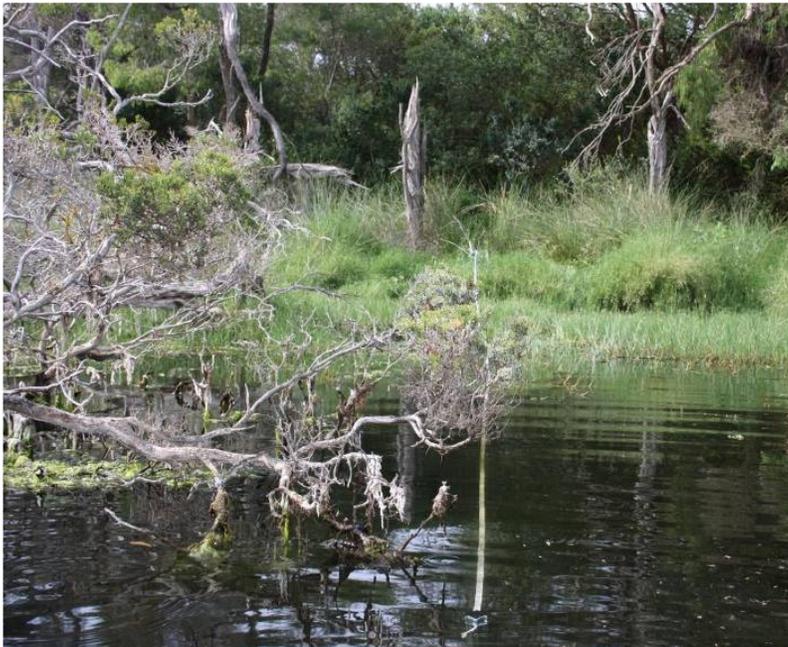
**Photo 12.1** Nullaki Jetty transect line

It should be noted that a number of *Melaleuca densa* trees were dead in the adjacent area.
