PEACEFUL BAY HERITAGE PRECINCT

CONSERVATION PLAN

PREPARED BY DAVID HEAVER AND ASSOCIATES ARCHITECTS
FOR THE SHIRE OF DENMARK

DECEMBER 2003

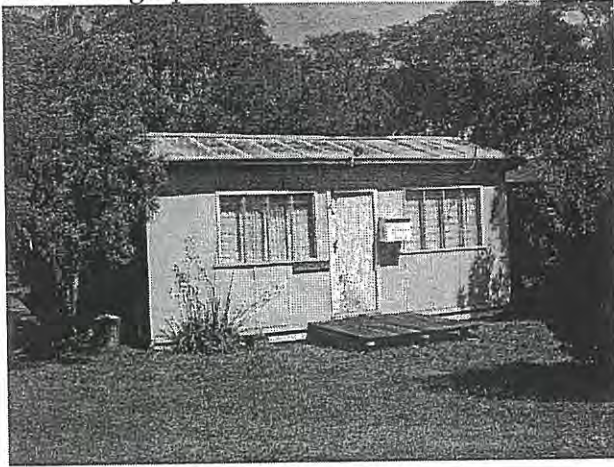
Photo 3 Typical gable cottage

The simple platform outside the front door has been introduced and is in keeping with the minimal detailing in the precinct.

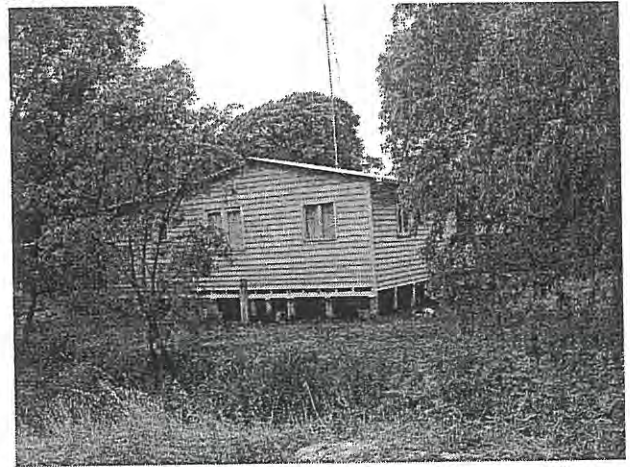
Photo 4 Timber clad gable without verandah

The skillion addition to the rear has been added. This house is located on East Avenue—note the native vegetation behind the house.

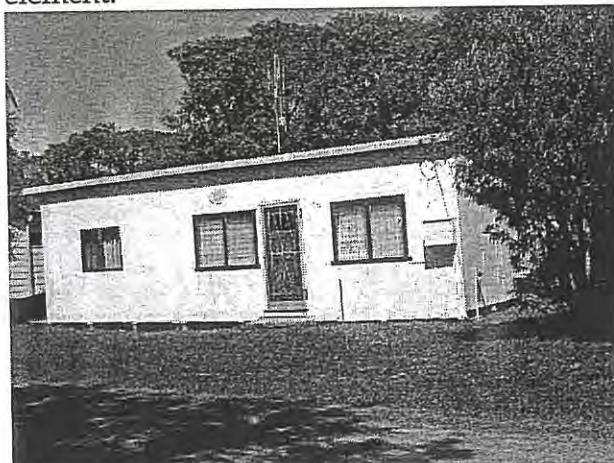
Photo 7 Shallow pitched skillion
The room to the left is an addition.

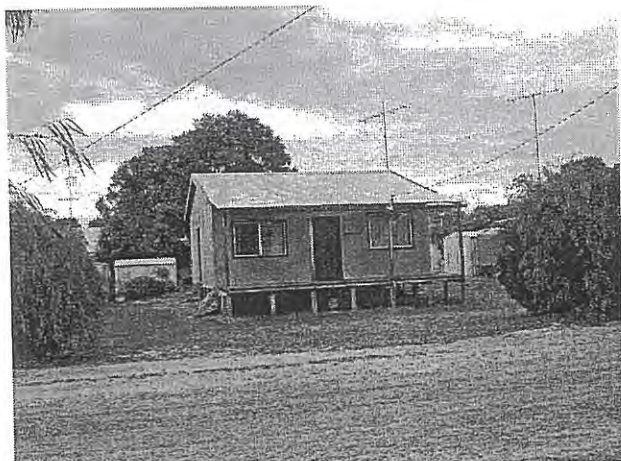
Photo 9 Typical fibro clad gable cottage
The verandah has been added.

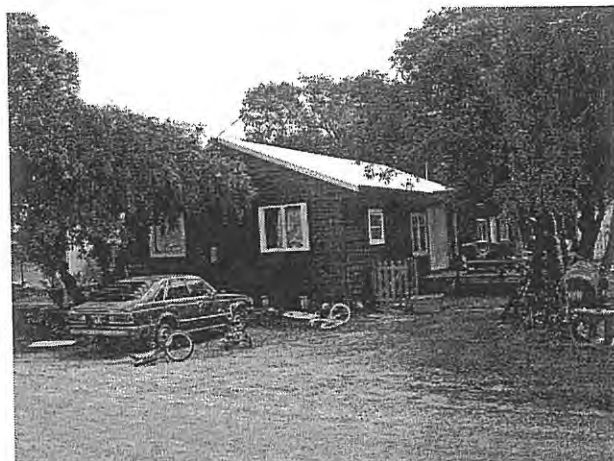
Photo 10 Typical jarrah mill house
Appropriately maintained and refurbished.
The introduced platform deck is simple and
has no decorative elements or balustrading.

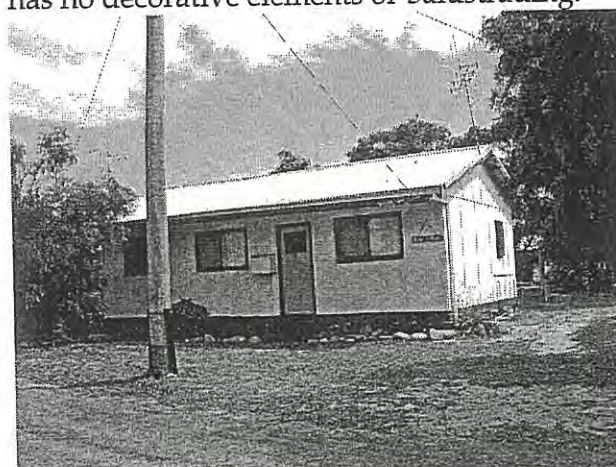
Photo 12 Typical fibro gable

This form is very common in the precinct.
This is a three bay example. The room to the
left is probably an addition.

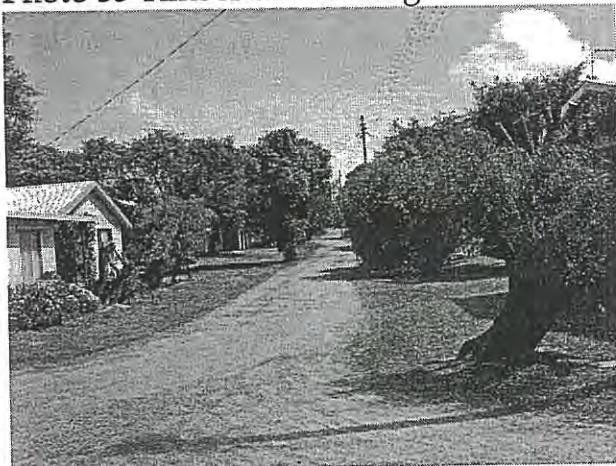
Photo 37 The road form is often curved. Roads curve around pre-existing peppermints. The roads are single lane and paved with gravel. There are no kerbs, drains, signs or other visual clutter.

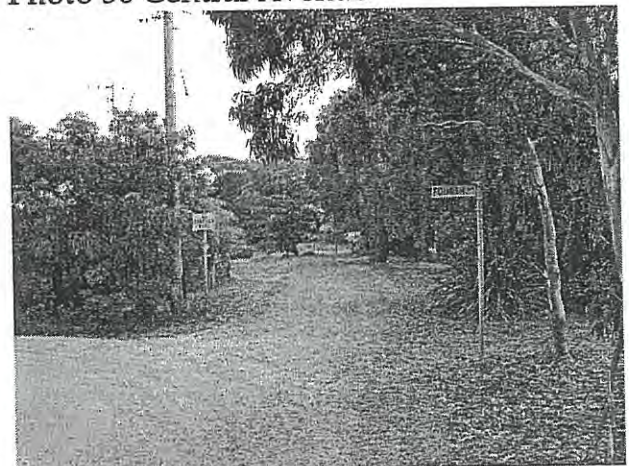
Photo 38 Track through to Fifth Avenue. The track through to Fifth Avenue, showing the buffer of native vegetation to the north of the precinct.

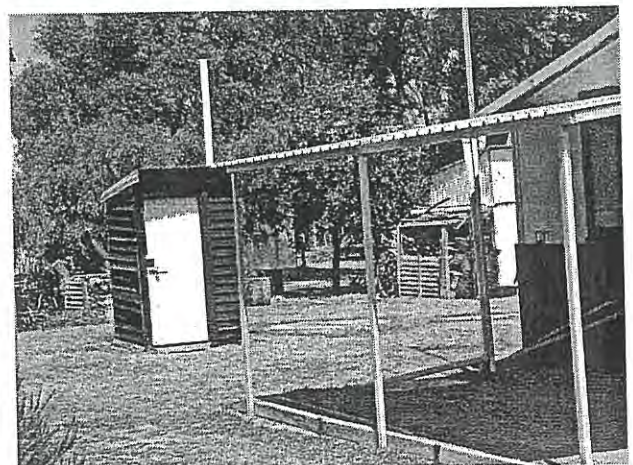
Photo 40 Toilet to the rear of the lot. Although ablutions were required to be included within the main body of the house, there are a few external toilets.

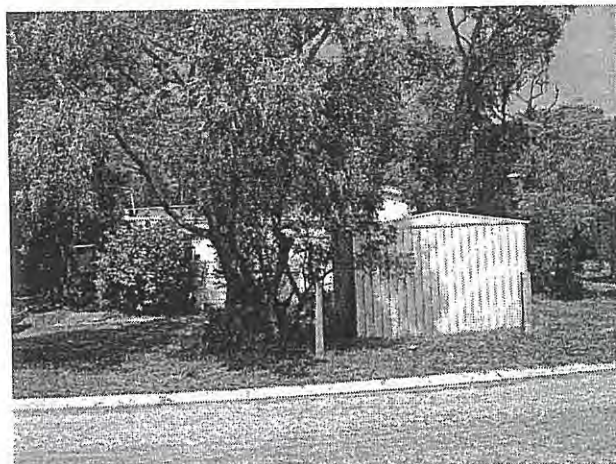
Photo 44 Large areas of gravelled surfaces around the Fire Brigade building

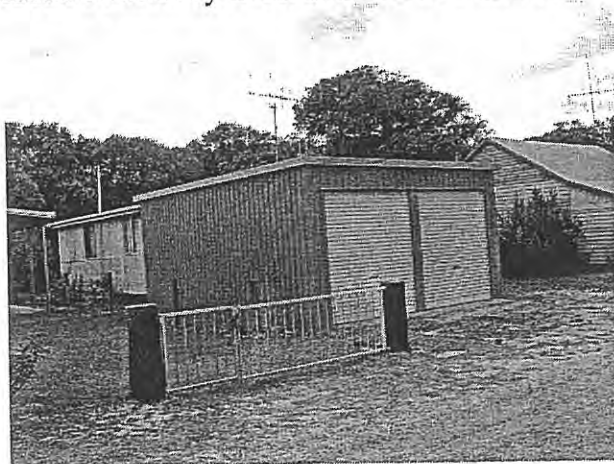
Photo 46 Peppermints have been lopped to stumps

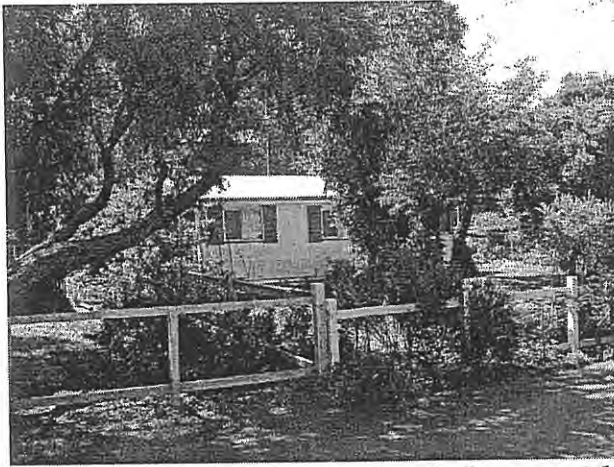
Photo 48 Wide post and rail fence is visually intrusive

- power poles and power lines
- brick construction e.g. no.79
- large garages and sheds at the front of the lots
- super six fences and other solid fencing such as close picket and wide profile post and rail and any fencing higher than 900 mm.
- decromastic and concrete roof tiles
- introduced exotic plants
- decorative detailing such as lattice work, gable decorations, balustrading (apart from where balustrading is required for BCA and safety reasons)
- hipped roofs that are not original
- telecommunications pits
- over height TV aerials

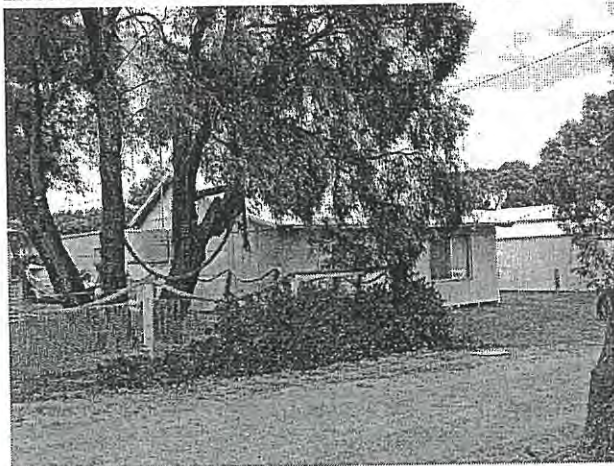
Photo 50 Light posts with mesh infill has little visual impact

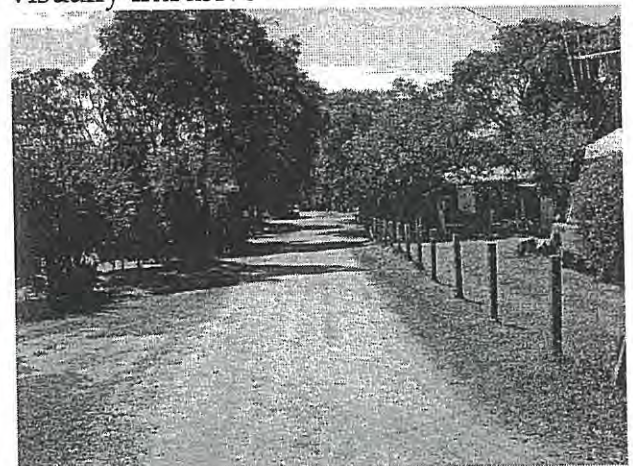
Photo 51 Solid super six fence on Fourth Avenue is visually intrusive

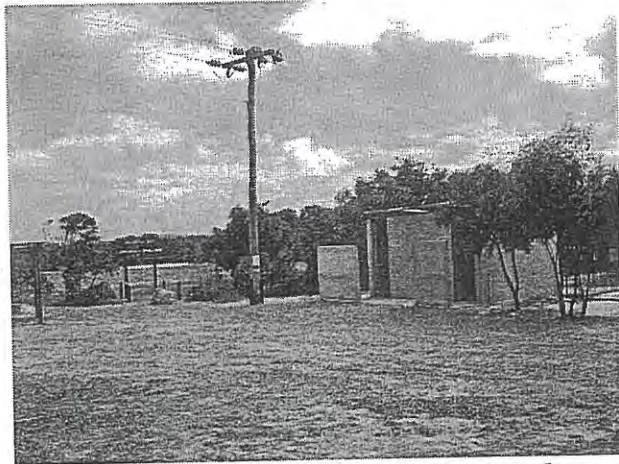
Photo 63 Carpark next to playground

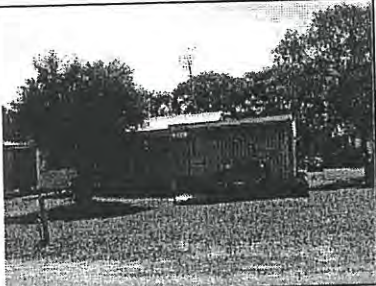
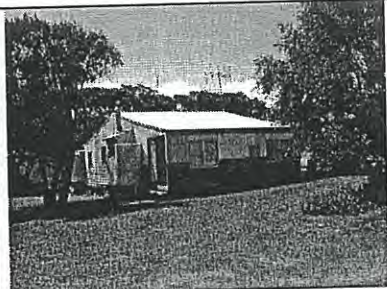
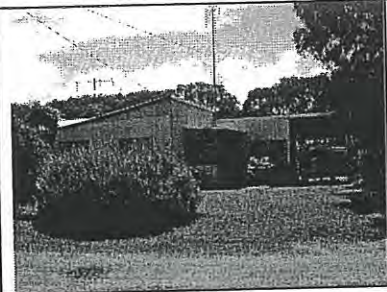
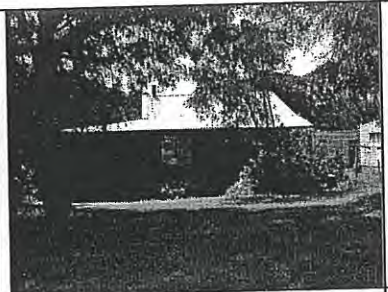
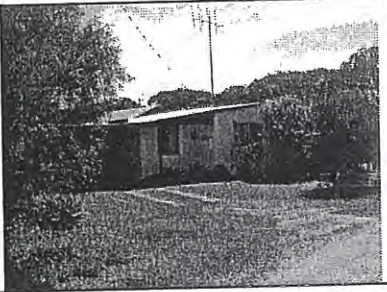
Second Avenue NW 65-61

House	65	64	63	62	61
Type	Side Facing Gable	Front facing gable	Skillion	Side Facing Gable	Skillion
Wall	Painted Jarrah	JWB/Fibro	Jarrah and fibro	JWB/Fibro	Fibro. Some original jarrah extant
Roof mat	Galvanised corrugated	Galvanised corrugated	Galvanised corrugated	Galvanised corrugated	Galvanised corrugated
Pitch	Med	Med	Low	Med	Low
Alter ations	Skillion front and rear Extension to east	Skillion front and rear	Additions to front	Hipped extension to front Garage	Skillion to front
Out buildings	Garage to east. Shed to rear NE	-	Shed to rear Skillion carport to East		Painted jarrah shed to rear
Chimney		Fibro	-	-	
Intrusive elements					
Other

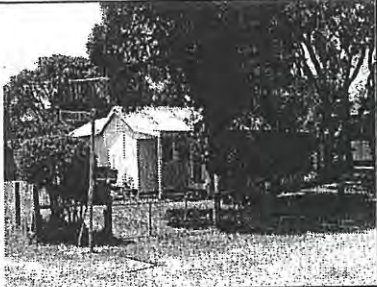
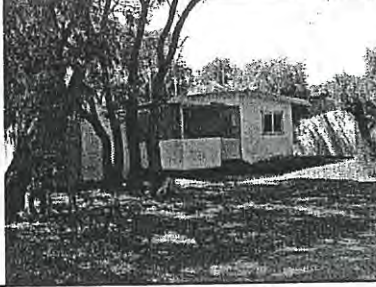
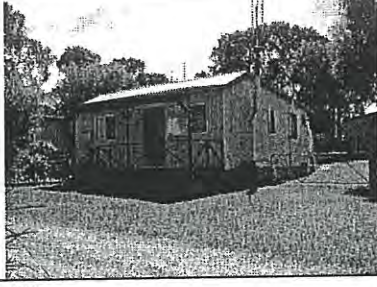
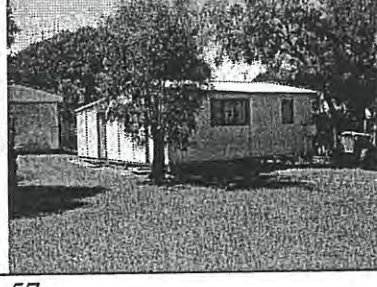
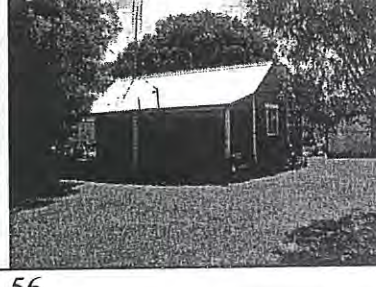
Second Avenue NE 60-56

House	60	59	58	57	56
Type	Side Facing Gable	Front facing gable	Side Facing Gable	Side Facing Gable	Side Facing Gable Mill house
Wall	Painted fibro	Painted fibro	Painted fibro	Painted fibro	Unpainted JWB
Roof	Galvanised corrugated	Galvanised corrugated	Colorbond custom orb	Galvanised corrugated	Galvanised corrugated
Pitch	Med	Low	Asymmetrical	Med/Low	Med
Alterations	Skillion to front and gable to rear	Extension to front	Front verandah Skillion to rear	Rear skillion	-
Out buildings	Painted jarrah toilet/laundry Galvanised shed	Garage to west	Double colorbond garage to NE.	Double fibro garage to NW	Steel shed to N
Chimney	PGI		PGI	-	
Intrusive elements					
Other				Original louvered windows

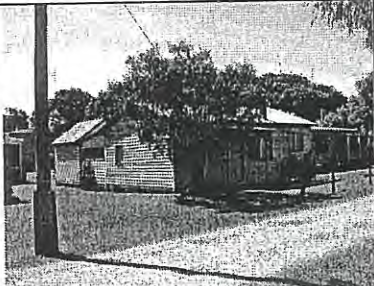
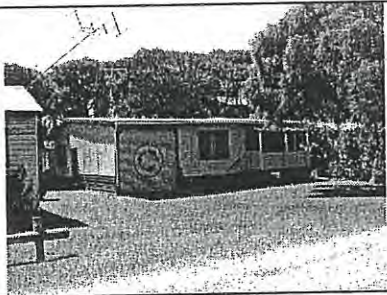
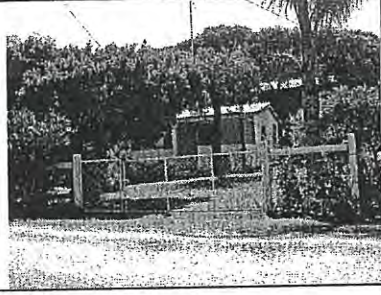
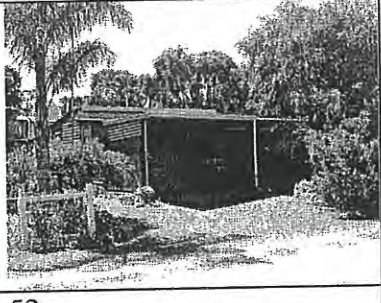
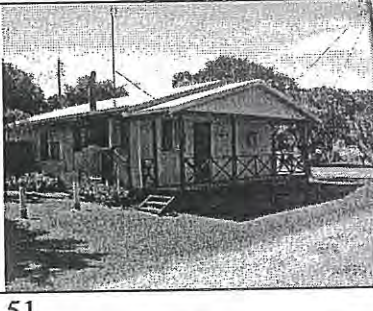
Second Avenue NE 55-51

House	55	54	53	52	51
Type	Side Facing Gable	Side Facing Gable	Side Facing Gable	Skillion	Front facing gable
Wall material	Painted JWB	Painted JWB	Fibro sheeting painted	Unpainted JWB	Fibro sheeting painted?
Roof material	Galvanised corrugated	Galvanised corrugated	Galvanised corrugated iron	Galvanised corrugated	Galvanised corrugated
Pitch	Med	Asymmetrical	Med	Low	Med
Alterations	Small steel porch Skillion extension to rear	Extension to front incorporating garage and verandah	Skillion to front	Skillion to front and carport	Gable verandah
Out buildings	Gable shed attached at rear	2 small shed to rear	-	Double garage to rear	Fibro garage to rear
Chimney	-	-		PGI	PGI
Intrusive elements					
Other

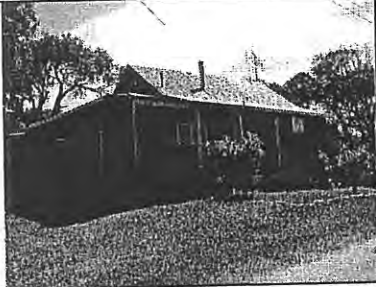
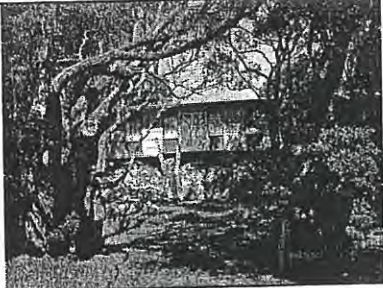
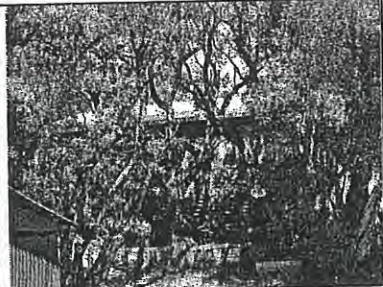
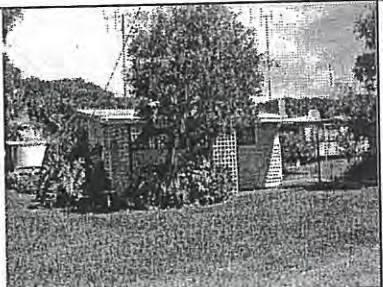
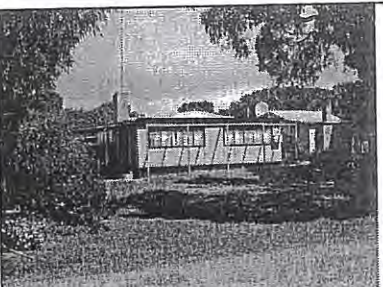
Third avenue SE 90-86

House	90	89	88	87	86
Type	Side Facing Gable	Side Facing Gable	Side Facing Gable	Side Facing Gable	Front Facing Gable
Wall material	JWB	Contemporary cladding	Fibro sheeting painted	JWB/ Fibro	Painted fibro
Roof mate	Galvanised corrugated iron	Galvanised corrugated iron	Galvanised corrugated iron	Galvanised corrugated iron	
Pitch	Med	Low/Med	Med	Med/low	
Alter ations	Skillion to west	-	-	Skillion verandah Skillion extension to rear	Skillion to front and rear Skillion carport to side Steel pergola to front
Out buildings	Small timber shed Fibro garage to front	-	Painted corrugated garage to front	Shed to rear. Skillion carport to SW	-
Chimney	-		Brick	-	Face brick
Intrusive elements		Cladding	-		Steel pergola to front
Other		Granite retaining wall to front

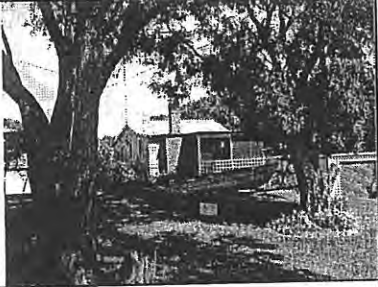
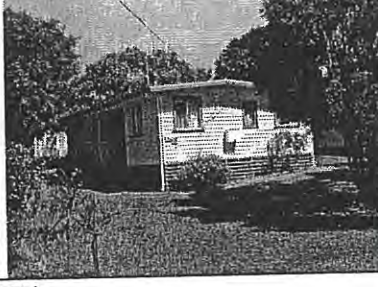
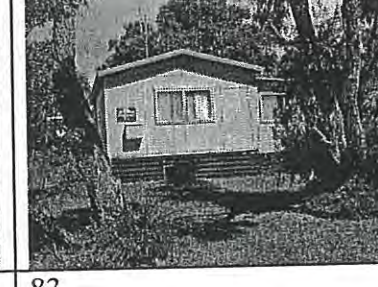
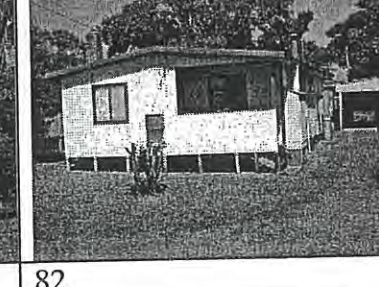
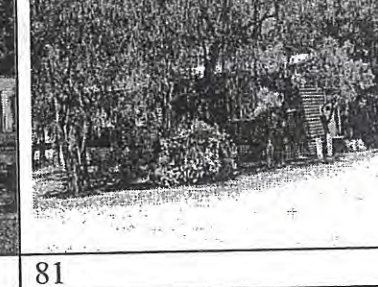
Third avenue SE 85-81

House	85	84	83	82	81
Type	Side facing gable	Front facing gable	Front facing gable	Front facing gable	Side facing gable
Wall mat	Painted contemporary pine boarding	Painted pine	Fibro sheeting painted	Fibro sheeting painted	JWB stained
Roof mat	Galvanised corrugated iron	Galvanised corrugated iron	Galvanised corrugated iron	Galvanised corrugated iron	Galvanised corrugated iron
Pitch	Med	Low	Low/Med	Low	Med
Alter ations	Skillion to front and rear		Skillion to west	Front verandah/sleepout	
Out buildings	Steel carport to NW	Small steel shed to rear	-	Double garage on SW corner	Garage to rear. Small jarrah shed to rear
Chimney	Brick		-	Brick to front. PGI to W	PGI to front
Intrusive elements	Brick chimney and lattice		-		
Other					Part of Shannon Hall

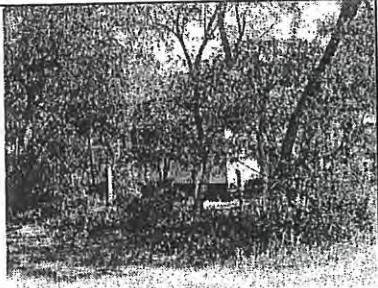
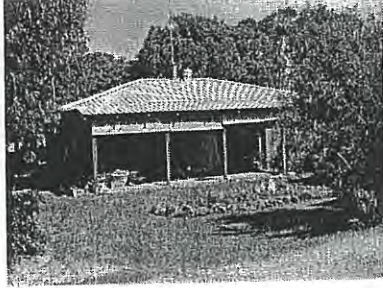
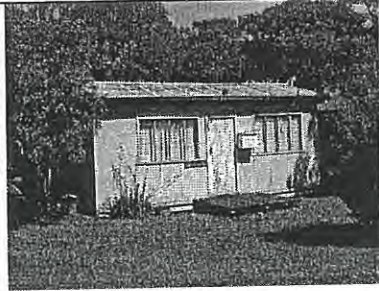
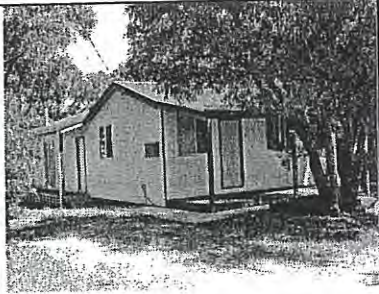
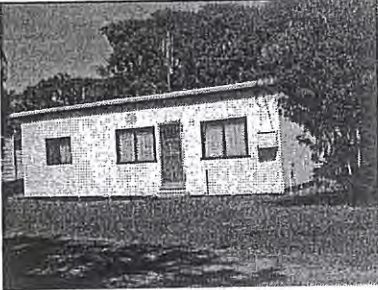
Third Avenue SW 80-76

House	80	79	78	77	76
Type	Skillion	Hipped	Side Facing Gable	Side Facing Gable	Skillion
Wall material	Painted fibro	Brick	Painted fibro	Painted hardiplank	Painted fibro
Roof material	Galvanised corrugated	Industrial profile steel	Galvanised corrugated iron	Colorbond custom orb	Galvanised corrugated
Pitch	Low	Med	Med	Med	Low
Alter ations	Skillion to front. Small timber porch	Skillion carport to East	Scillion to rear	Fibro skillion to rear	Extension to east
Out buildings	Steel shed to rear	Shed to rear	Steel shed to rear	Steel garage	Double steel garage to SW
Chimney	PGI	-			-
Intrusive elements		Brickwork		Cladding and lattice work	
Other

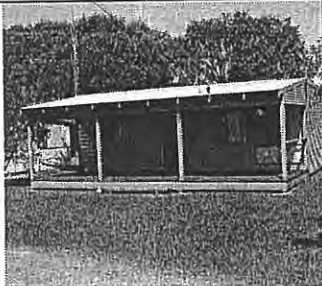
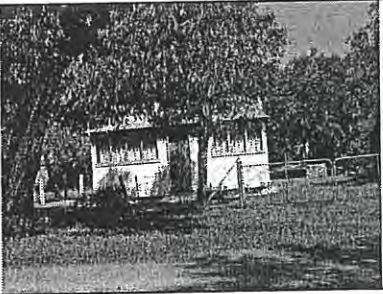
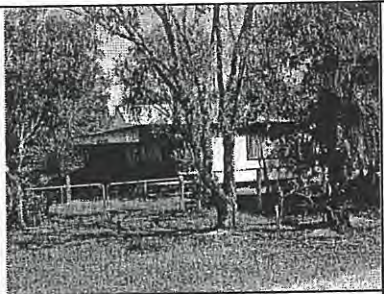
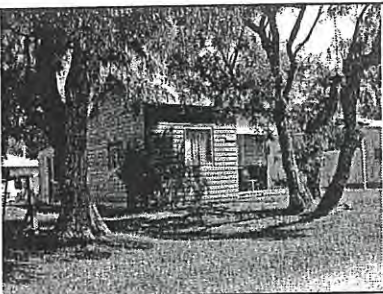
Third Avenue SW 75-71

House	75	74	73	72	71
Type	Scillion	Side Facing Gable +enclosed verandah	Side Facing Gable	Side Facing Gable	Side Facing Gable
Wall material	JWB	Painted fibro	Painted fibro with JWB to dado height	Painted fibro with JWB to dado height	Unpainted fibro
Roof material	Galvanised corrugated iron	Galvanised corrugated iron	Galvanised corrugated iron	Galvanised corrugated iron	Galvanised corrugated iron
Pitch	Low	Med	Med	Med	Med
Alterations	Skillion verandah. Corrugated colorbond wall sheeting to N and W	Skillion to front	Skillion verandah and sleepout. Skillion carport to east	Skillion carport. Skillion to rear	Skillion to front and rear. Verandah to rear.
Out buildings	-	-	Laundry to rear	-	Colorbond garage to rear
Chimney	-	PGI	PGI	PGI	-
Intrusive elements	Corrugated colorbond wall sheeting			Fibro to front verandah	
Other

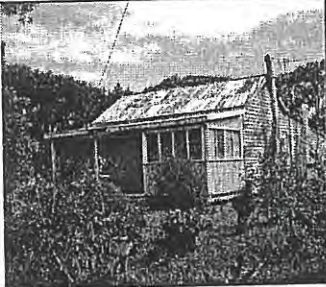
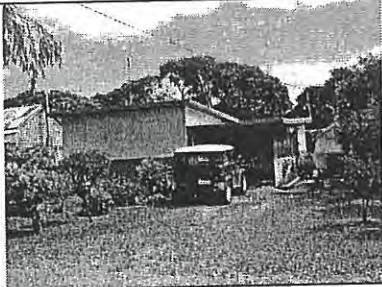
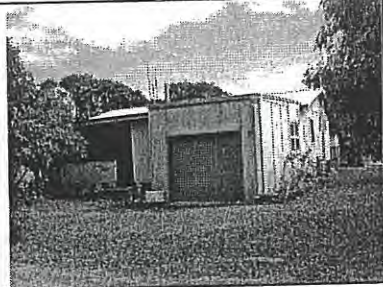
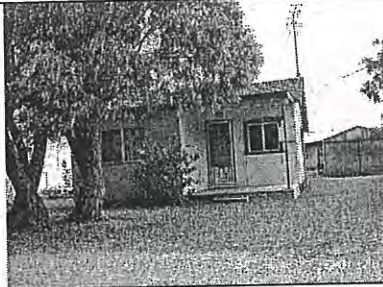
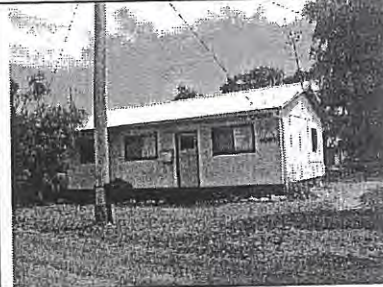
Third Avenue NW 91-95

House	91	92	93	94	95
Type	Side Facing Gable	Skillion	Side Facing Gable	Side Facing Gable	Side Facing Gable
Wall material	JWB	JWB/ Fibro	Unpainted Fibro	Painted fibro	Painted fibro
Roof material	Galvanised corrugated iron	Galvanised corrugated iron	Galvanised corrugated iron	Concrete tile	Galvanised corrugated iron
Pitch	Med	Low	Low	Med	Med
Alterations	Sleepout enclosed? Skillion extension to rear	Carport to east	Single fibro garage to front	Sleepout/verandah	-
Out buildings	-	Fibro shed to rear	Fibro shed to rear	Steel shed to rear	Steel shed to rear
Chimney	PGI	-	-		
Intrusive elements			Garage to front		
Other

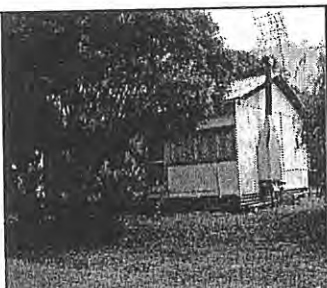
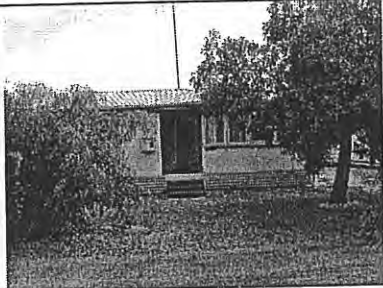
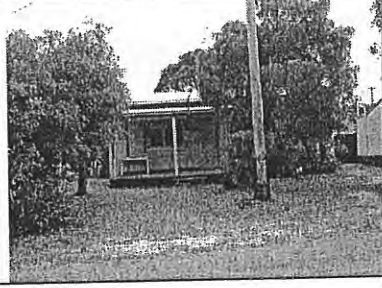
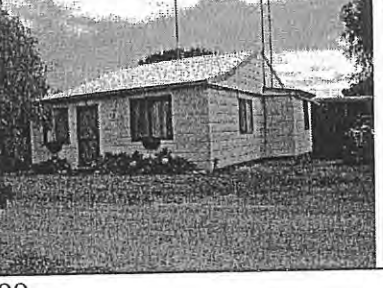
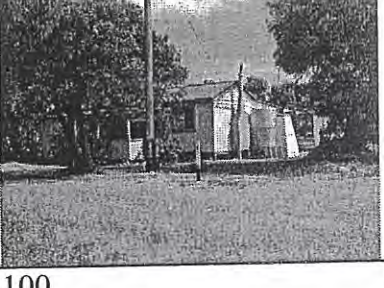
Third Avenue NW 96-100

House	96	97	98	99	100
Type	Side Facing Gable	Side Facing Gable	Side Facing Gable	Side Facing Gable	Side Facing Gable
Wall material	Painted fibro	JWB	Unpainted fibro	Fibre cement boards	Painted fibro
Roof material	Galvanised corrugated iron	Galvanised corrugated iron	Galvanised corrugated iron	Colorbond custom orb	Galvanised corrugated iron painted
Pitch	Med	Med	Med	Med	Med
Alterations	Verandah to rear	Fibro skillion to front Timber skillion extension to rear		Verandah enclosed	Skillion verandah
Out buildings	-	Steel shed to rear	-	Large boatshed E boundary	Small shed to rear
Chimney	PGI	Brick	-		PGI
Intrusive elements	-			External cladding	Fibreglass water tank Toilet? to rear
Other

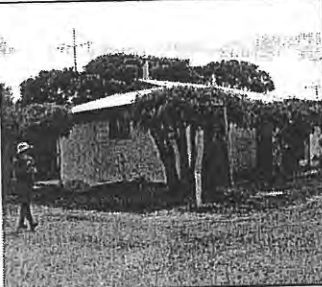
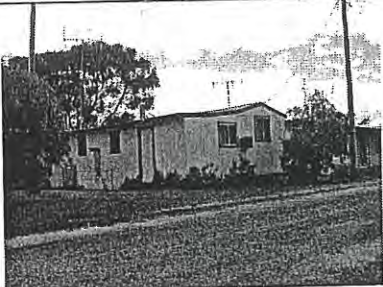
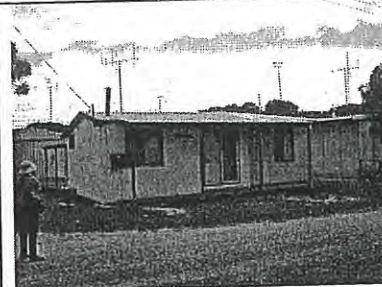
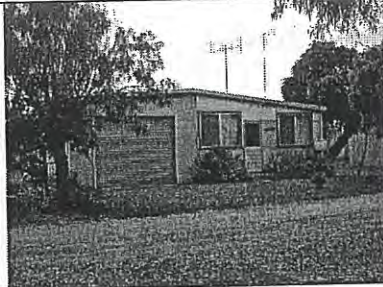
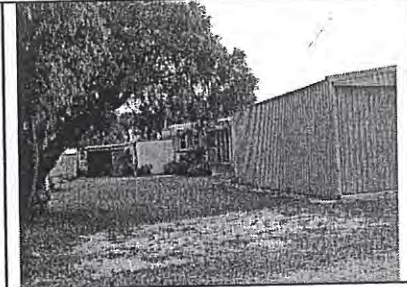
Third Avenue NE 111-115

House	111	112	113	114	115
Type	Hipped	Front facing gable	Side Facing Gable	Front facing gable	Front facing gable
Wall	Painted fibro	Painted fibro	Unpainted fibro	Fibro sheeting	Fibro sheeting
Roof	Galvanised corrugated iron	Galvanised corrugated iron	Galvanised corrugated iron	Galvanised corrugated iron	
Pitch	Med/Low	Med/Low	Med/Low	Low	Low
Alterations	Verandah to rear	Skillion to west side	Extension to rear. Brick floored verandah on bush poles		
Out buildings	-	Shed to rear	Double steel shed to rear	Jarraah shed to rear	Double shed to front east boundary Shed NW corner
Chimney	-	-	-		
Intrusive elements					
Other				Originally JWB

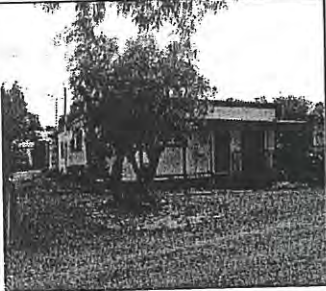
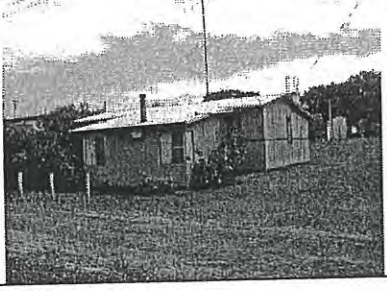
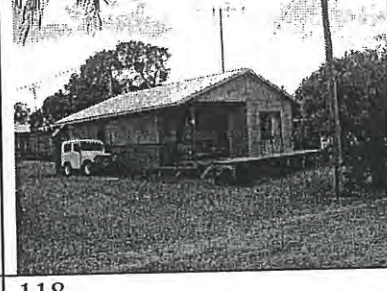
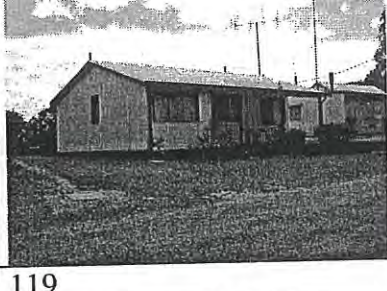
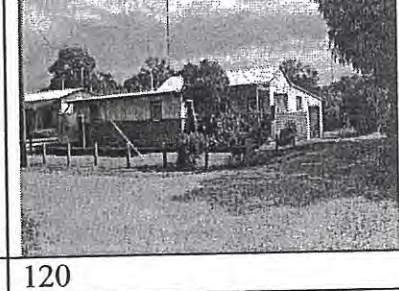
Third Avenue NE 116-120

House	116	117	118	119	120
Type	Skillion	Side Facing Gable	Front facing gable	Side Facing Gable	Side Facing Gable
Wall material	Painted fibro sheeting	Fibro sheeting	JWB to dado Fibro sheeting	Fibro sheeting	Fibro sheeting JWB to dado height
Roof	Galvanised corrugated	Galvanised corrugated	Galvanised corrugated	Galvanised corrugated	Galvanised corrugated
Pitch	Low	Med	Med	Med	Med
Alterations	Verandah to front	Skillion to front	Front sleepout/deck		Skillion extension to south
Out buildings	Steel shed to rear	Small timber woodshed NW corner	-	Steel garage to rear	Garage to N
Chimney	PGI	-		-	
Intrusive elements	Lattice

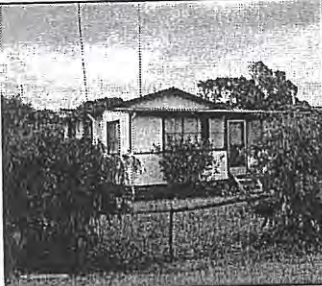
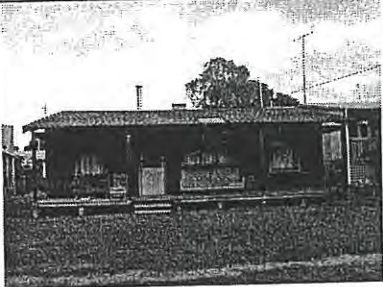
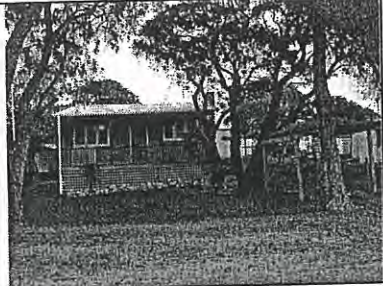
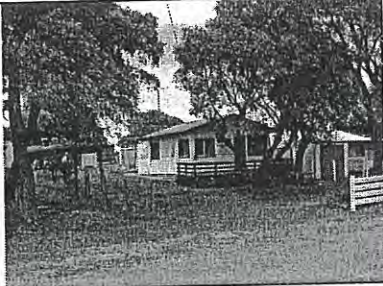
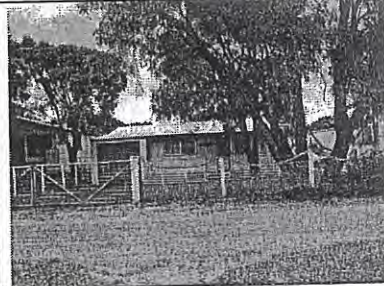
Fourth Avenue SE 121- 125

House	121	122	123	124	125
Type	Front facing gable	Mill house	Side facing gable	Front facing gable	Skillion
Wall material	Fibro sheeting	JWB	Fibro sheeting	Fibro sheeting	Fibro sheeting
Roof material	Corrugated colorbond	Concrete tiles	Galvanised corrugated	Corrugated colorbond	Galvanised corrugated
Pitch	Low	Med	Med	Med	Low
Alter ations	Enclosed front verandah Skillion extension to rear	Windows	Brick chimney	Garage to east	Skillion to front Garage attached to east side
Out buildings	-	Fibro shed	Carport front NW corner. Steel shed	Toilet to rear	
Chimney			Brick		-
Intrusive elements		Concrete roof tiles			Lattice verandah
Other		Most of original timber windows remain

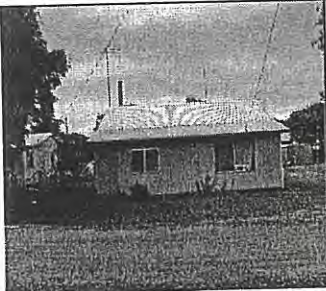
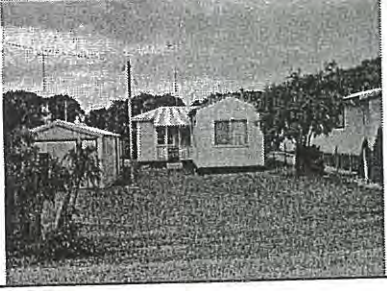
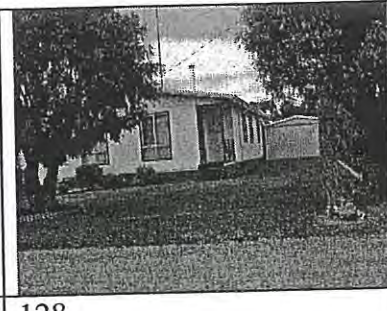
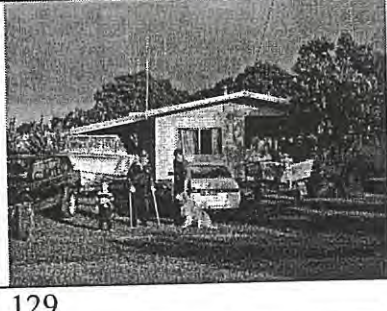
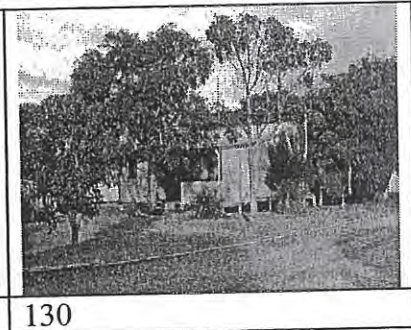
Fourth Avenue SE 126-1 30

House	126	127	128	129	130
Type	Side facing gable	Hip	Side facing gable. Front facing gable added	Front facing gable	Side facing gable
Wall material	Fibro sheeting	Painted fibro	Fibro sheeting	Unpainted fibro	Fibro sheeting
Roof material	Galvanised corrugated iron	Galvanised corrugated iron	Galvanised corrugated iron	Galvanised corrugated iron	Galvanised corrugated iron
Pitch	Med	Med	Low	Low	Med
Alterations	Enclosed skillion verandah Skillion extension to rear	Gable extension to front	Possibly front section is an addition	Shallow gable extension to front with skillion carport	Sc extension to front
Out buildings	Small steel shed to SW	Double garage at front of block	Double steel garage SW corner		Steel shed to rear
Chimney	-				PGI
Intrusive elements					
Other					Peppermint hedge

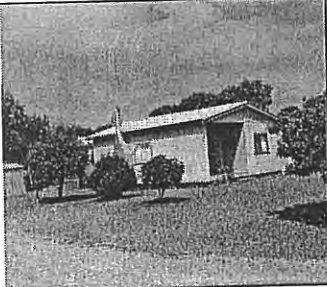
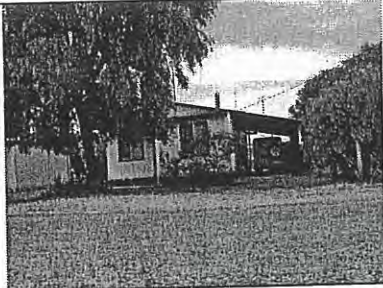
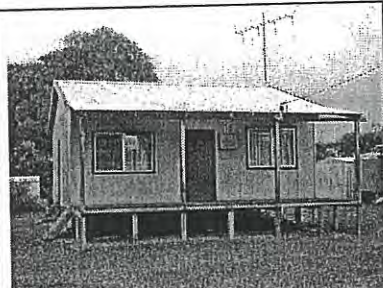
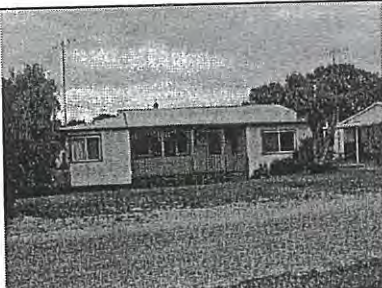
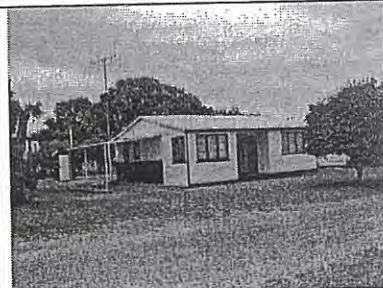
Fourth Avenue SW101-105

House	101	102	103	104	105
Type	Front facing gable	Front facing gable		Side Facing Gable	Side Facing Gable
Wall material	Painted fibro	Painted fibro	Painted fibro	Painted fibro	Painted fibro with JWB to dado
Roof material	Painted corrugated iron	Galvanised corrugated	Galvanised corrugated	Corrugated colorbond	Galvanised corrugated iron
Pitch	Med	Low		Med/Low	Med
Alterations	Skillion to west	Skillion to front and side	Front verandah	Verandah	Front skillion
Out buildings	Small shed to rear	-	Small shed to rear	Double steel carport to SW Small shed to rear	Toilet
Chimney	PGI	Skillion to front Skillion carport	Recent verandah to front	Hipped extension to SE	Enclosed verandah
Intrusive elements				Lattice	
Other

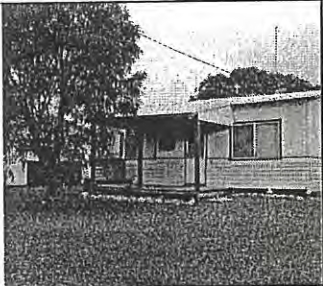
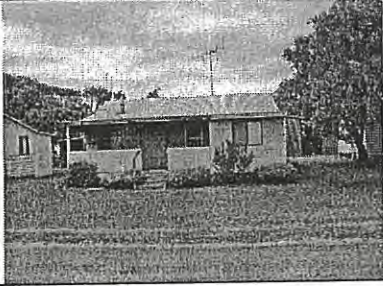
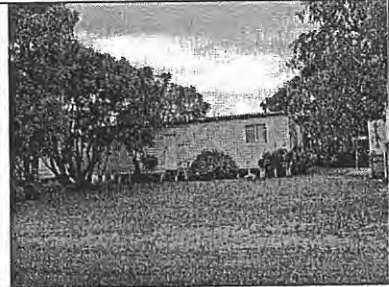
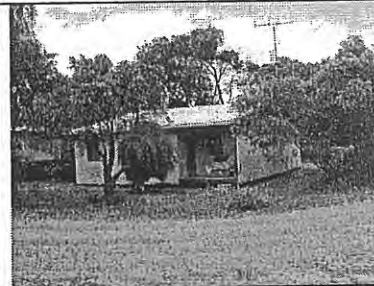
Fourth Avenue SW 106-110

House	106	107	108 Enough for now	109	110
Type	Side facing gable	Side facing gable	Skillion	Skillion	Side facing gable
Wall material	JWB to dado, fibro sheeting	Fibre boards	Painted JWB	JWB to dado, fibro sheeting	Fibro sheeting
Roof material	Galvanised corrugated	Galvanised corrugated	Galvanised corrugated	Galvanised corrugated	Galvanised corrugated
Pitch	Med	Med	Low	Low	Med
Alterations	Front verandah	Skillion to front. Front verandah/sleepout Extended to rear by cranking roof plane up	-	-	Extension to front?
Out buildings	Toilet. Steel shed	Steel shed to rear	-	Small shed	Small shed
Chimney	-	-	-	Timber/fibro	-
Intrusive elements	-	Fibre boarding. Fibre cement balustrading	-	-	-
Other

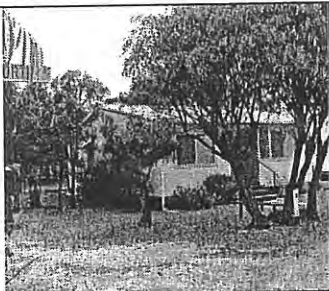
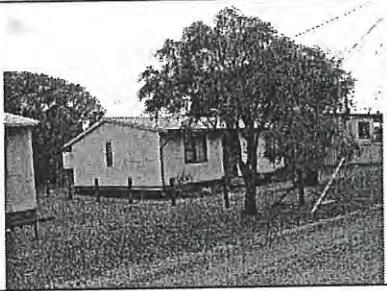
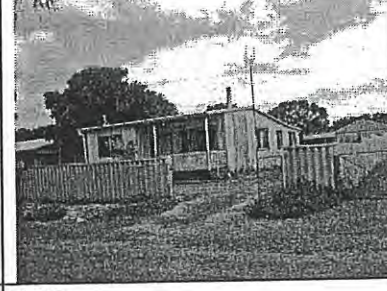
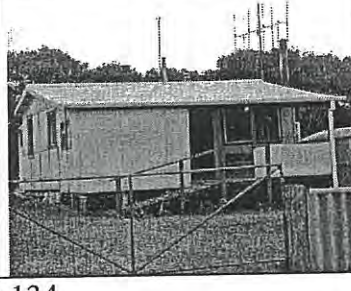
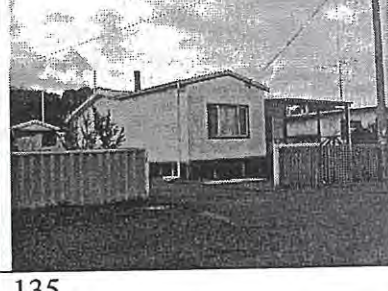
Fourth Avenue NW 131-136

House	131	132	133	134	135
Type	Side Facing Gable	Side Facing Gable	Side Facing Gable	Side Facing Gable	Side Facing Gable
Wall	Painted fibro	Painted fibro	Vertical industrial profile steel cladding	Fibro sheeting	Fibro sheeting
Roof	Galvanised corrugated iron	Galvanised corrugated iron	Query	Galvanised corrugated iron	Galvanised corrugated iron
Pitch	Med	Med	Low	Med/Low	Med
Alterations	Front sleepout	-	Skillion to rear	Skillion front sleepout/verandah	Gable and verandah addition to front
Out buildings	Steel shed to rear	Steel shed to rear	Double garage and store to NE	Steel shed to rear	Garage to rear
Chimney	-	-	-	PGI	
Intrusive elements	-	-	Wall cladding Super six fence	Super six fence	Super six fence to side
Other					Picket fence

Super six fences and other solid fences including solid pickets should not be allowed. Any super six or solid fencing that exists should be removed or replaced when the opportunity arises.

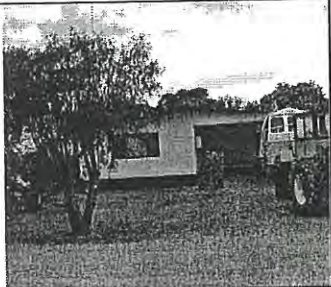
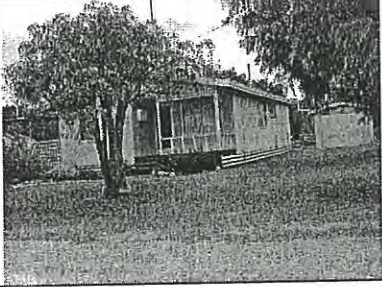
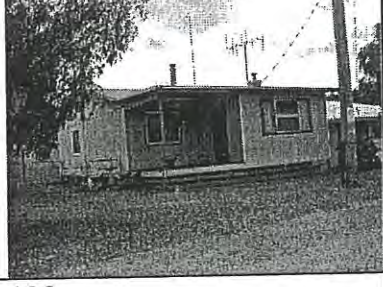
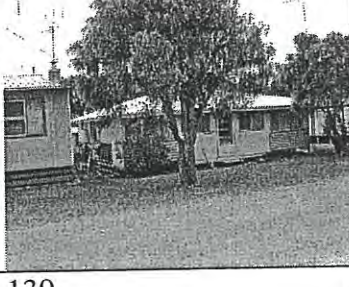
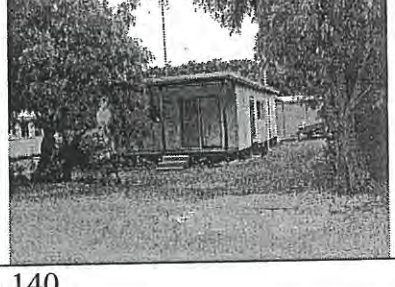
Fourth Avenue North West 136-140

House	136	137	138	139	140
Type	Front facing gable	Front facing gable	Side Facing Gable	Hipped	
Wall material	Painted fibro	Painted fibro	Painted fibro	JWB to dado/fibro sheeting	Painted fibro
Roof material	Galvanised corrugated	Galvanised corrugated	Galvanised corrugated	Galvanised corrugated iron	Galvanised corrugated
Pitch	Low	Low		Med	
Alterations	Query	Front verandah Rear pergola	Skillion sleepout/verandah to front	Enclosure to front verandah	
Out buildings	Colorbond garage to NE	Fibro garage to NE	Double garage to rear	Lightweight carport SE corner	Sleepout/verandah to front Steel shed to rear
Chimney	-	-	Brick	-	-
Intrusive elements		Latticework	Brick chimney		
Other

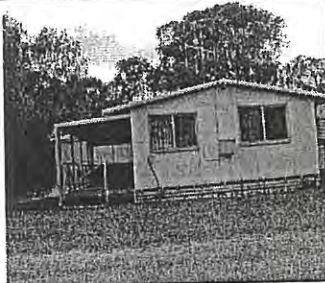
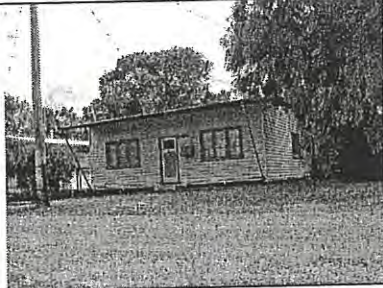
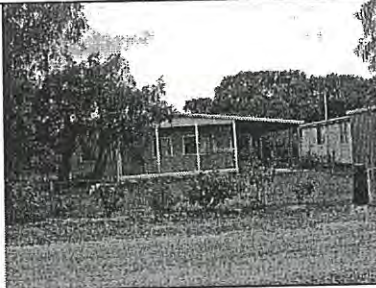
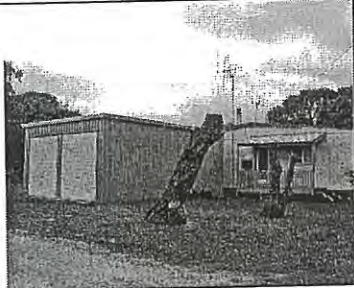
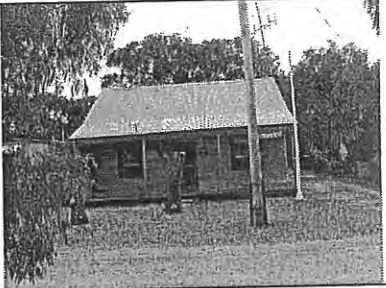
Fourth Avenue NE 141- 145

House	141	142	143	144	145 "Shannon"
Type	Front facing gable	Side Facing Gable	Front facing gable	Front facing gable	Side Facing Gable
Wall material	Fibro sheeting	Painted JWB	Unpainted fibro	Fibro	JWB
Roof material	Galvanised corrugated	Galvanised corrugated	Galvanised corrugated	Galvanised corrugated	Colorbond custom orb
Pitch	Low	Low	Low	Low	Med
Alter ations	Skillion verandah to w side	Front eaves overhang supports Skillion to rear	Verandah Skillion carport to east	Verandah with lattice balcony	Rear skillion verandah
Out buildings	-	-	-	Double steel carport to front	Double timber garage
Chimney	-	-	-		
Intrusive elements					
Other

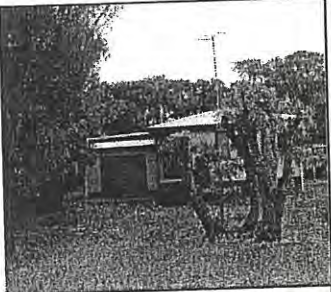
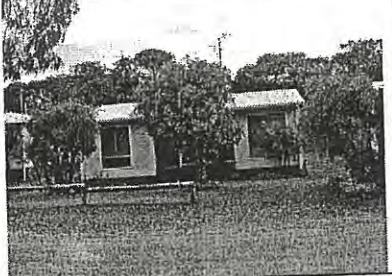
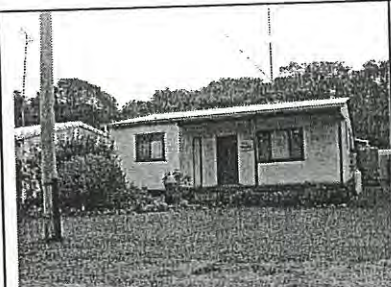
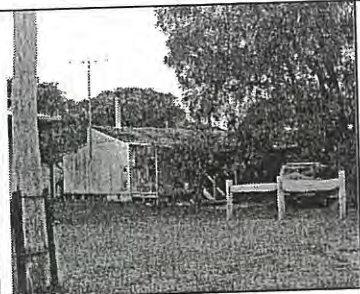
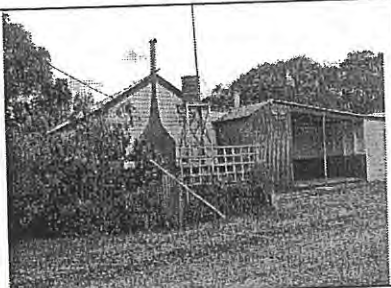
Fourth Avenue NE 146- 150

House	146	147	148	149	150
Type	Hip	Side Facing Gable	Side Facing Gable	Skillion	Side Facing Gable
Wall material	Fibro	Painted fibro	Painted fibro	Vertical fibro	JWB
Roof material	Galvanised corrugated	Galvanised corrugated	Galvanised corrugated	Tiles	Galvanised corrugated
Pitch	Med	Med	Med	Med	Med
Alter ations	Garage to west	-	Skillion to rear	Gable to front	Skillion to rear
Out buildings	-	-	Small shed	Small shed	Double steel garage to rear
Chimney	-	-	-	-	PGI
Intrusive elements	Garage extension	-	-	Roof tiles and cladding	-
Other

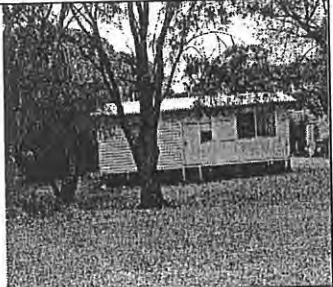
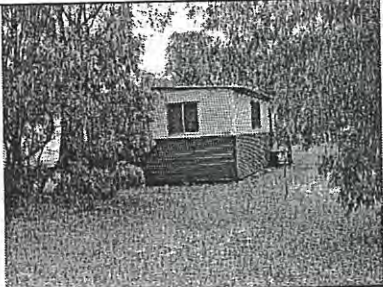
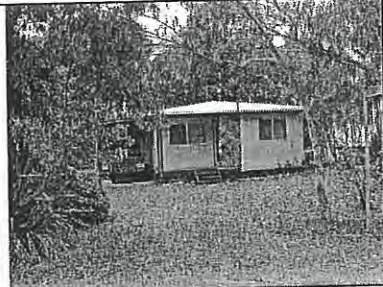
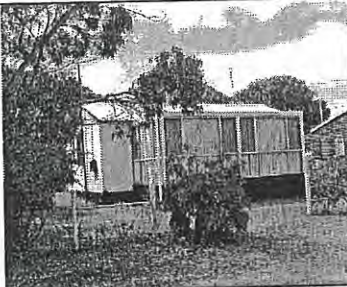
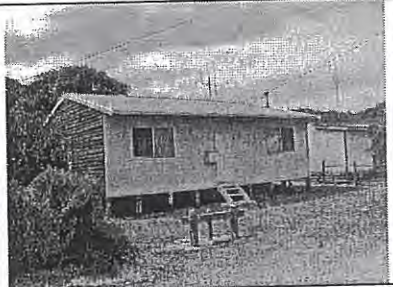
East Avenue 151-155

House	151	152	153	154	155
Type	Side Facing Gable	Front Facing Gable	Hip	Side Facing Gable	Side Facing Gable
Wall material	Painted Jarrah	Corrugated	Painted fibro	Painted fibro	JWB Painted fibro
Roof material	Galvanised corrugated	Galvanised corrugated	Galvanised corrugated	Galvanised corrugated	Colorbond custom orb
Pitch	Med	Low	Low	Med	Med
Alterations	Skillion to rear Front verandah enclosure	Walls reclad in corrugated colorbond	Skillion carport and extension to rear	Sunroom to front Skillion to rear	Skillion to rear
Out buildings	Steel shed and carport to rear	-	-	Laundry to rear	-
Chimney	PGI	-	-	PGI	PGI
Intrusive elements		Corrugated colorbond wall cladding	-	Aluminium sun room to front	Colorbond roofing
Other					Original jarrah boards remain on N facade

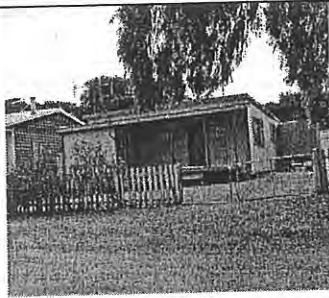
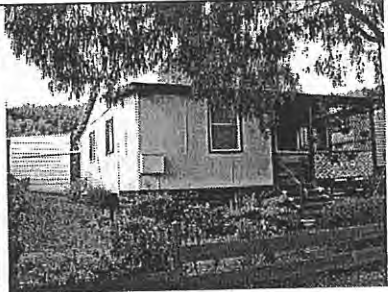
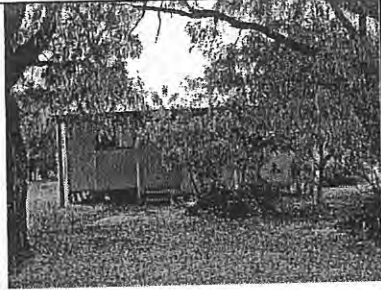
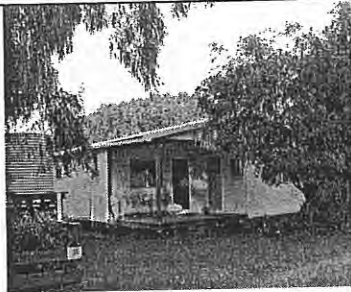
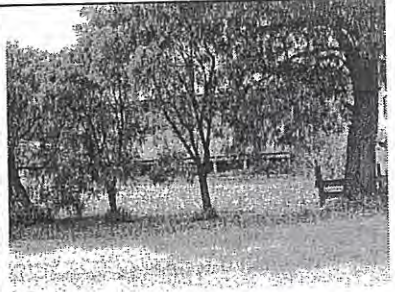
East Avenue 156-160

House	156	157	158	159	160
Type	Skillion	Side Facing Gable	Side Facing Gable	Side Facing Gable	Side Facing Gable
Wall material	Painted fibro	Unpainted fibro	Painted fibro	Painted fibro	Painted fibro
Roof material	Galvanised corrugated	Galvanised corrugated	Galvanised corrugated	Galvanised corrugated	Galvanised corrugated
Pitch	Low	Med/low	Med	Med	Med
Alter ations	-	Skillion extension to front and rear	Verandah to rear	Enclosed sleepout	-
Out buildings	Double steel garage	Double steel garage	Small steel shed	Painted jarrah shed to rear	-
Chimney	-	-	-	-	-
Intrusive elements					
Other

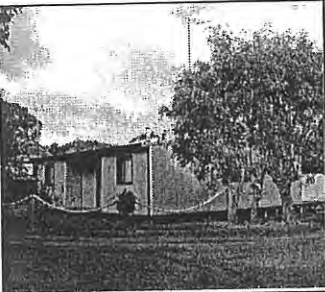
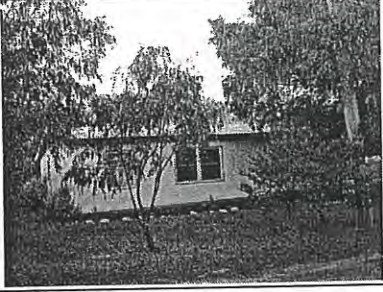
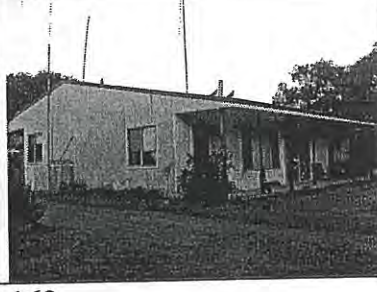
East Avenue 161-163

House	161	162	163
Type	Front facing gable	Side facing gable	Side facing gable
Wall material	Vertical cladding	Painted fibro	Painted fibro
Roof material	Galvanised corrugated	Colorbond custom orb	
Pitch	Low/ Med (asymmetrical)	Low/ Med	Med
Alterations		Verandah to south	
Out buildings	Garage	Double garage to rear	Double garage to rear and fibro shed
Chimney			
Intrusive elements	Cladding		
Other			House for caravan park on larger lot
