COASTAL RESERVES MANAGEMENT PLAN

MARCH 2024

Prepared by:
Land Insights

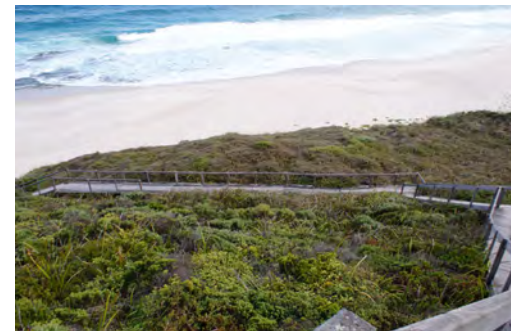
Back Beach access

Back Beach is isolated and more difficult to access than other sites, which protects it from usage pressures but also makes it vulnerable to human impact without regular management presence. The main challenges are:

- Dune erosion and vegetation damage along the access track, caused by 4WD vehicles driving off the path into the vegetation.
- Track degradation from vehicles not reducing tire pressures, creating wallow holes and getting stuck.
- Exposure of the pedestrian access down the cliff to wind, salt spray, and moisture, which can damage the stairway. Regular inspections and maintenance are needed to prevent safety issues.
- Expected growth in pedestrian traffic from the WOW Trail passing through the site, which may increase site usage. Continuous monitoring of site usage is advised to enable timely management responses if usage increases significantly.

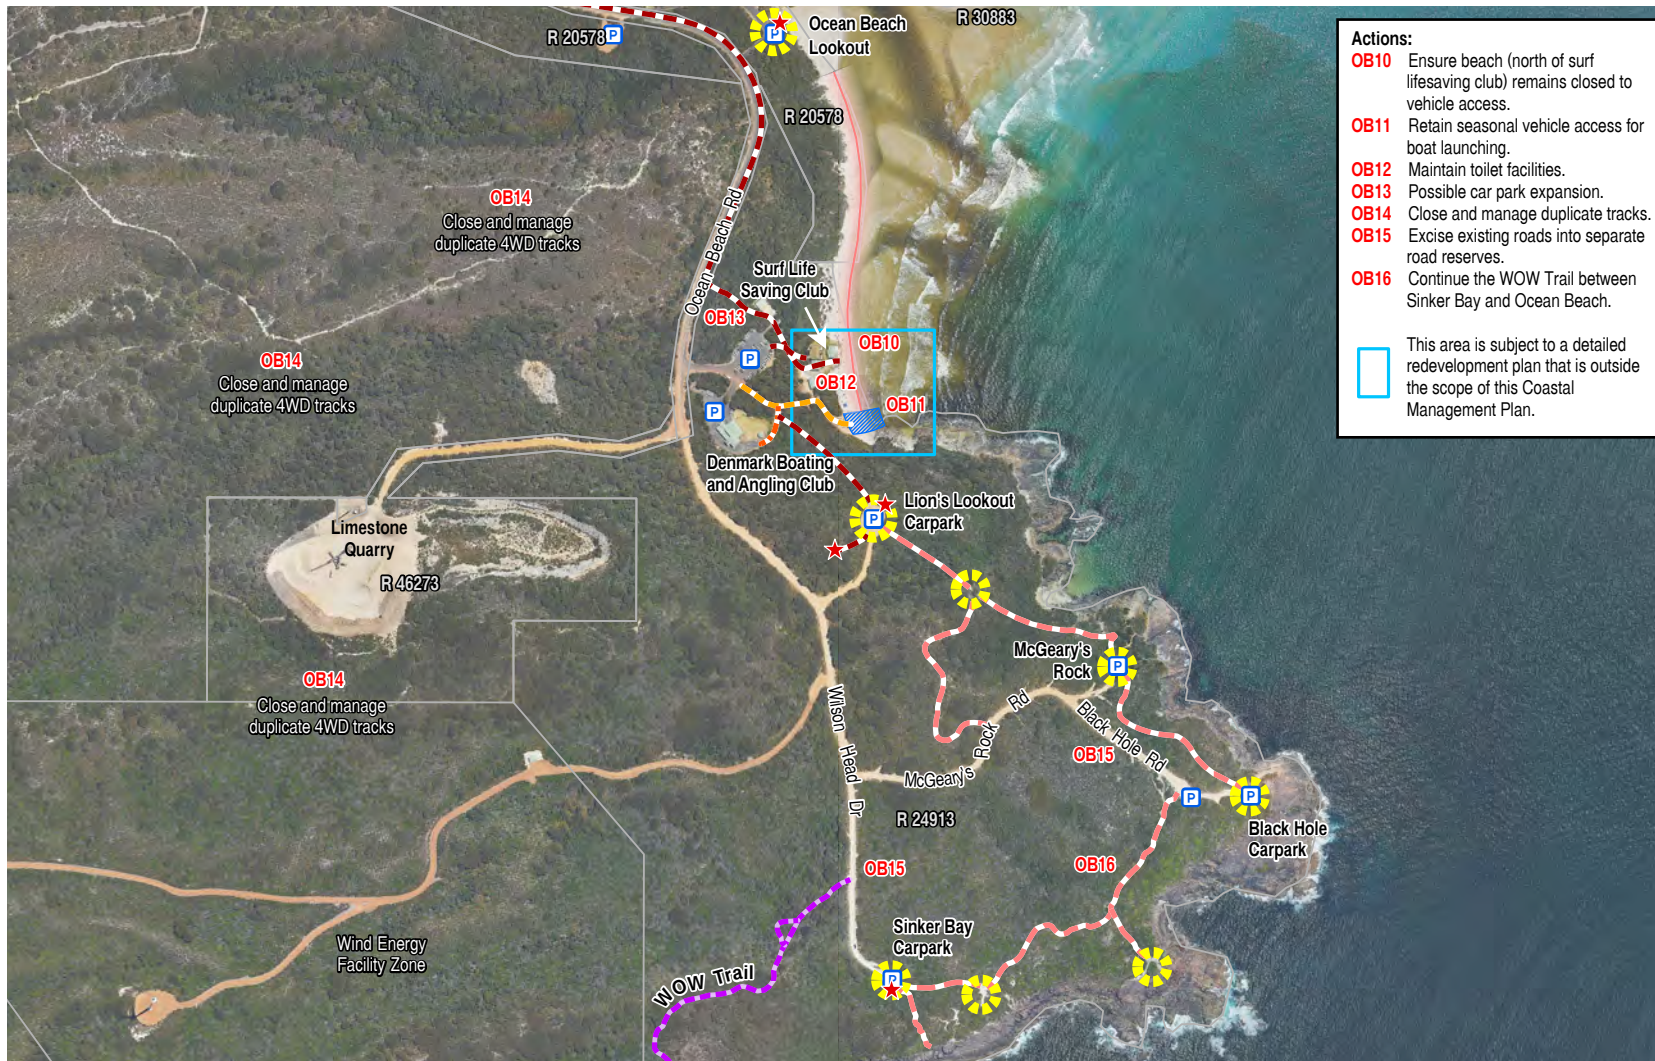
Plan 5.4
Prawn Rock Channel (actions)
SHIRE OF DENMARK

- OB10** Ensure beach (north of surf lifesaving club) remains closed to vehicle access.
- OB11** Retain seasonal vehicle access for boat launching.
- OB12** Maintain toilet facilities.
- OB13** Possible car park expansion.
- OB14** Close and manage duplicate tracks.
- OB15** Excise existing roads into separate road reserves.
- OB16** Continue the WOW Trail between Sinker Bay and Ocean Beach.

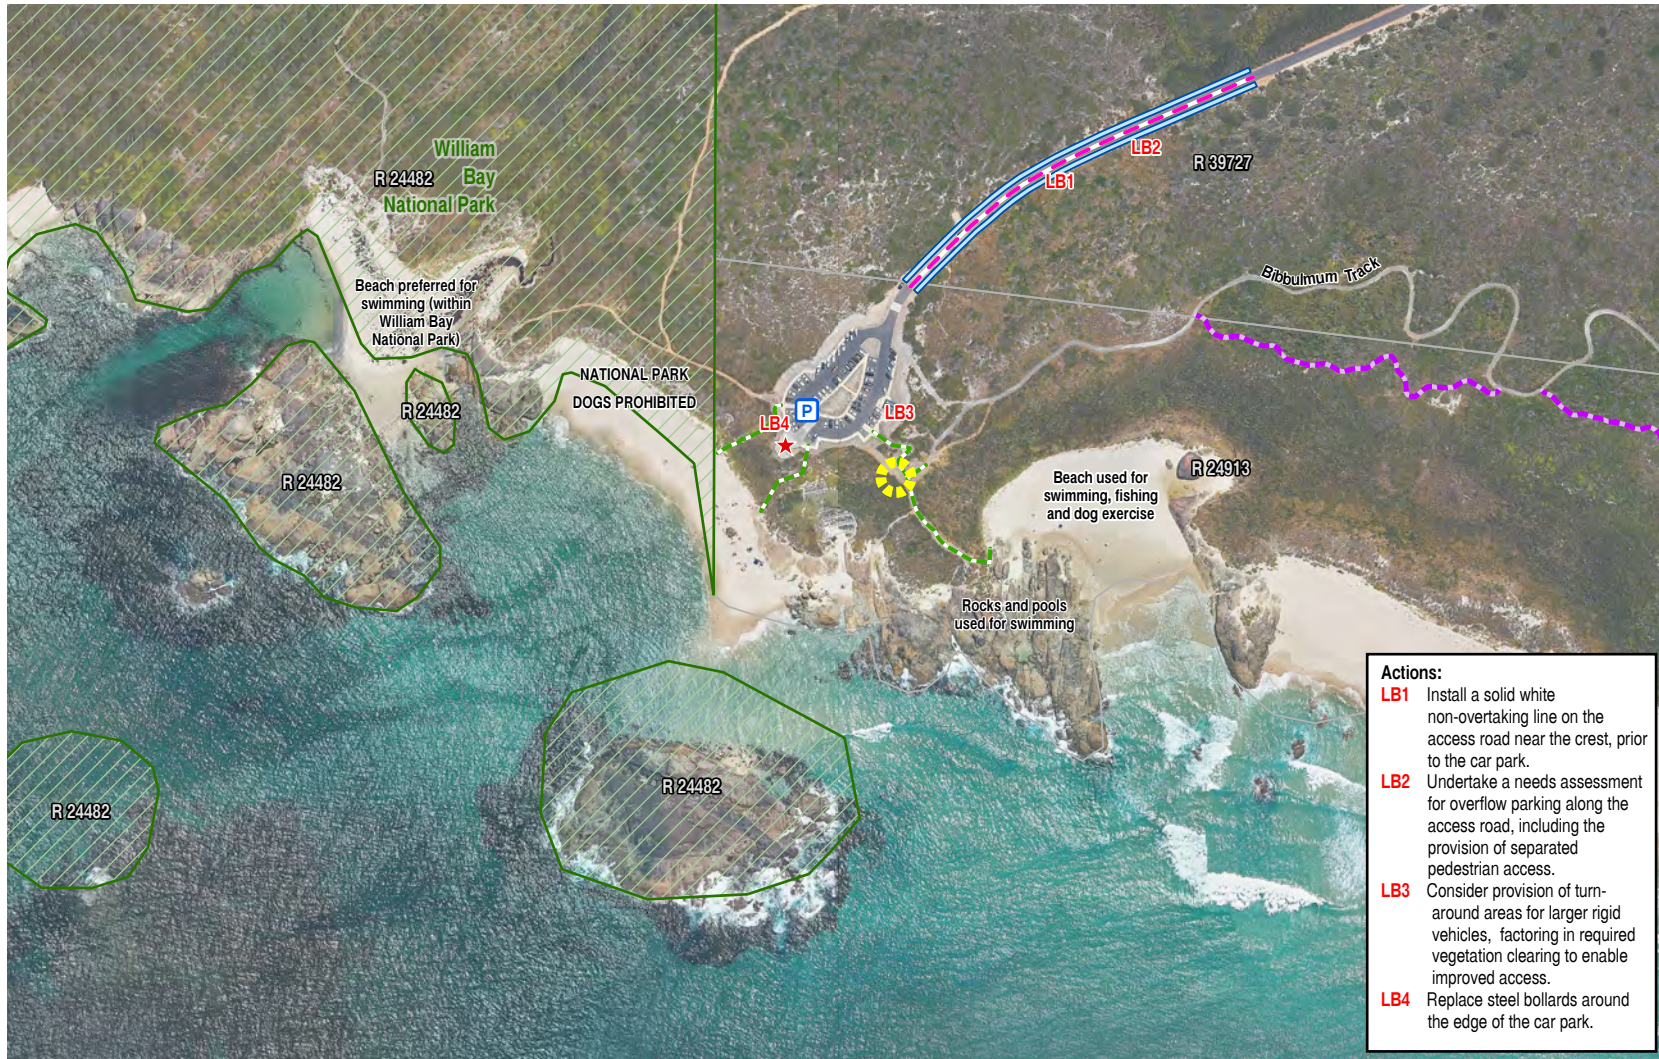
Lights Beach car park

- Actions:**
- LB1** Install a solid white non-overtaking line on the access road near the crest, prior to the car park.
 - LB2** Undertake a needs assessment for overflow parking along the access road, including the provision of separated pedestrian access.
 - LB3** Consider provision of turn-around areas for larger rigid vehicles, factoring in required vegetation clearing to enable improved access.
 - LB4** Replace steel bollards around the edge of the car park.

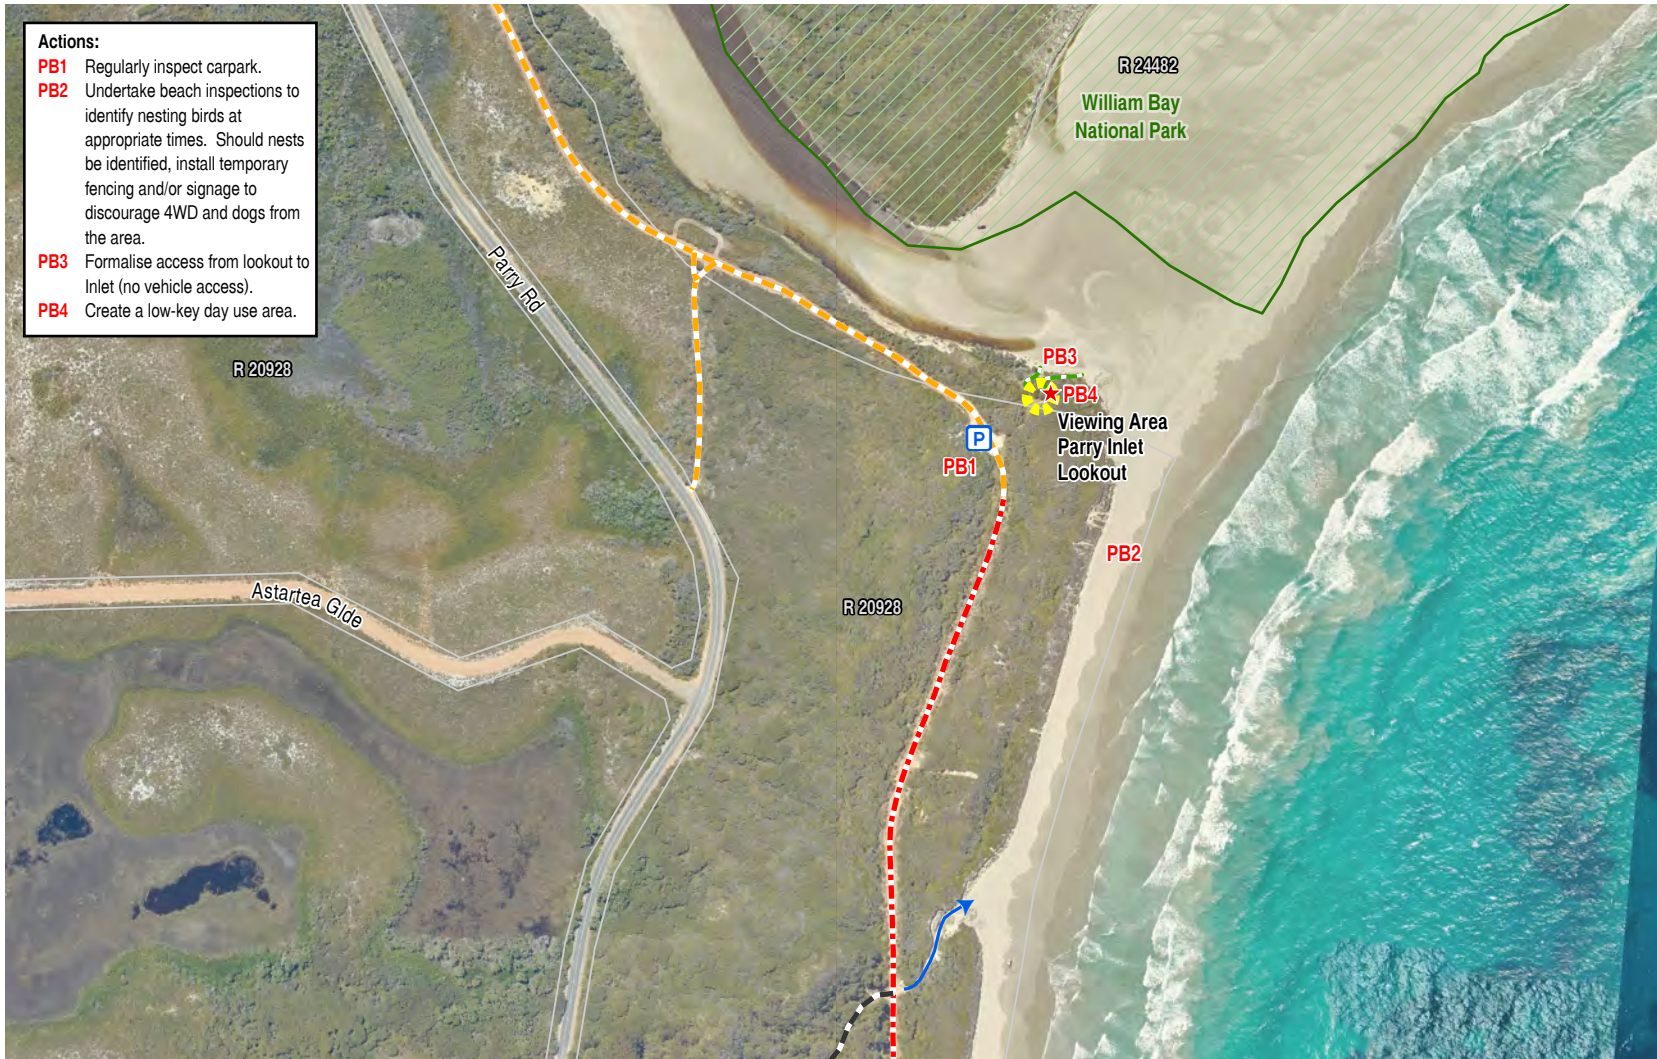
Parry Beach day use area and emergency vehicle access

Actions:
PB1 Regularly inspect carpark.
PB2 Undertake beach inspections to identify nesting birds at appropriate times. Should nests be identified, install temporary fencing and/or signage to discourage 4WD and dogs from the area.
PB3 Formalise access from lookout to Inlet (no vehicle access).
PB4 Create a low-key day use area.

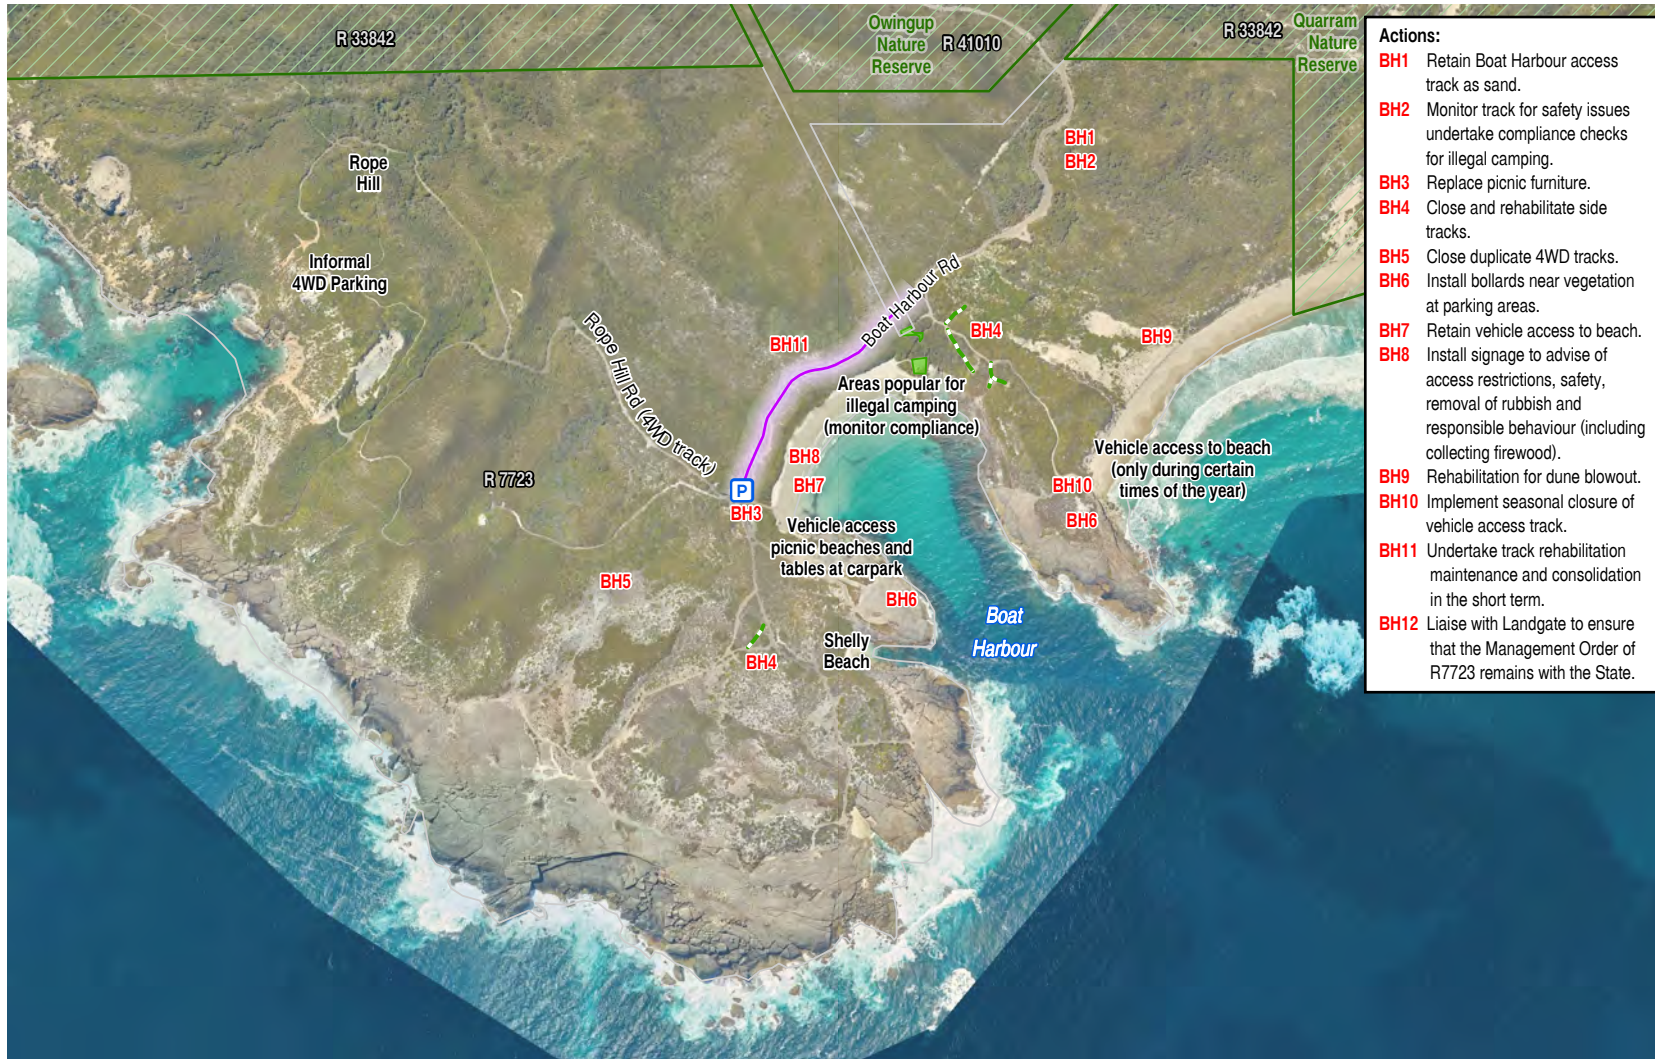
Plan 8.3
Boat Harbour - Environmental
SHIRE OF DENMARK

- Actions:**
- BH1** Retain Boat Harbour access track as sand.
 - BH2** Monitor track for safety issues undertake compliance checks for illegal camping.
 - BH3** Replace picnic furniture.
 - BH4** Close and rehabilitate side tracks.
 - BH5** Close duplicate 4WD tracks.
 - BH6** Install bollards near vegetation at parking areas.
 - BH7** Retain vehicle access to beach.
 - BH8** Install signage to advise of access restrictions, safety, removal of rubbish and responsible behaviour (including collecting firewood).
 - BH9** Rehabilitation for dune blowout.
 - BH10** Implement seasonal closure of vehicle access track.
 - BH11** Undertake track rehabilitation maintenance and consolidation in the short term.
 - BH12** Liaise with Landgate to ensure that the Management Order of R7723 remains with the State.

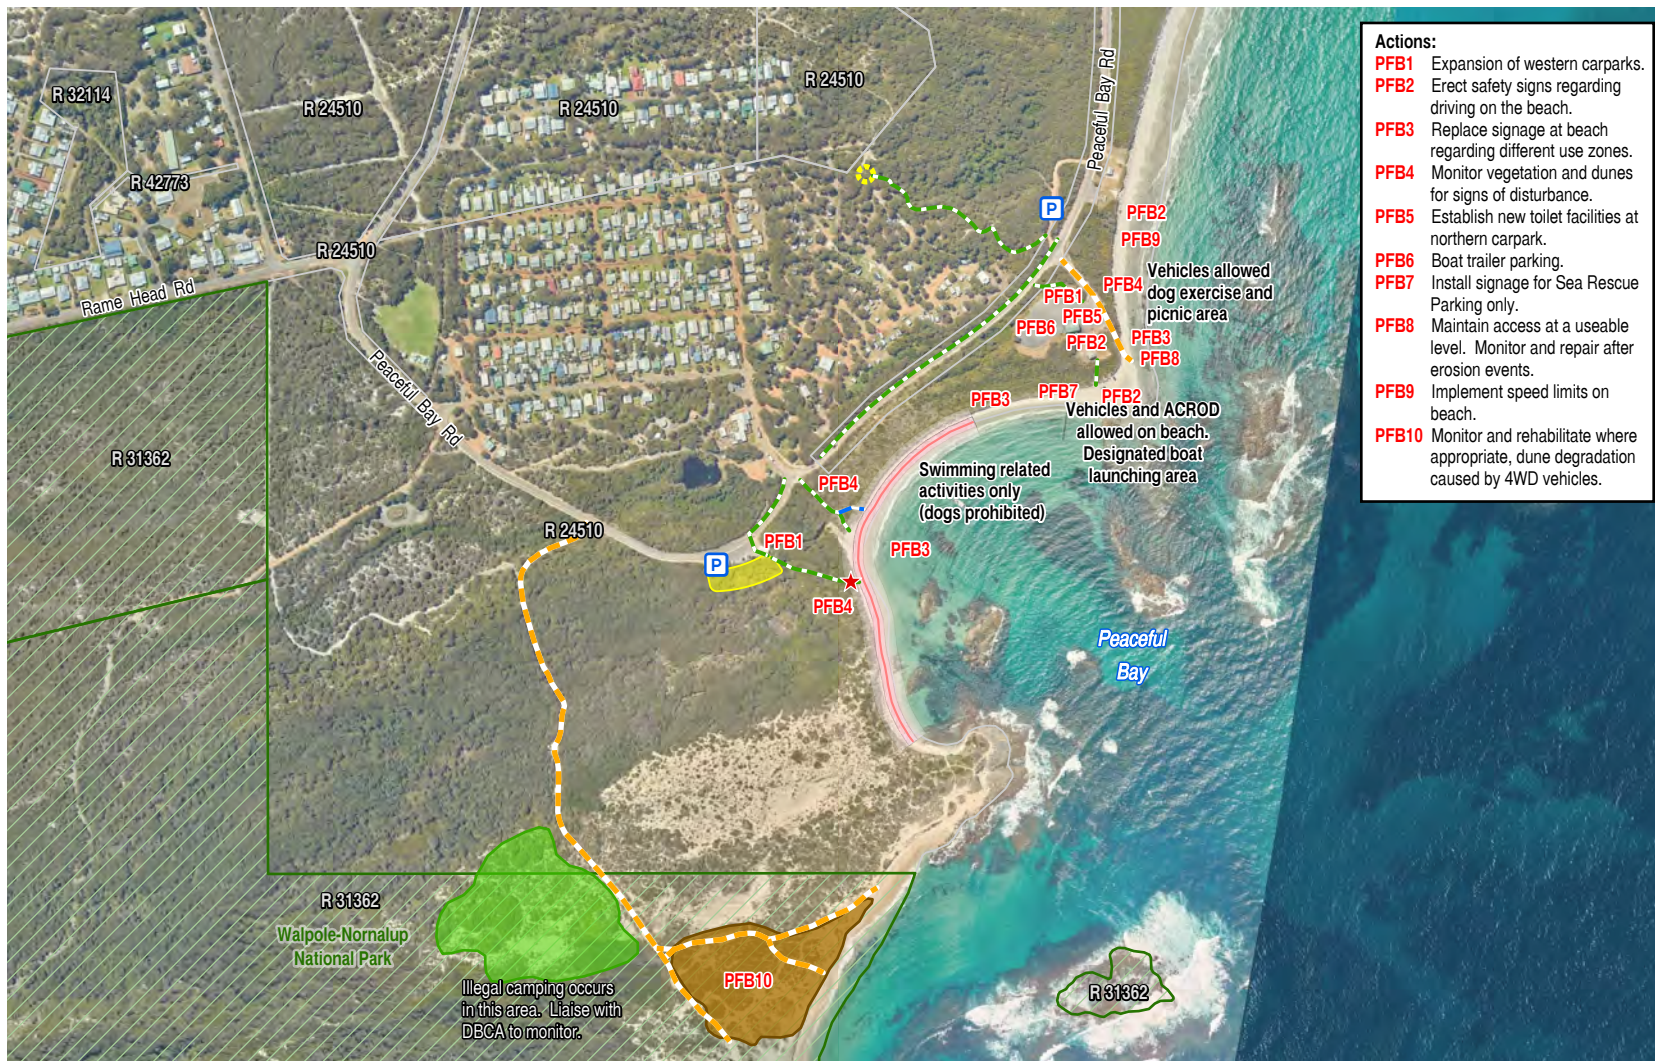
- Actions:**
- PFB1** Expansion of western carparks.
 - PFB2** Erect safety signs regarding driving on the beach.
 - PFB3** Replace signage at beach regarding different use zones.
 - PFB4** Monitor vegetation and dunes for signs of disturbance.
 - PFB5** Establish new toilet facilities at northern carpark.
 - PFB6** Boat trailer parking.
 - PFB7** Install signage for Sea Rescue Parking only.
 - PFB8** Maintain access at a useable level. Monitor and repair after erosion events.
 - PFB9** Implement speed limits on beach.
 - PFB10** Monitor and rehabilitate where appropriate, dune degradation caused by 4WD vehicles.

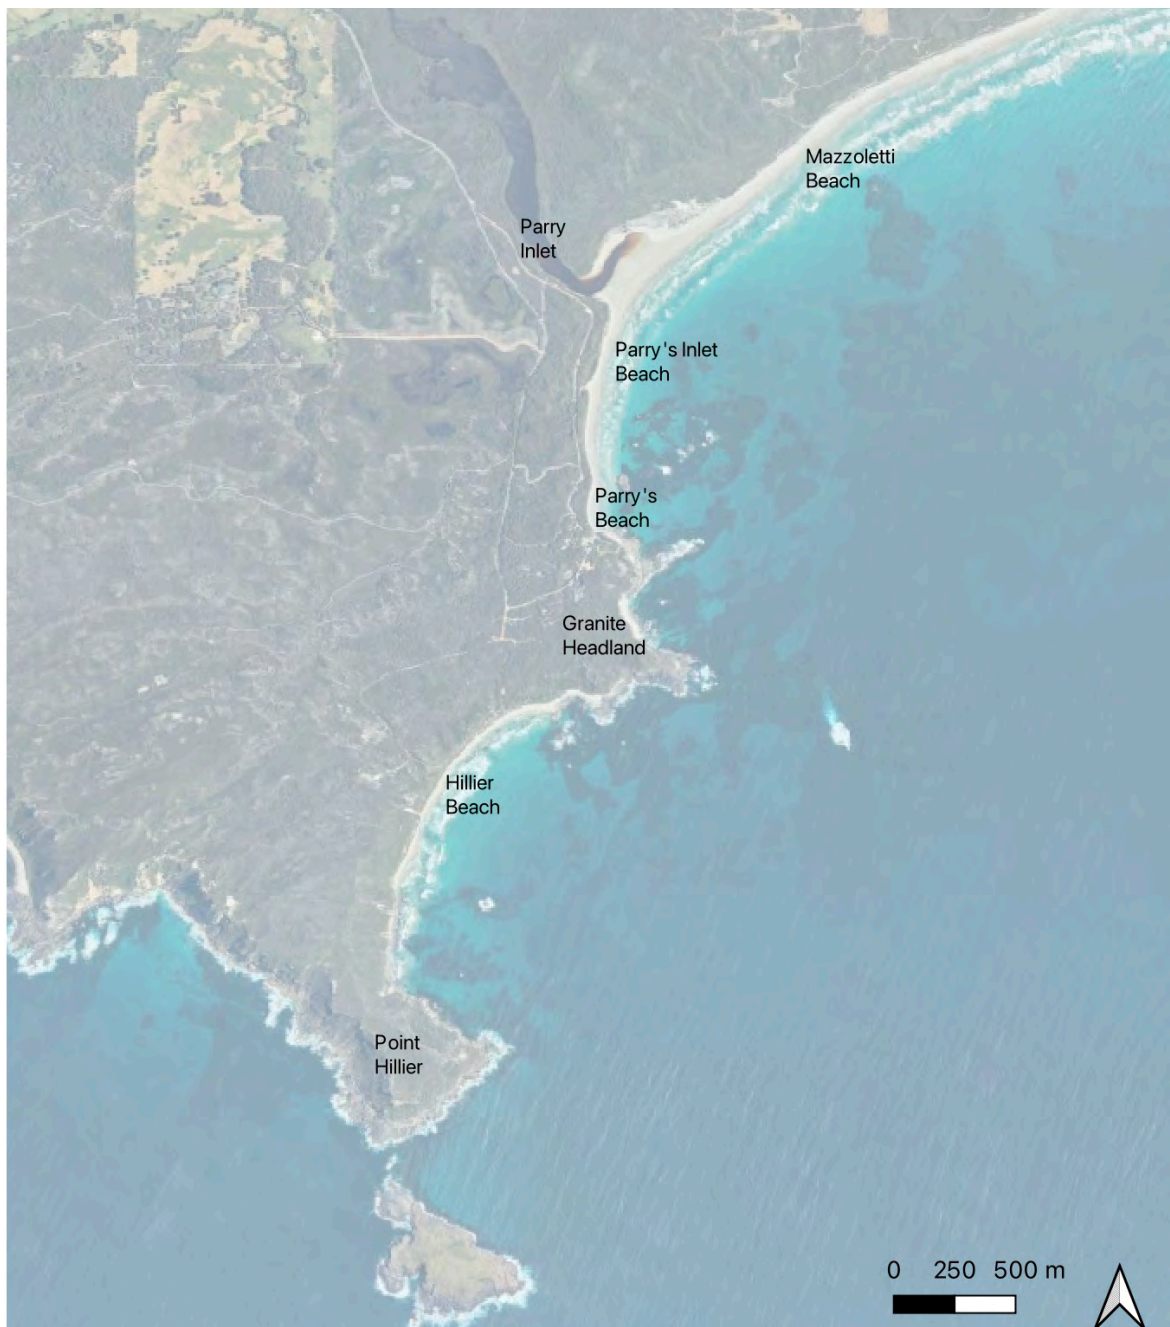
Figure 2-1 Beaches in Parry Beach Reserve

The coastline in Parry Beach Reserve has been segmented into distinct beach forms, namely (from north to south) Mazzoletti Beach, Parry Inlet, Parry Inlet Beach and Parry Beach (Figure 2-1). The reserve's coastline and the estuarine boundary have 2km of rocky headlands, 2.4km of sandy beaches and approximately 2km of tidal estuary (5).

Parry Beach commences on the southern side of the foreland/granite island, and curves to the south for 200 m to the start of a 600 m wide granite headland. This beach is protected by the point and reefs, with waves averaging about 1m, which break across a narrow low tide terrace backed by a low gradient beach face. There is a large car park, camping and caravan area behind the southern end of the beach, which is also used to launch small boats.

South of the small Parry Beach settlement is a 20 m high point that forms the western boundary of the Parry beaches, with the larger Point Hillier located 1.5 km to the south. In amongst and between the points are three small beaches, and one main beach 1 km long east facing (Hillier Beach) that connects the northern point with the first rocks of Point Hillier (6).

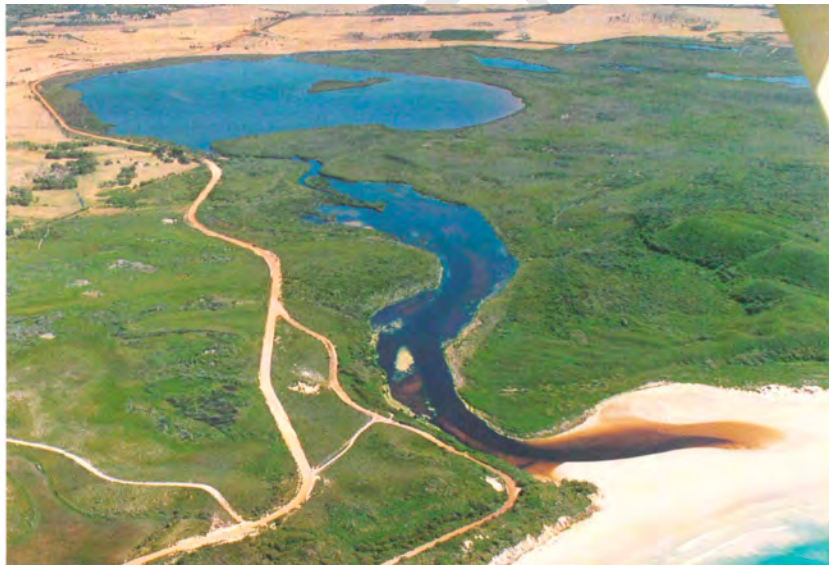
Figure 2-2 Parry Inlet (7).

Parry Inlet is a relatively small inlet for the south coast, with an area of only 1.4 km², fed by the Kordabup River. The catchment of Parry Inlet is relatively small, just over 100km², of which at least 80% of is cleared farmlands. The inlet breaks out across the junction of Mazzoletti and Parry beaches during winter rains. The Kordabup River is the only river flowing into the estuary. It is estuarine for about 2 km where it borders the north side of a large swamp from which there are drainage channels from the river (7).

When the channel opens to the ocean it flows close to the southwestern shore but typically migrates northeast behind the beach and may flow to the sea anywhere within 300m from the southwestern shore. The bar opens naturally or is opened by the Shire in winter (July to September) to prevent flooding of the road along the western shore of the Inlet and of pastures and potato paddocks (8). It may close and open again several times during the winter. The bar now normally closes each summer but is reported to have remained open for five years in the early 1940s. (7).

The sandbar is currently breached by the Shire of Denmark to reduce flooding impacts on Parry Road and adjacent private property. The Shire decides the location of the bar opening in consultation with the Parry Beach Voluntary Management Group (PBVMG). Location is based on achieving maximum initial scouring of the channel and minimum erosion of the coast sandhills on the western bank of the channel. The channel is typically pegged by a representative of the PBVMG prior to excavation commencing (8).

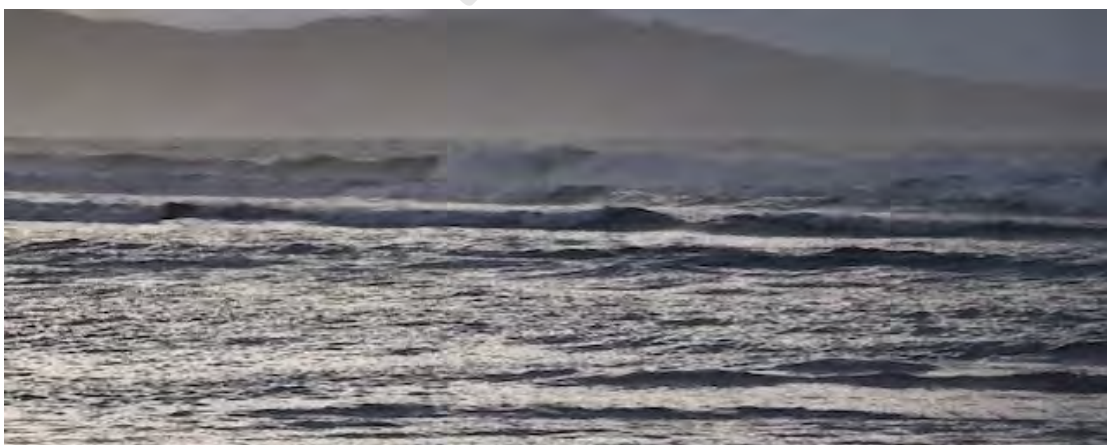
Figure 4-2 Breaking waves near Parry Beach Inlet (June 2022, supplied Shire of Denmark)

Exposure to offshore waves decreases south from Parry Inlet towards the beaches adjacent to the Caravan Park, where the rocky headland and granite island provide greater sheltering. Breaking waves are described as typically being between 1 to 1.5m adjacent to Parry Inlet (Figure 4-2), to 1m further south towards the Caravan Park (6).

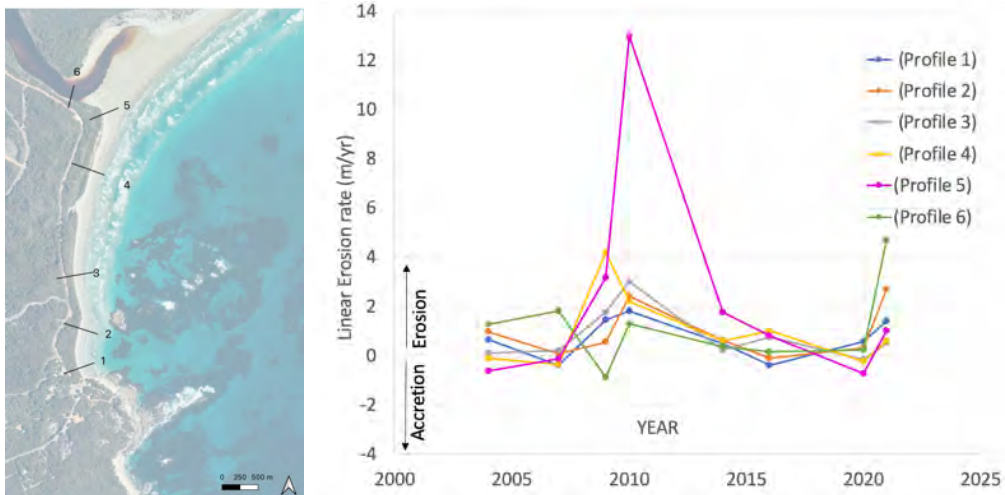
Figure 5-2 Coastline Movements – Parry Beach

The coastline movement analysis also identified the southern bank of the Parry inlet has been subject to erosion in recent years, with steep scarps evident approximately 150m inland from Inlet Mouth, where there is a narrow buffer (<10m) to the access road. An 80m section of riverbank has demonstrated erosion of ~6m between 2016 and 2020, forming a steep and unstable erosion scarp (Figure 5-3).

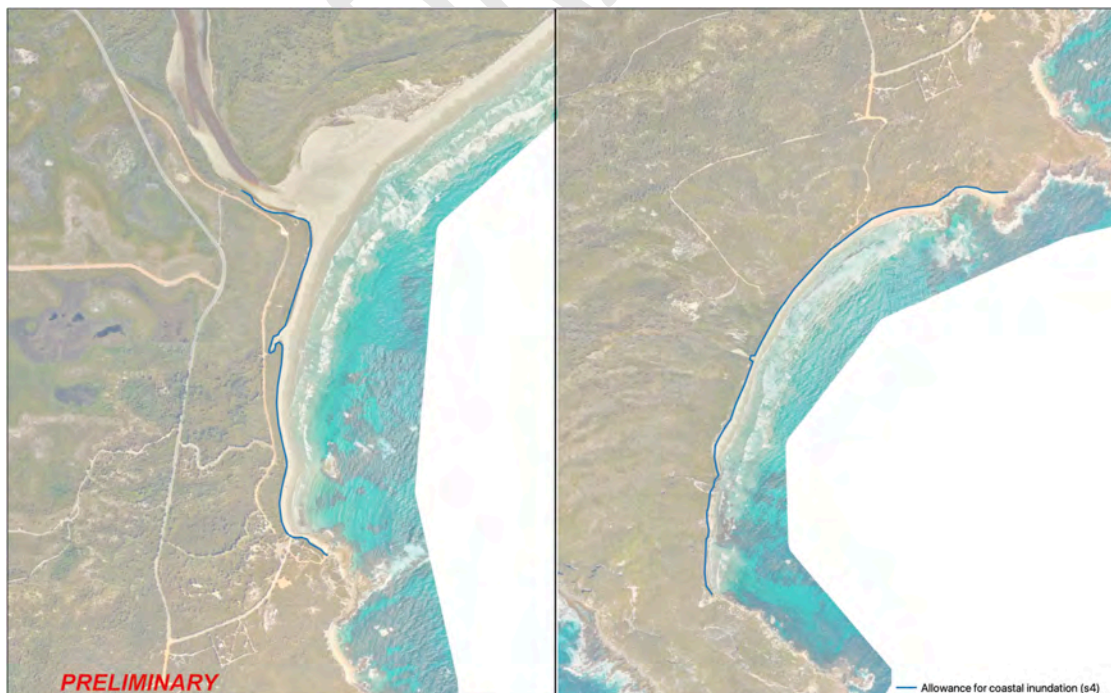
Figure 6-3 Mapping of allowance for coastal inundation

There is ~35 years of water level data available from the nearest tide gauge (Albany), extrapolation of a 500-year ARI water event is not appropriate. The City of Albany CHRMAP (15) provides inundation levels for the 100-year planning frame of 2.62m, based on (16). This has been adopted as the proposed maximum extent of inundation.

Available survey of the wider Parry Beach Reserve is limited to a 30m grid, which typically resolves to approximately 5m contours and is not sufficient to map the inundation extents. However, the high-resolution UAV survey of a small section of Parry Beach, completed in 2023, has been used to demonstrate that the vegetation line along Parry Beach is approximately associated with 3mAHD contour. This has been used as a guide to map the inundation allowances. This is valid for a preliminary mapping of the coastal inundation under the guidelines of SPP2.6 only.

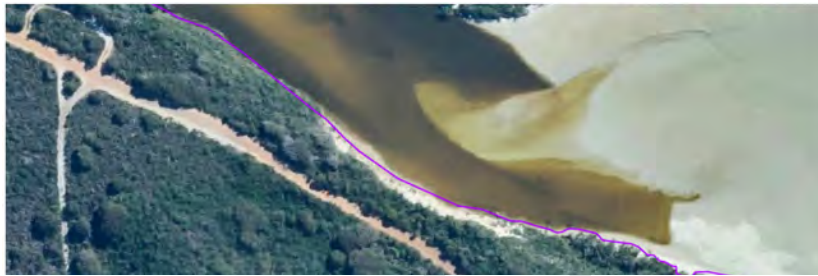
Figure 7-1 Southern embankment of the Inlet (narrow buffers to gravel road)

Erosion scarps are evident along the southern embankment of the Inlet, adjacent to the access track to the day-use area. There are narrow buffers to the gravel road, and monitoring of the steep embankment is recommended.

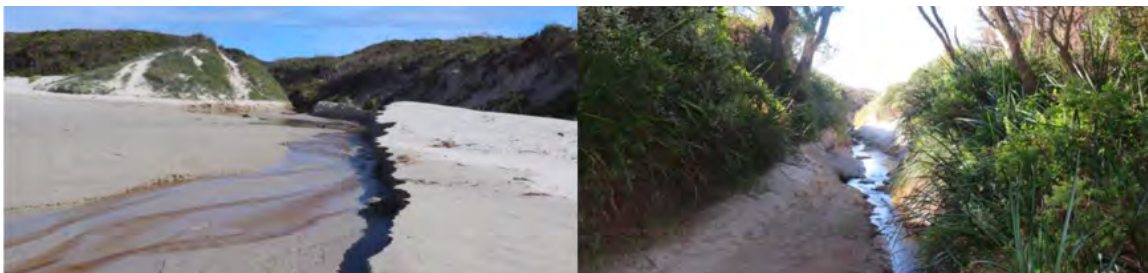
Figure 7-2 Creek outlet south of Parry Inlet (August 2023)

A cutting in the dune 400m to the south of Parry Inlet had been identified by the Shire as a potential second site for vehicle access to the beach, allowing separation between beach users and vehicles along the beaches between the creek and the current access. However, during the site inspection this cutting was associated with the outlet of a creek channel that drains a relatively large body of water to the west of the gravel access road. This had scoured a deep and narrow channel with steep and unstable embankments. The creek outlet was actively running through the high dunes, created localised beach erosion.

This is not considered to be a suitable site for secondary beach access, as it would be sited on an active creek line, require substantial clearing of the adjacent embankments for a suitable cutting, and be subject to ongoing scour and erosion during period of active creek flow.

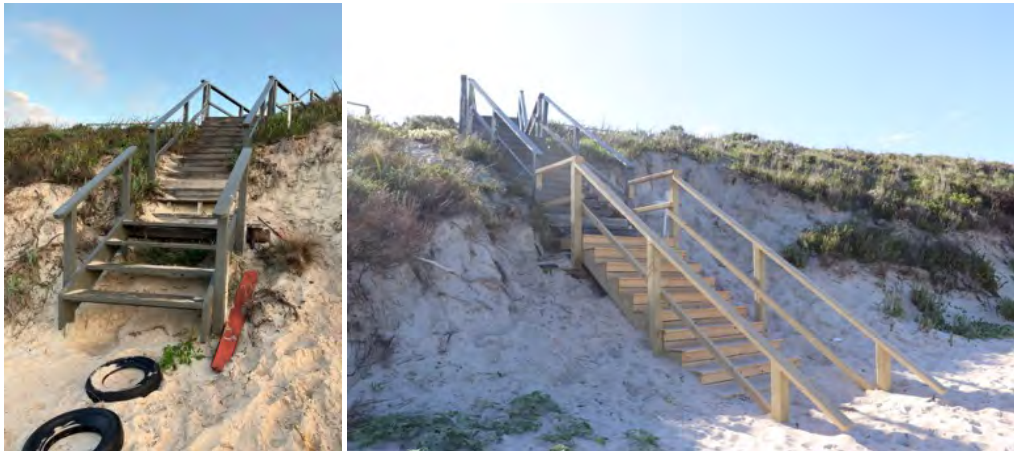
Figure 7-4 Timber Access stairs at Hillier Beach in June 2022 (left) and August 2023 (right)

Beach access stairs at Hiller Beach were inspected and provided good access to beach users. It is understood undermining of this structure has occurred in the past. The current design is reasonable for the beach which has been recently accreting, but should continue to be inspected after storms and adapted to ensure the lower stairs are level flush with the beach.

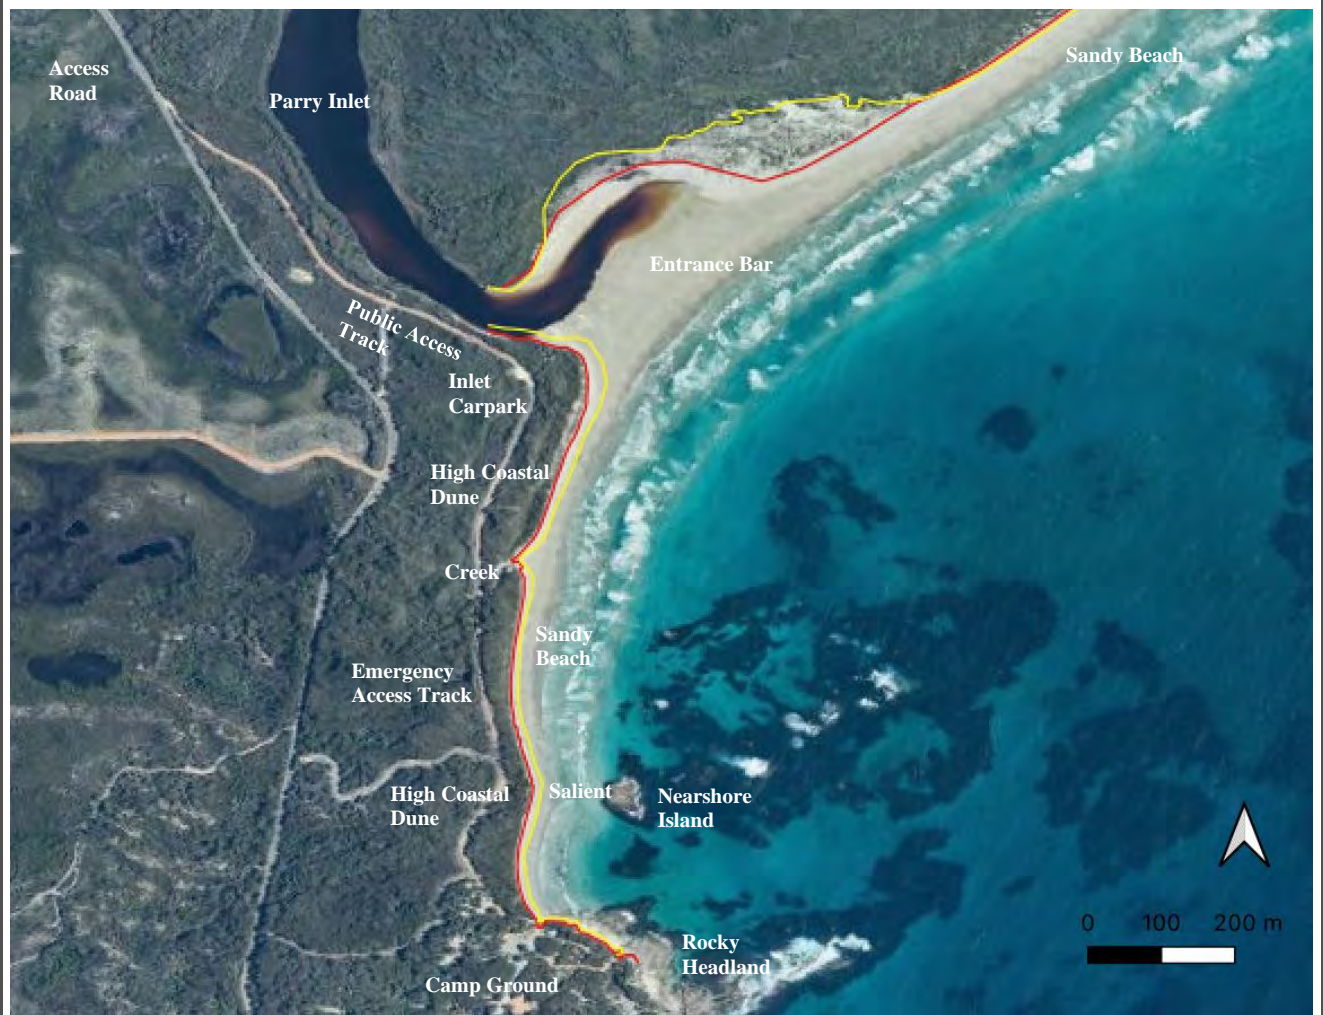
Parry Beach 2021 imagery showing key geomorphic features and Shire assets. Note 2001 coastal vegetation line shown in yellow, and 2021 coastal vegetation line shown in red.

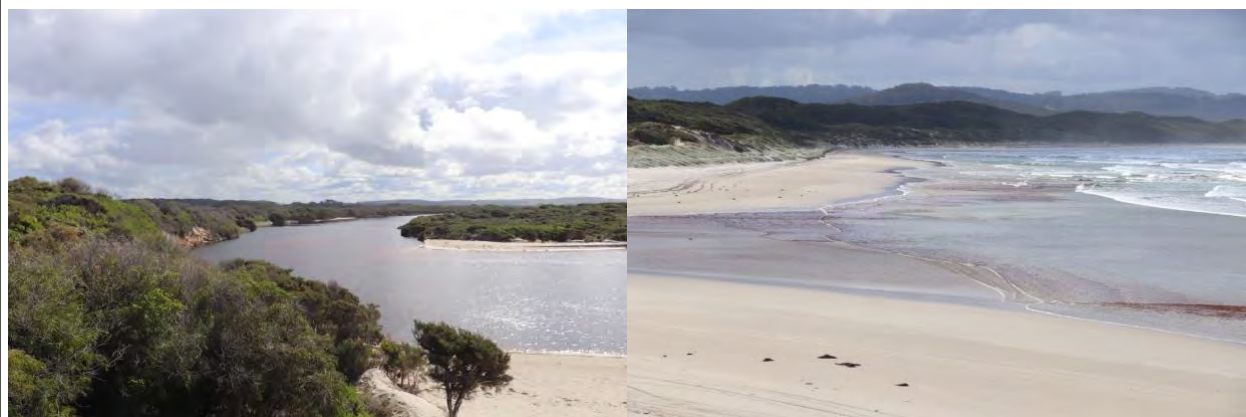
Parry Inlet (left) with erosion along the southern bank, and beach to the north of entrance bar (right). Entrance channel was shallow and able to be crossed by 4WD vehicles.

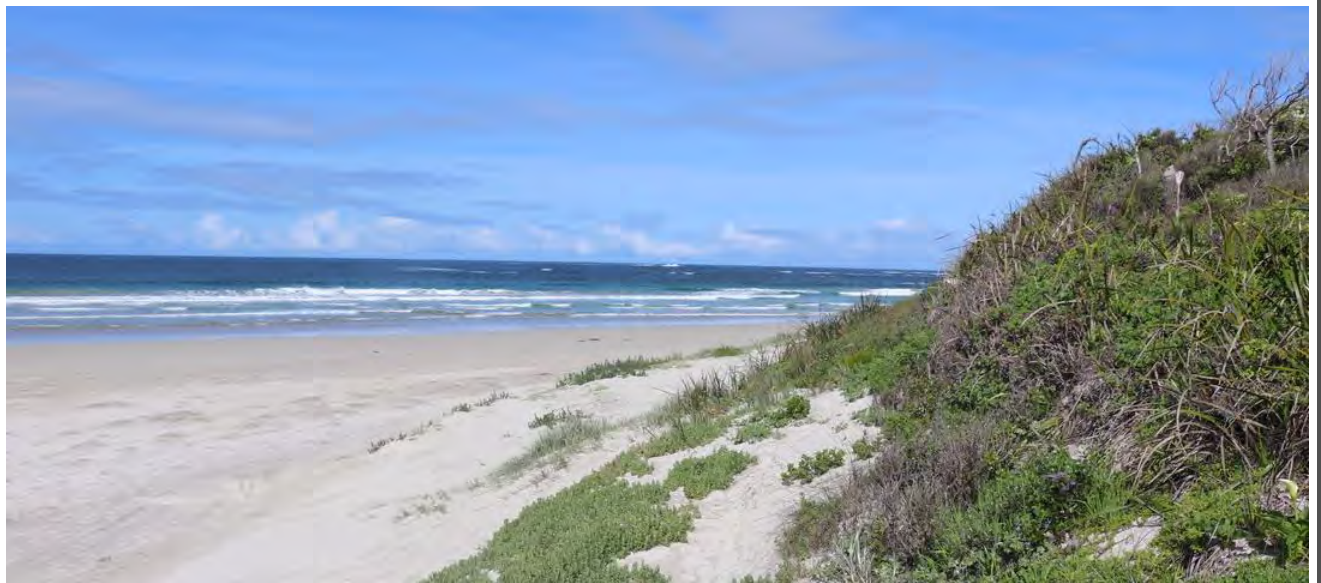
Coastal dunes on southern side of entrance are highly mobile, although incipient coastal vegetation indicates recent localised accretion.

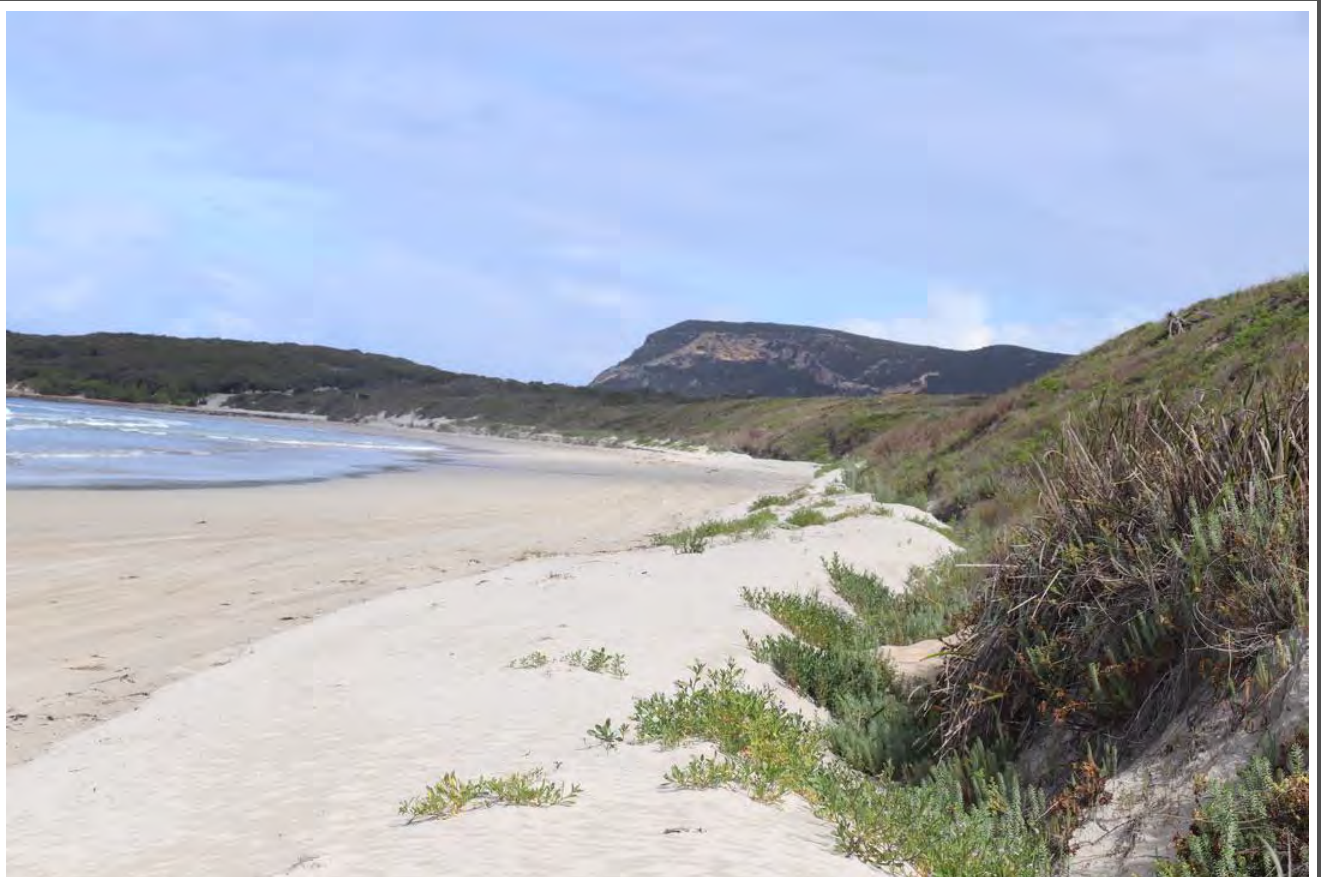
High coastal dunes between Parry Inlet and creek. Recent accretion of foredune observed. Dunes are very high and undulating with deep swales behind the primary dune. Beach is wide.

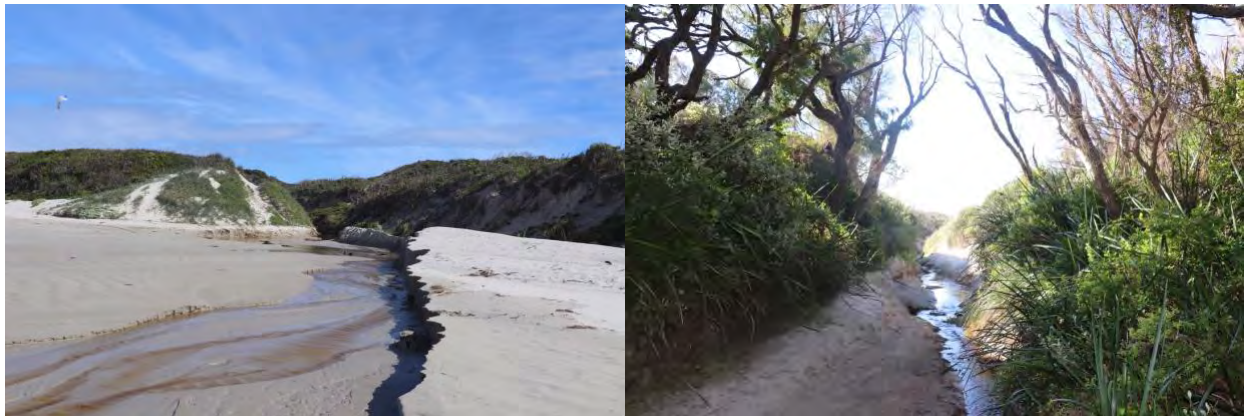
Creek between entrance and salient. This is an established creek line that drains larger low-lying areas within swales behind the dunes. Recent erosion evident on northern side with deep narrow gully between high dunes.

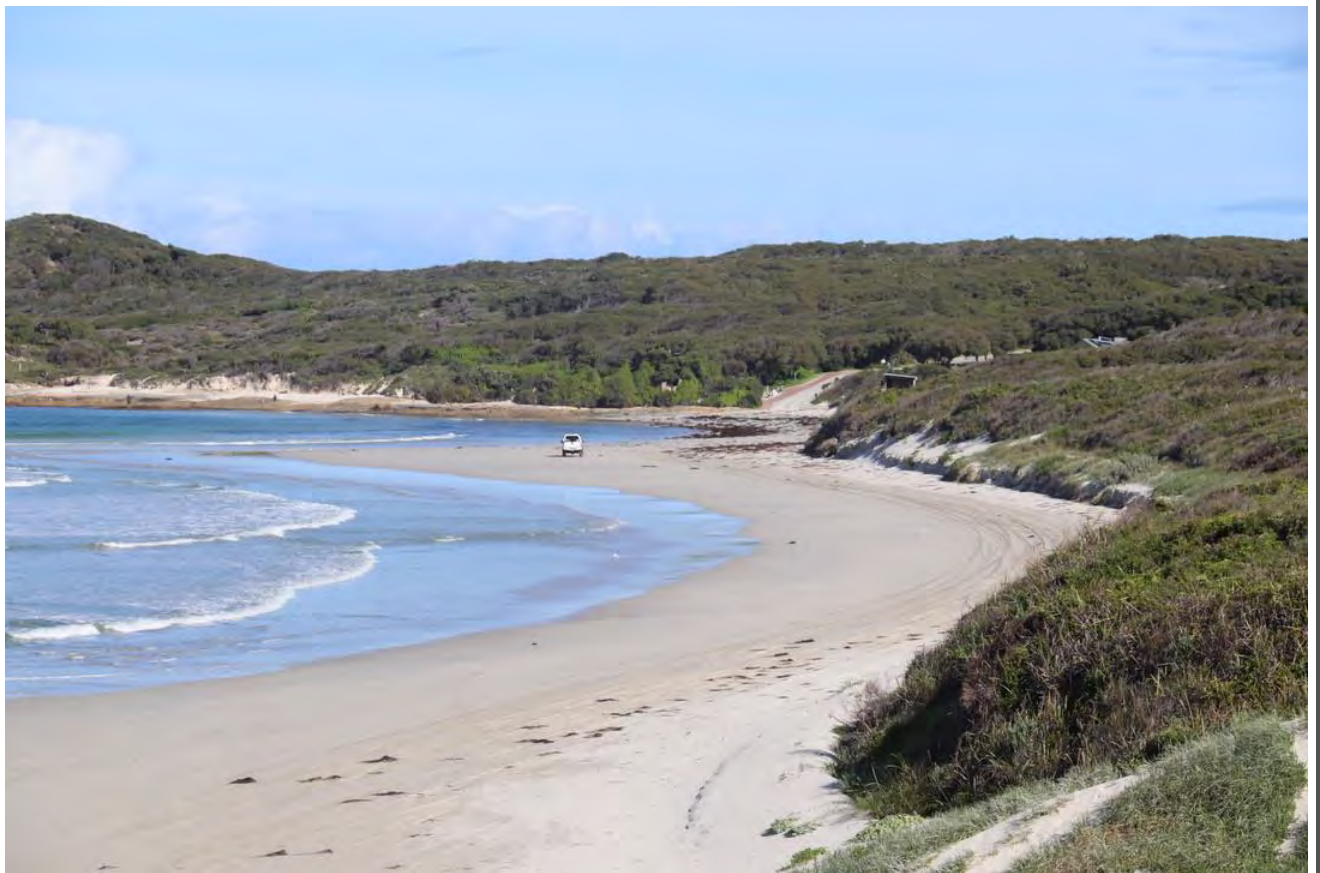
Local salient due to nearshore island. This provides control of embayed beach to the south. Foredune erosion evident to north and south of salient, with wide flat sandy beach.

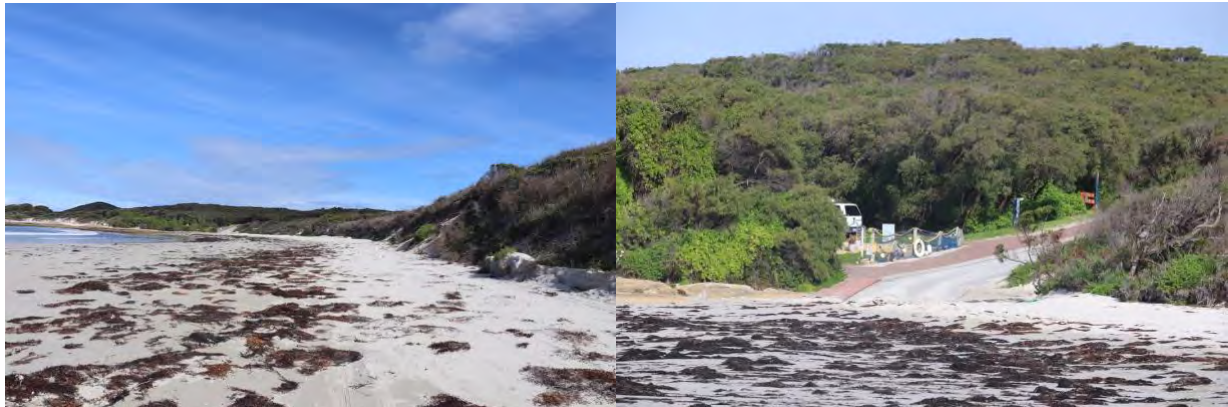
Embayed beach between salient and campground vehicle beach access ramp. Beach access is at a low point in the dunes at the southern end of the beach adjacent to the rocky headland. Coastal dunes show evidence of historic erosion, with moderate wrack accumulations on beach.
