COASTAL RESERVES MANAGEMENT PLAN

MARCH 2024

Prepared by:
Land Insights

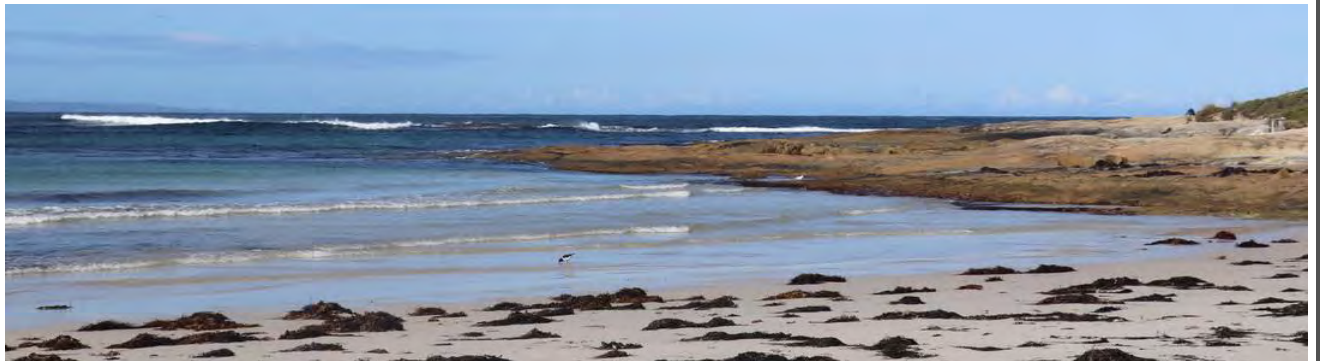
Rocks headland provides a control at the southern end of the beach. Offshore reefs dissipate wave energy.

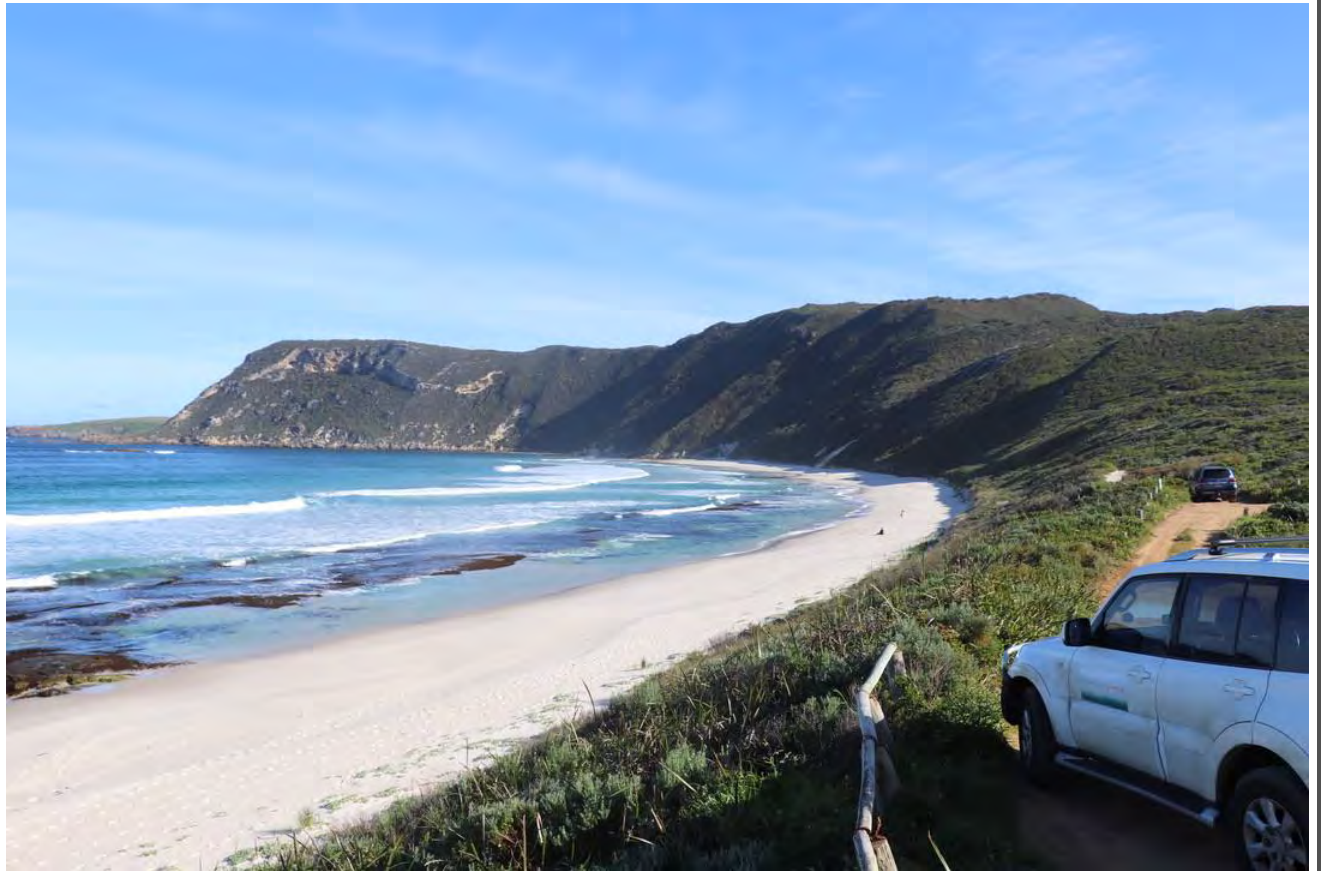
Hillier Beach to the south. Higher energy beach with greater exposure to the southwest. Nearshore reef platforms, moderately wide undulating sandy beach with beach cusps, and steep high dunes with recent evidence of accretion. Beach access stairs were functional.

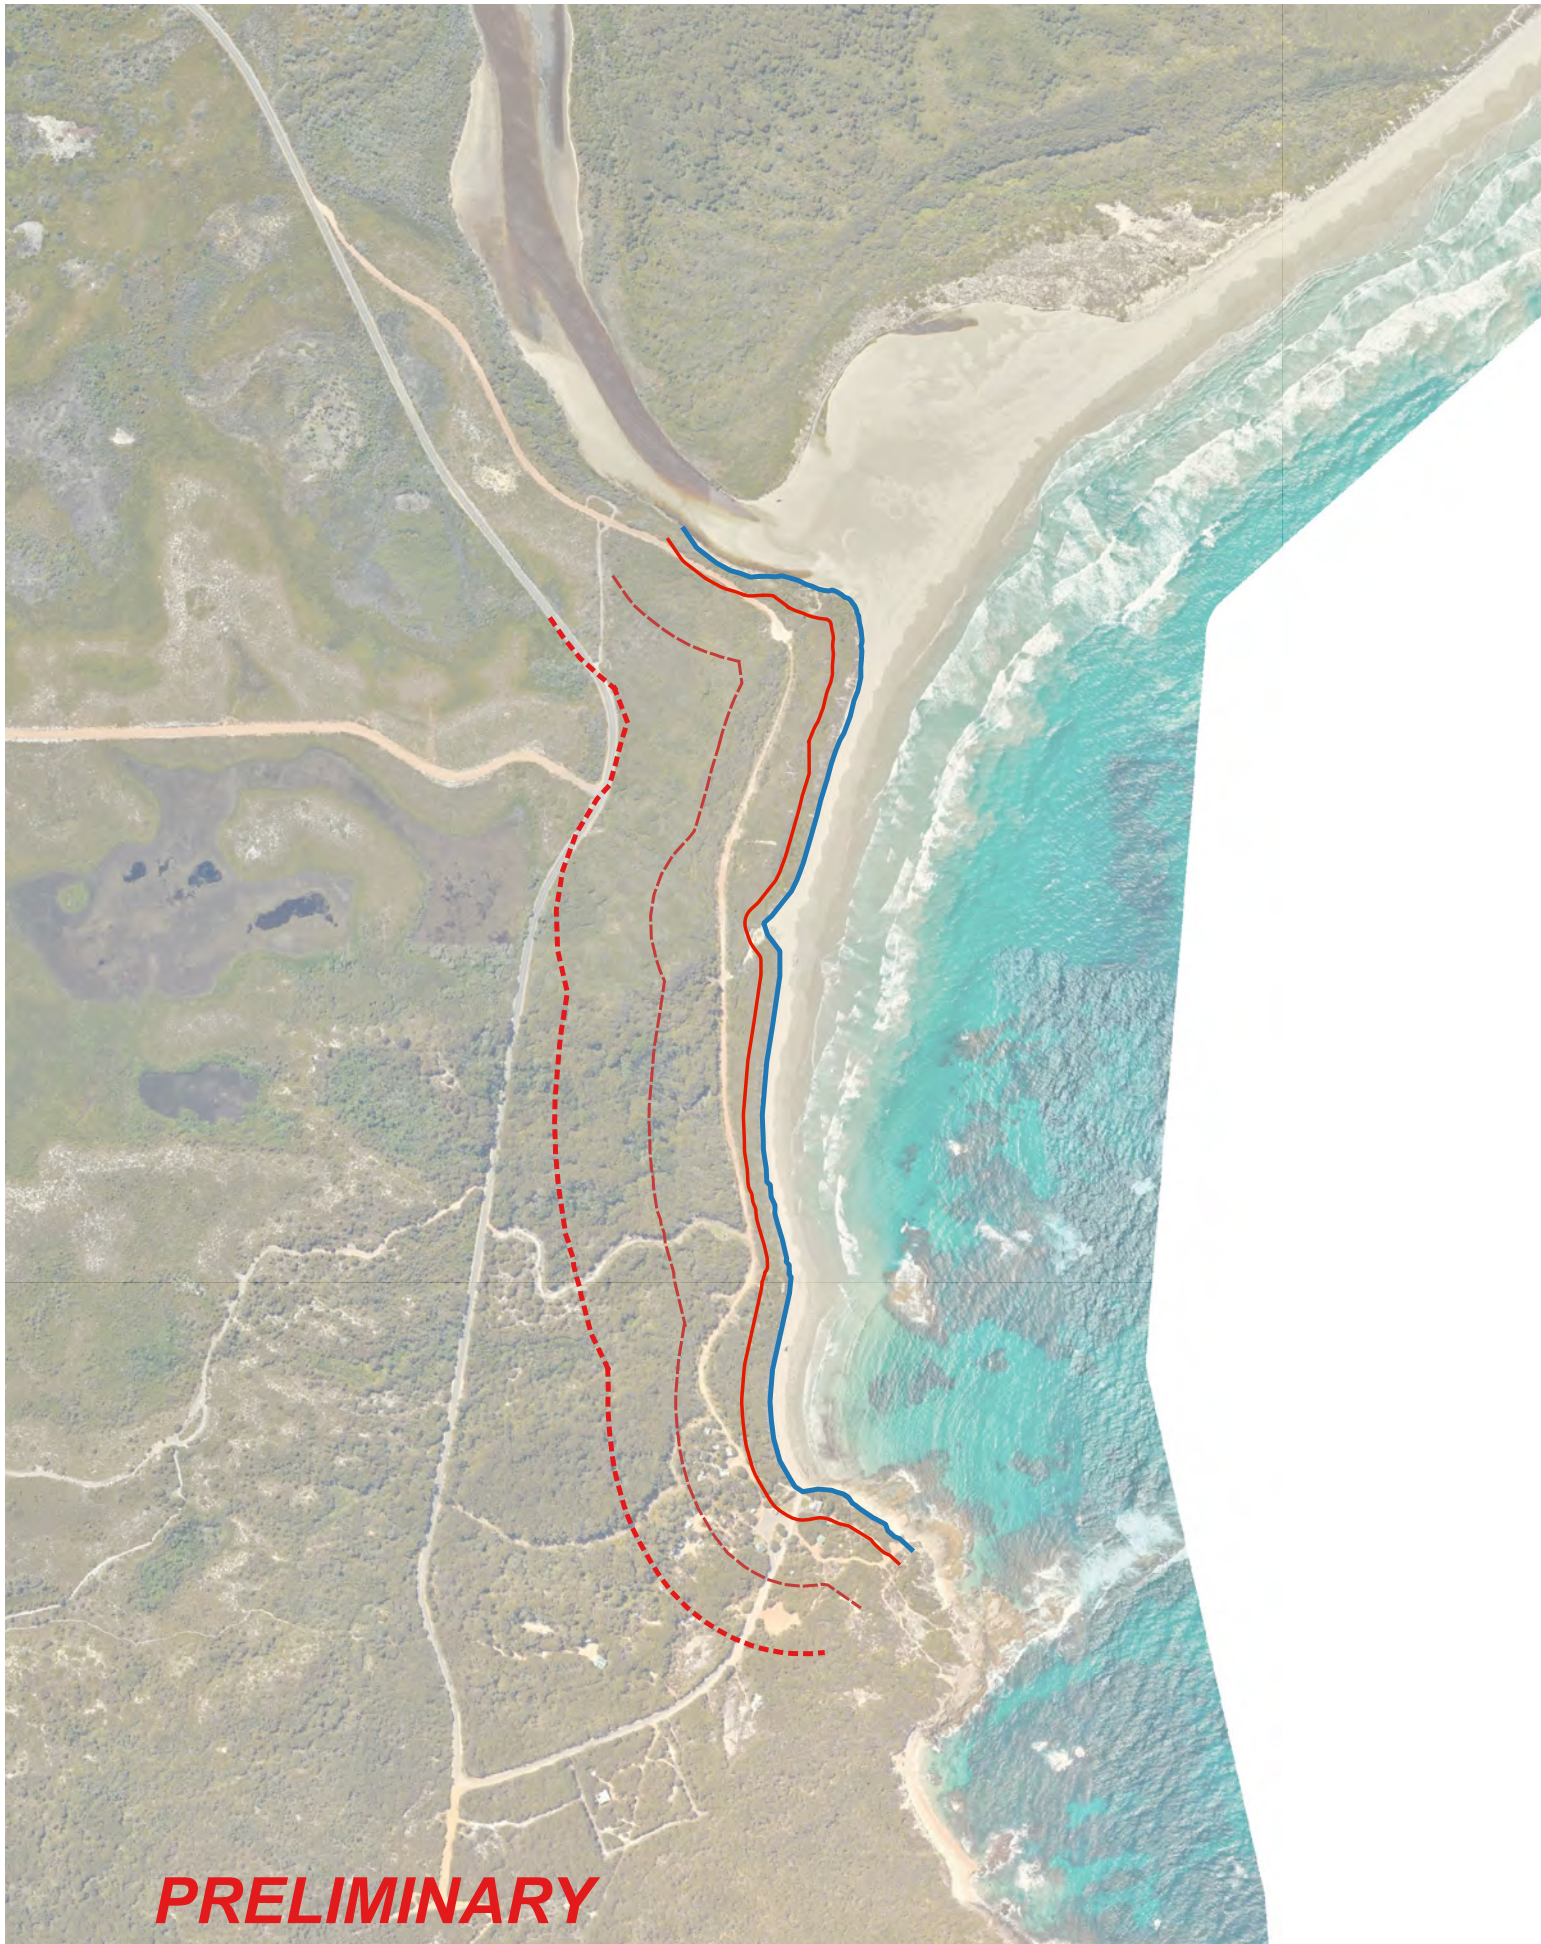
- HSD_Parrys Beach Denmark
- 10yr Planning Allowance_Parrys Beach Denmark
- - - 50yr Planning Allowance_Parrys Beach Denmark
- - - 100yr Planning Allowance_Parrys Beach Denmark
